June 12, 2013

21-1-21664-001

RE: DOCUMENT REVIEW SERVICES, MARINE DRIVE BINWALL RETAINING STRUCTURES, CITY OF WHITE ROCK, WHITE ROCK, BRITISH COLUMBIA

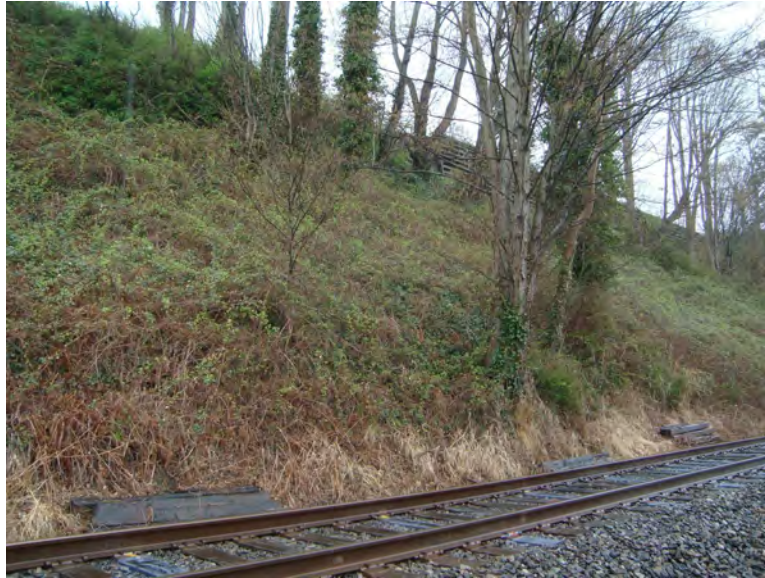
The hump hillside slope is generally vegetated with scattered deciduous trees and dense brush. Blackberry bushes make up a large part of the brush vegetation. The slope reaches a maximum height of approximately 20 m above the BNSF tracks and has slope inclinations between approximately 30° and 45°, as measured in the field with a hand-held inclinometer. Photograph 1 below illustrates the representative vegetation on the hump hillside.

Photograph 1: Representative Vegetation on the Hump Hillside

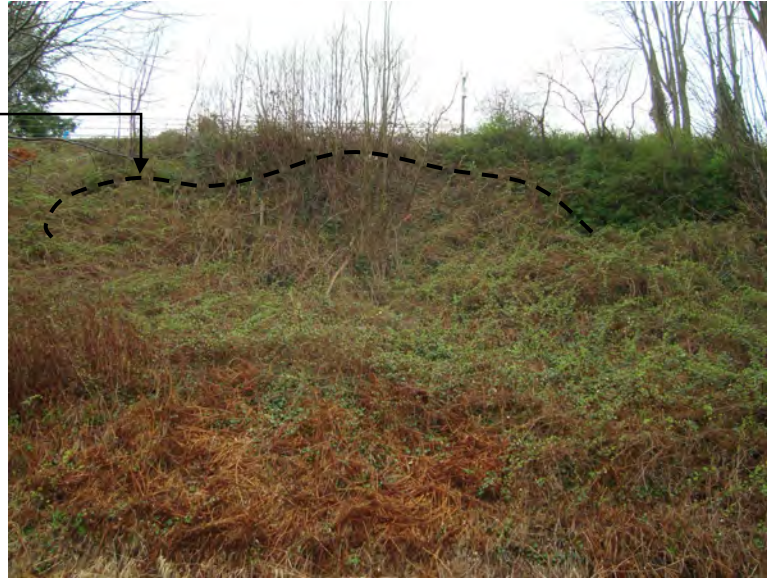
Shallow and medium seated landslide scarps were observed at multiple locations along the extent of the slope. Slope inclination is greatest at the scarp locations and increases to a maximum inclination of approximately 45°. The landslide scarps were generally observed to be vegetated with young deciduous trees and brush. Curved and leaning tree trunks were also observed on the subject hillside.

Vegetated scarps indicate that landslide activity had not occurred in the immediate past. However, as landslide scarps curve/bent tree trunks are present on the subject slope, the slope is considered susceptible to localized surficial creep and shallow seated failures. A vegetated landslide scarp observed during the site reconnaissance is presented in Photograph 2 below.

Photograph 2: Example of a Vegetated Landslide Scarp

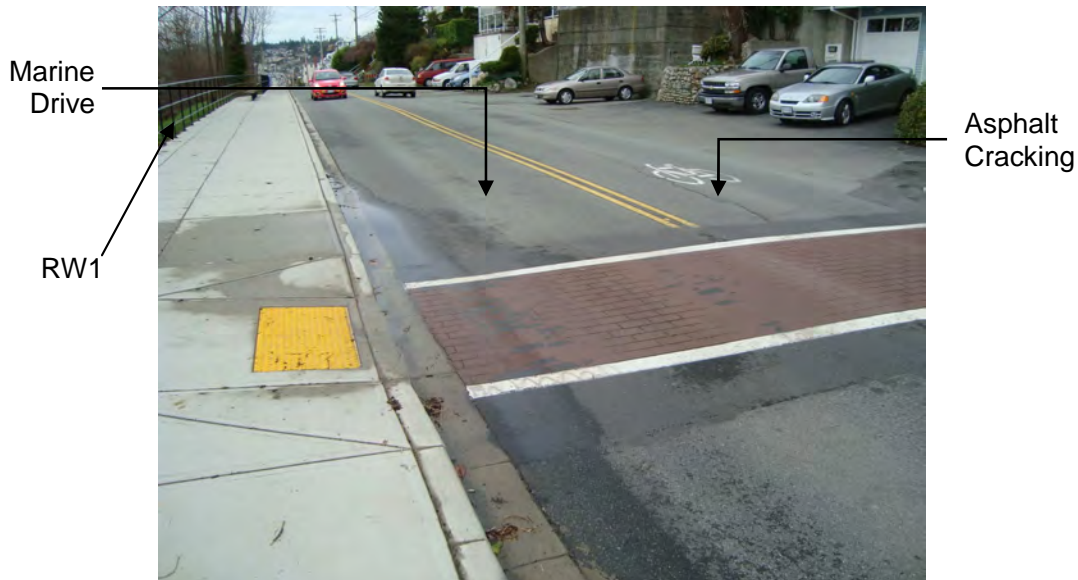
The extent of Marine Drive associated with the hump hillside exhibited asphalt tension cracking and localized ground settlement. In particular, asphalt cracking was observed in both the eastbound and westbound lanes of Marine Drive behind RW1. Based on information provided by the Client, Levelton understands that the section of Marine Drive associated with the hump hillside was paved within approximately the last two years. Additionally, a review of Google Earth Streetview indicated that longitudinal cracking was present in the asphalt prior to re-paving. Photograph 3 below illustrates longitudinal (tension) cracking in the Marine Drive new asphalt located behind RW1.

Photograph 3: Asphalt Cracking Along Marine Drive Behind RW1

We recommend that the City monitor the condition of the pavement above and near the three steel binwalls, and that any cracks be sealed such that surface water is not permitted to infiltrate the wall backfill. We recommend that irrigation, sprinkler systems, and other sources of potential uncontrolled water release be prohibited near the top of the three steel binwalls and adjacent areas.

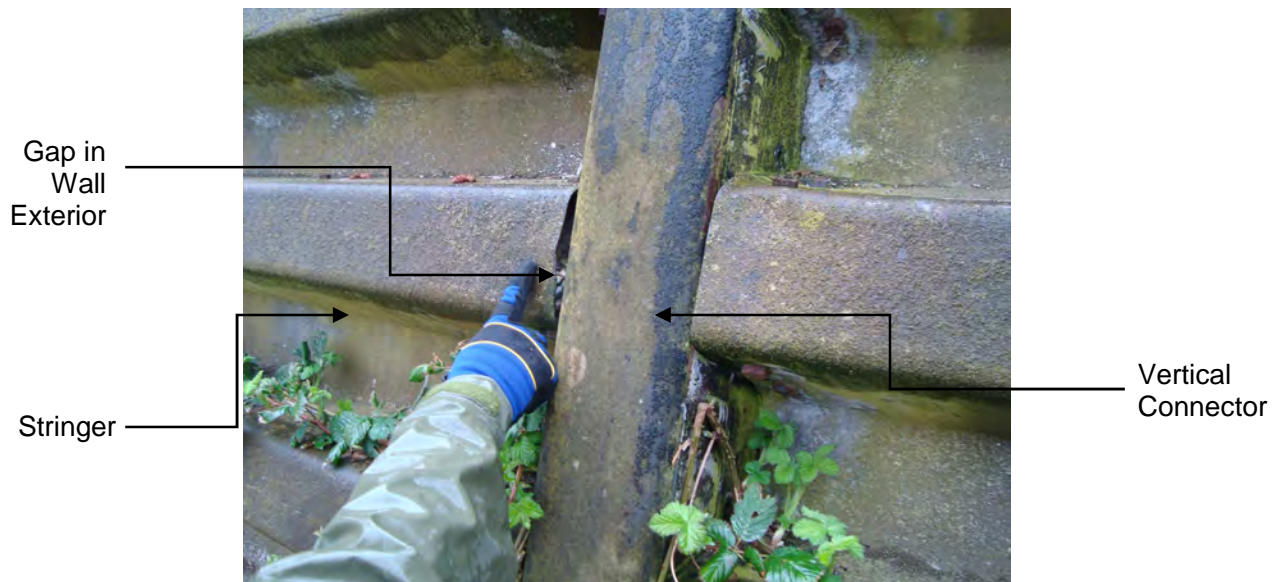
The exterior of RW1 was comprised of lightweight horizontal steel member facing (stringers) and vertical metal connectors. Vertical gaps up to approximately 20 mm wide were observed between the stringers and vertical connectors at locations along the wall exterior. RW1 backfill observed through the gaps appeared to be comprised of pea gravel. Where visible through gaps in the wall exterior, the pea gravel backfill occupied approximately half the height of one stringer, indicating that some wall backfill has likely been lost through the vertical gaps. Photograph 4 below illustrates a representative gap in the wall facing.

Photograph 4: Representative Gap in RW1 Exterior Facing

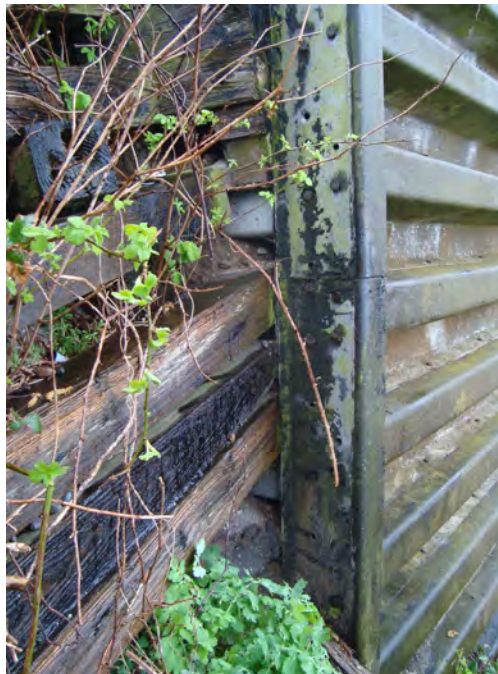
Wood crib retaining walls less than 2 m high were located at either end of RW1. The wood crib retaining walls are not considered to provide substantial support to the slope. The wood crib retaining wall located at the west end of RW1 is illustrated in Photograph 5 below.

Photograph 5: Wood Crib Retaining Wall and RW1

Both EBA and Levelton recommended that the City complete additional work to improve stability along Marine Drive. We support Levelton's recommendation to replace the wood crib retaining walls adjacent to the steel binwall and to complete a structural examination of the metal facing and connections, as well as a corrosion assessment to estimate the remaining design life of the bin walls. We also support their recommendation that the condition of sanitary and storm sewer mains along Marine Drive be reviewed, or evaluated for the presence of water leakage.

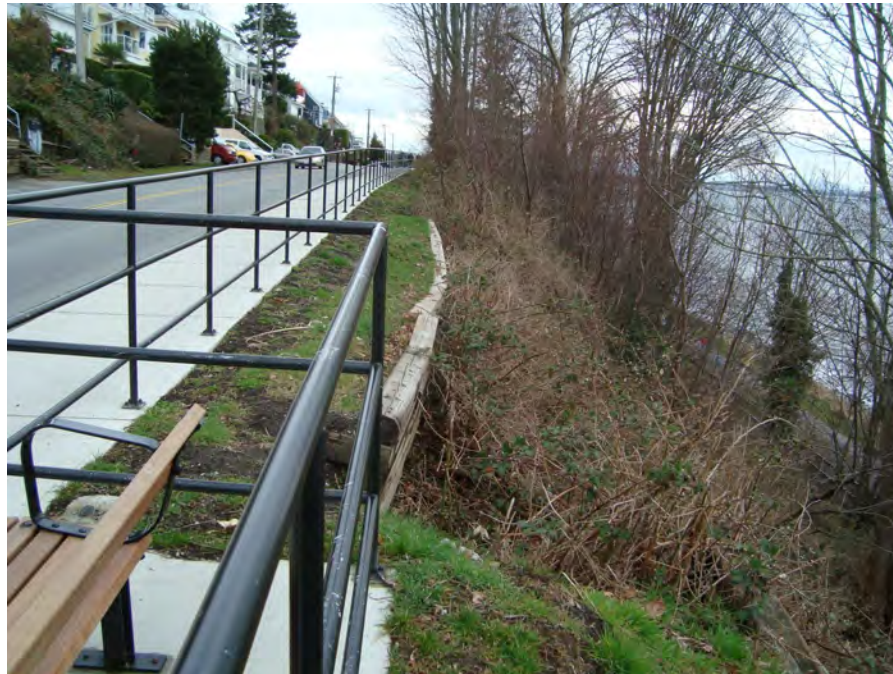
The bin wall to the west of RW1 was observed to be flanked by two wood crib retaining walls at either end of the bin wall. The bin wall to the east of RW1 was observed to have a wood crib retaining wall located at the west extent of this wall. These wood crib walls are considered marginally unstable and require immediate replacement with an engineered retaining wall system. Photograph 6 below illustrates the wood crib retaining wall associated with the bin wall located near 15191 Marine Drive.

Photograph 6: Wood Crib Wall near 15191 Marine Drive
