***Tree Inspection Report for RF Binnie & Associates Ltd.***

**November 2, 2018**

**Prepared by Owen Croy**

**Location:** Memorial Park, 15000 Blk Marine Drive, White Rock, BC

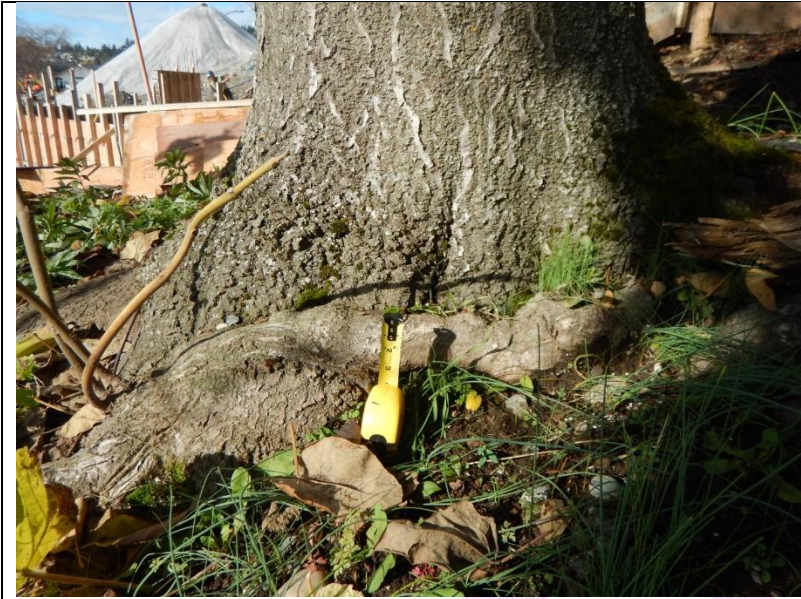
- Retaining walls to the south, north and east have constrained the tree's root system in those directions.
- The tree has a surface root on its east side (figure 1., Appendix II) which has also constrained the growth of the root system towards the east, with notable lack of trunk flare on the east side.

Figure 1. Lateral surface root inhibiting root development on East side.

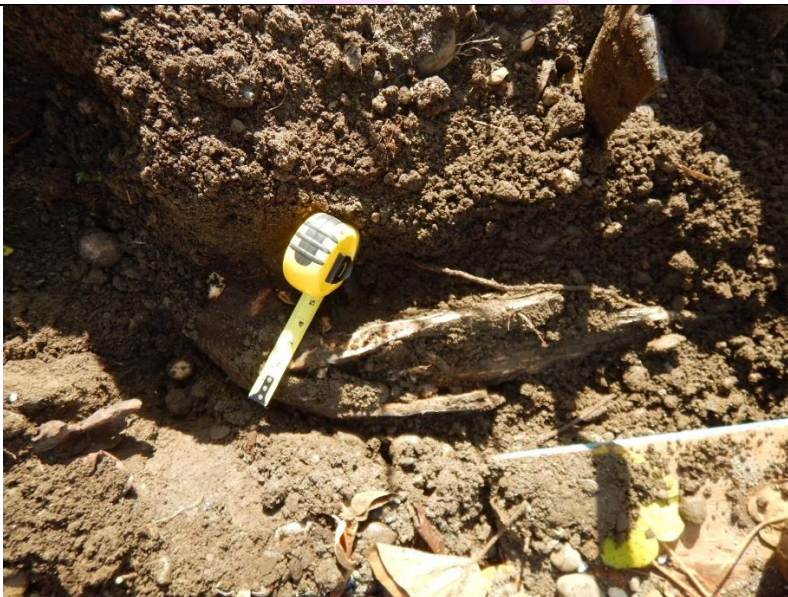
- The tree had a well-developed root system on its west side.
- Construction workers at the site advise that one very large root extended to the south-west of the tree approximately 7.6 m; this root has been severed at a distance of 3.8 m from the base of the tree. (Figure 2., Appendix II) The approximate diameter of the root where severed by machine (not cleanly cut) is approximately 15 cm.

The removal of a large portion of the tree's roots on the north-west, west and south-west sides of the tree has occurred. This has resulted in a reduced capacity of the tree to take up both water and nutrients. This has in turn caused considerable die-back within the crown of the tree. Anecdotal evidence reported by construction staff indicate that the leaves were drooping during hot days in July and August; this was likely the result of root damage and removal. Unfortunately, several of the large roots were not cut cleanly, but rather were raggedly severed, likely through the use of a large mechanical device such as a back-hoe. These raggedly broken roots will not heal as quickly as cleanly cut roots, which will make them more susceptible to colonization by fungal pathogens that can cause root decay.

Figure 2. Large root severed by machine 3.4 to south-west of stem.

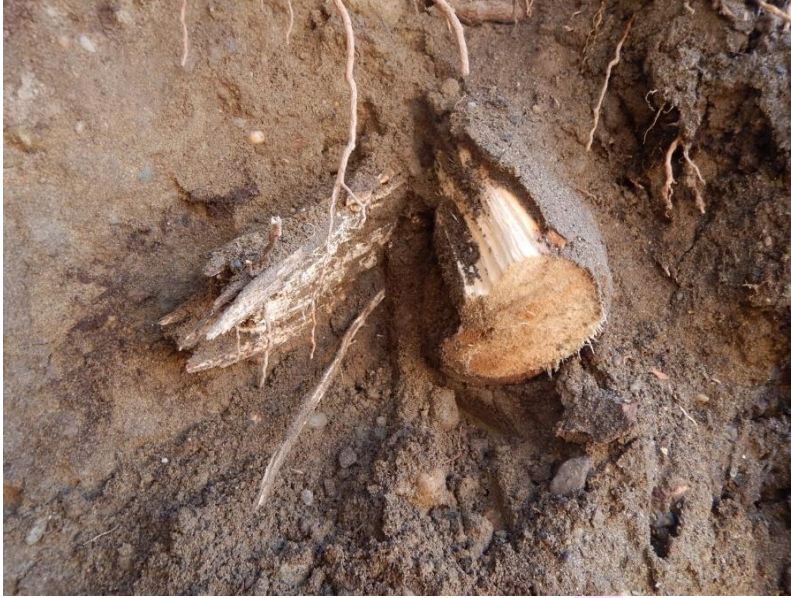
- Another large root of 12 cm diameter has been cut at a distance of 3.4 m from the tree on its north-west side. (Figure 3., Appendix II)
- Several roots of 5 cm diameter have been severed approximately 3.5 m from the tree on its north-west side.

Figure 3. Large root north-west of tree severed.

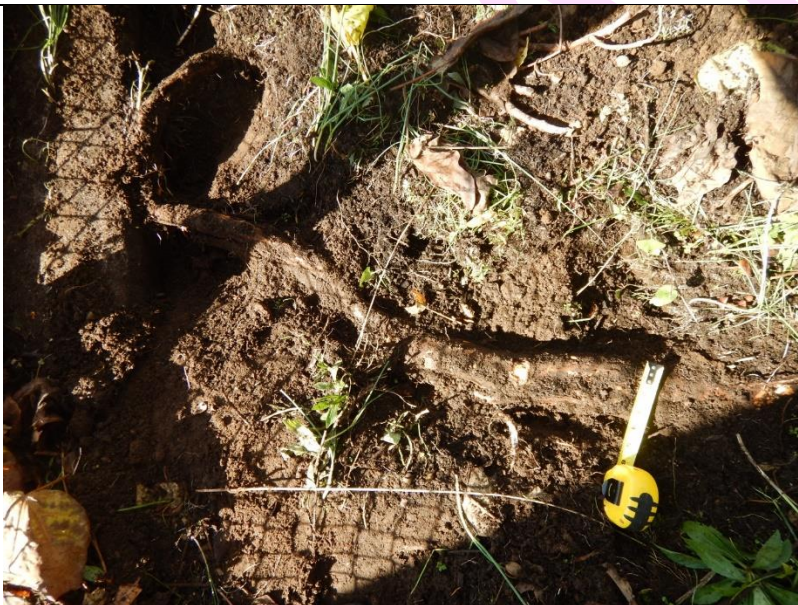
- Intact roots were excavated on the south side of the tree, starting at 1 m from the retaining wall. At 1.0 m, the roots were approximately 8 cm in diameter. (Figure 4, Appendix II)  
Roots of 4-5 cm diameter were present at the south retaining wall, where the roots turn and run horizontally along the wall at a depth of 20 cm.
- Test holes were dug in front (south side) of the south retaining wall. The footing for the wall is present between 62 cm and 50 cm. No roots were observed growing beneath the footing for the south retaining wall. However, historical trenching for utility construction may have severed roots growing on the south side of the south retaining wall.

Figure 4. Intact roots on the south side of the tree, measured 1.0 m north of the retaining wall.

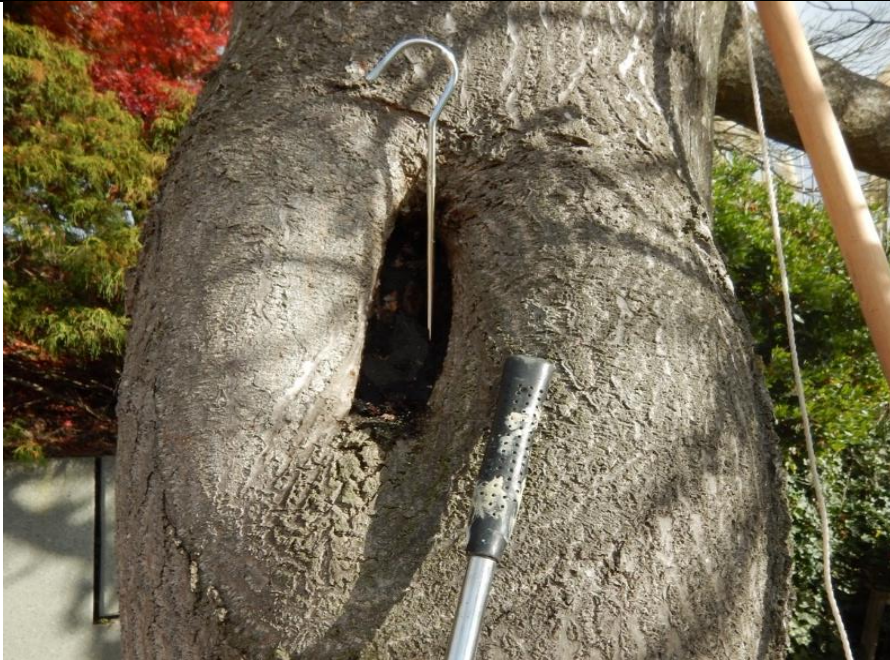
- The main stem has an old wound, 20 cm tall x 6 cm wide, likely arising from the removal of a large scaffold branch, at approximately 1.6 m. Wet, decayed wood is present within the wound. (Figure 5, Appendix II) A metal probe inserted into the decayed wood shows that the wet decayed wood extends approximately 43 cm below the lower lip of the wound in the centre of the main stem. Sound wood appears to be present above the wound.

- The main stem is swollen by approximately 10 cm diameter below the wound, which is likely a growth response of the tree related to the decay occurring within the main stem below the wound.

- Sounding of the main stem with a mallet supports the conclusions drawn from inserting the metal probe; that is, little decay occurs above the wound, but significant decay is present at and below the wound.

The large wound in the tree has not calloused over with response wood. This opening in the stem, together with the presence of decay in the tree, has likely also impaired (to a minor extent) the tree's ability to transport and store carbohydrates while also creating an area of weakness in the main stem.

While there is a open wound and wet decayed wood in the main stem, there is also considerable sound wood to provide support to the tree under normal weather conditions. The likelihood of complete mid-stem failure is possible; failure could occur, but it is unlikely during normal weather conditions. In and of itself, this would not be a sole reason for immediate removal of the tree. However, as there are railway tracks, a pathway and passive park areas within the strike zone of the tree, the risk is elevated, especially during times of adverse weather conditions where exposure to prevailing storm winds is high. (e.g. winds equal to or exceeding 80 km/hour from the south and south-west)

Figure 5. Wound located on main stem, showing steel probe inserted 41 cm into wet decayed wood within.

- **If the tree is to be retained, two guy cables should be installed 2/3 of the height of the tree, anchored back to the north-west and north-east sides of the tree, into secure devices installed in the ground. Also, careful evaluation of extent of the decay should be made through advanced testing to establish a base-line of extent of the decay, with follow-up testing carried out one year later to determine if the decayed area is expanding within the stem of the tree.**

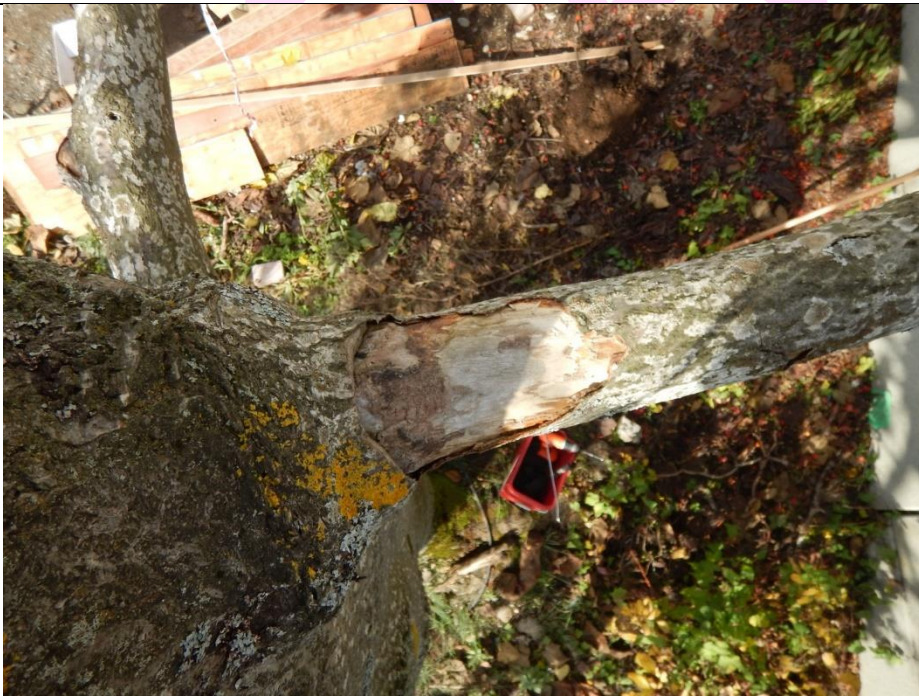
- Visual inspection (tree was climbed) and sampling by way of a pole pruner shows that several large branches growing on the west and north side of the tree are completely dead all the way back to the main stem. (Figure 6, Appendix II)
- Numerous large live branches have subordinate smaller branches that are dead.
- It is estimated that 25-30% of the crown is dead.
- Examination of live branches within the tree indicate minimal twig growth and shoot elongation in the 2018 growing season.
- The live branches have a heavy seed crop, which is often associated with stress in trees. (As this is mast year for this species, the heavy seed crop cannot necessarily be associated with stress in the tree.)

Several subordinate branches in the 3-6 cm diameter range have already fallen from the tree. Given the tree's exposure to ongoing on-shore winds and the number of dead branches in the canopy, failure of additional dead subordinate branches is imminent under normal wind patterns. Failure of dead large branches is probable during periods of elevated wind speeds.

Figure 6. 12 cm diameter branch dead all the way to the main stem.

- **If the tree is to be retained, it's crown should be cleaned of dead branches and the tree should be regularly monitored for die-back of additional branches, with pruning and removal of dead branches as required.**
