December 21, 2018

Project No.: 1180031

Reference: White Rock Pier – Emergency Inspection December 20, 2018

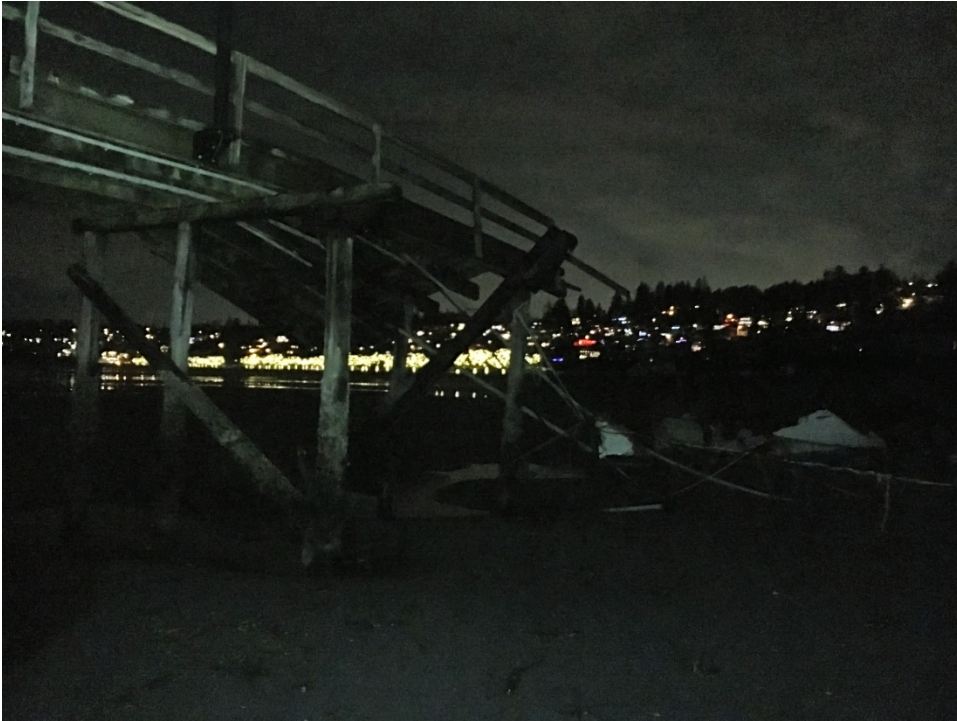
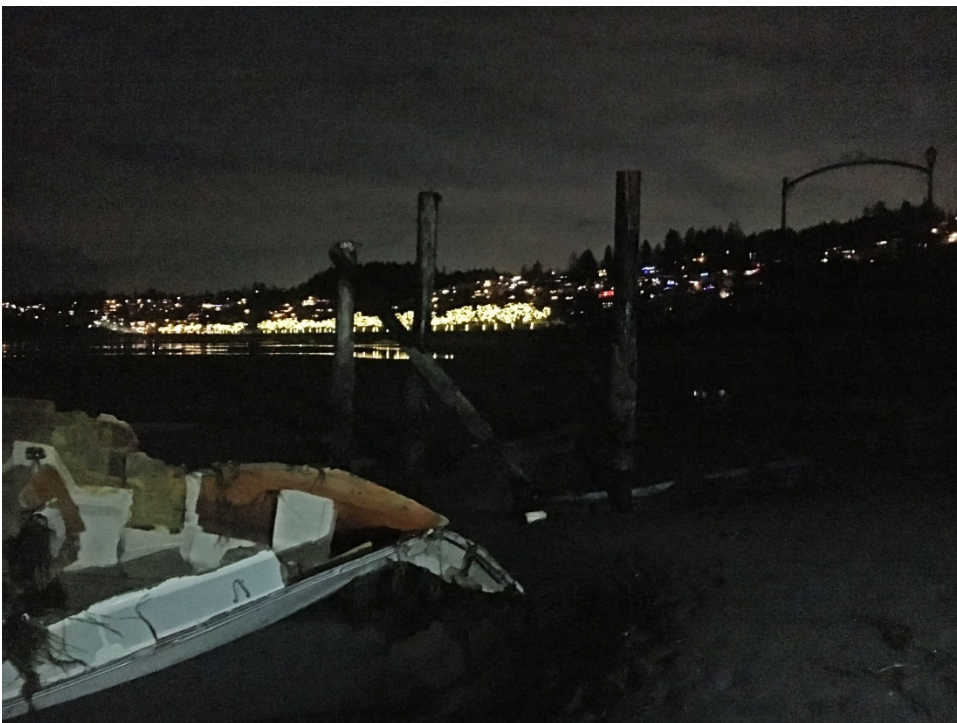
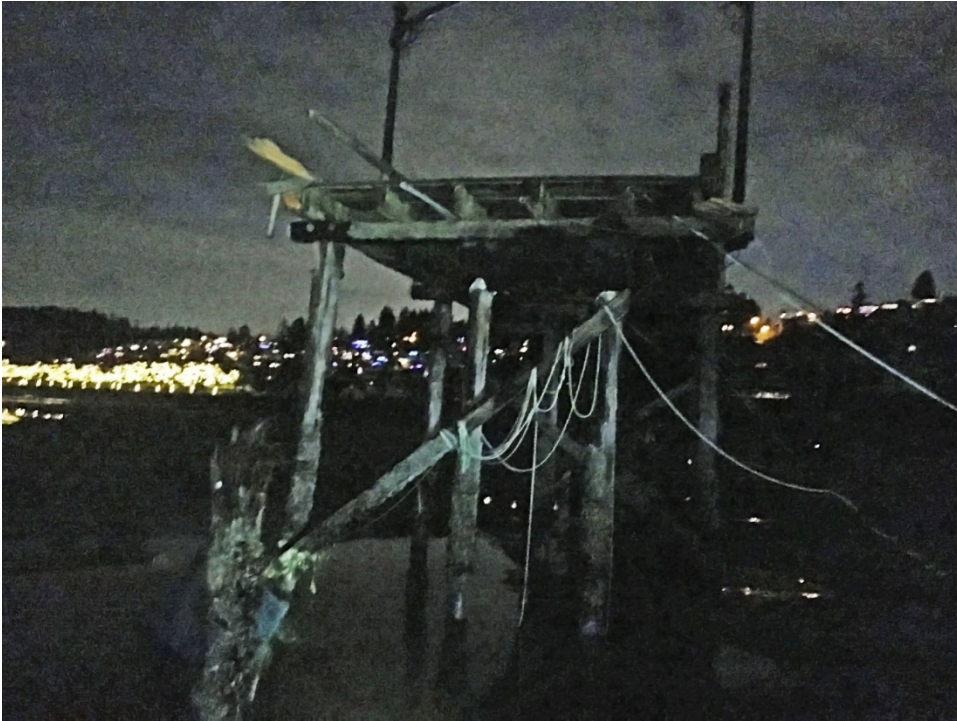
- Several pile bents along the pier have sustained impact damage likely from floating debris and/or loose vessels. Typical damage observed during the inspection includes displacement of pile resulting in failure of drift pins, fracturing of piles at connection to pile cap and failure of cross bracing. A detailed list of damage identified during the inspection along with recommended repair is presented in Appendix 1.
- The section of the Pier between Bent No. 33 to Bent No. 43 has failed completely (Photograph Nos. 1 to 3). Most piles and all superstructure at this location are missing. Utilities and power lines at this location have been dislodged from their installed position and have been strewn on the East side. Debris from damaged boats have been lodged along this section of the pier.

-	Cross brace is fractured	Replace cross brace
31	A	Pile is missing	Replace Pile
33	A	Pile fractured at top 1500 mm. Drift pin connection to pile cap has failed.	Replace Pile
33 to 44	All	Piles are either missing or have failed	Replace Piles

-	Super structure is missing	Replace superstructure
45	A	Pile fractured at top 1500 mm. Drift pin connection to pile cap has failed.	Replace Pile
45	A	Pile fractured at top 1200 mm. Drift pin connection to pile cap has failed.	Replace Pile
48 to 49	-	Boat debris lodged between bents	-
50	A	Drift pin connection to pile cap has failed.	Replace Pile
51 to 52	-	Piles damaged or missing	Replace Piles

Photo 1: Failed section of Pier between Bent No. 33 to 44

Photo 2: Failed section of Pier between Bent No. 33 to 44

Photo 3: Failed section of Pier between Bent No. 33 to 44

Removal of debris from this location, replacement of pile bents and superstructure and installation of removed utilities and power lines is recommended.

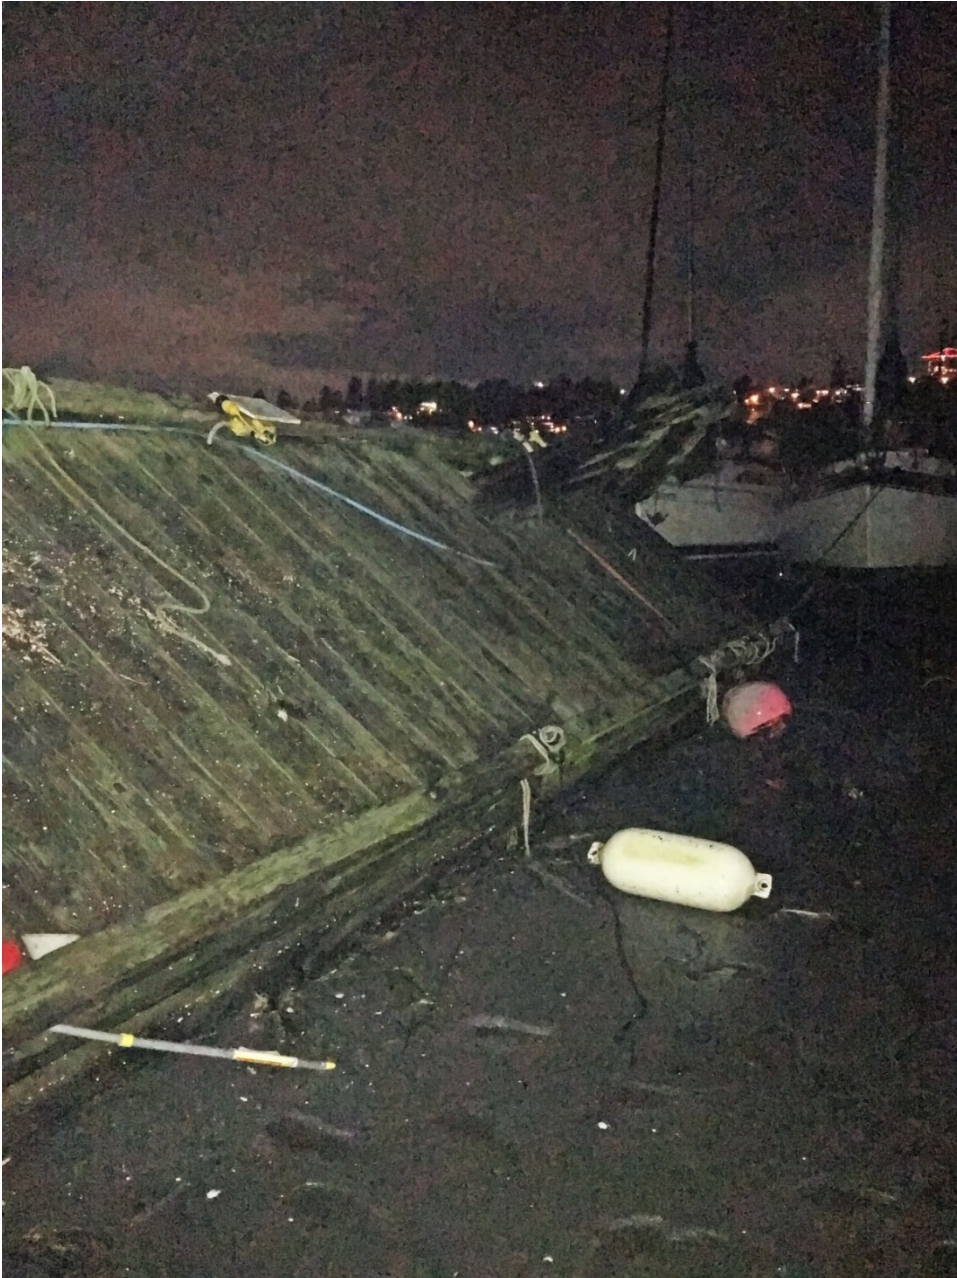
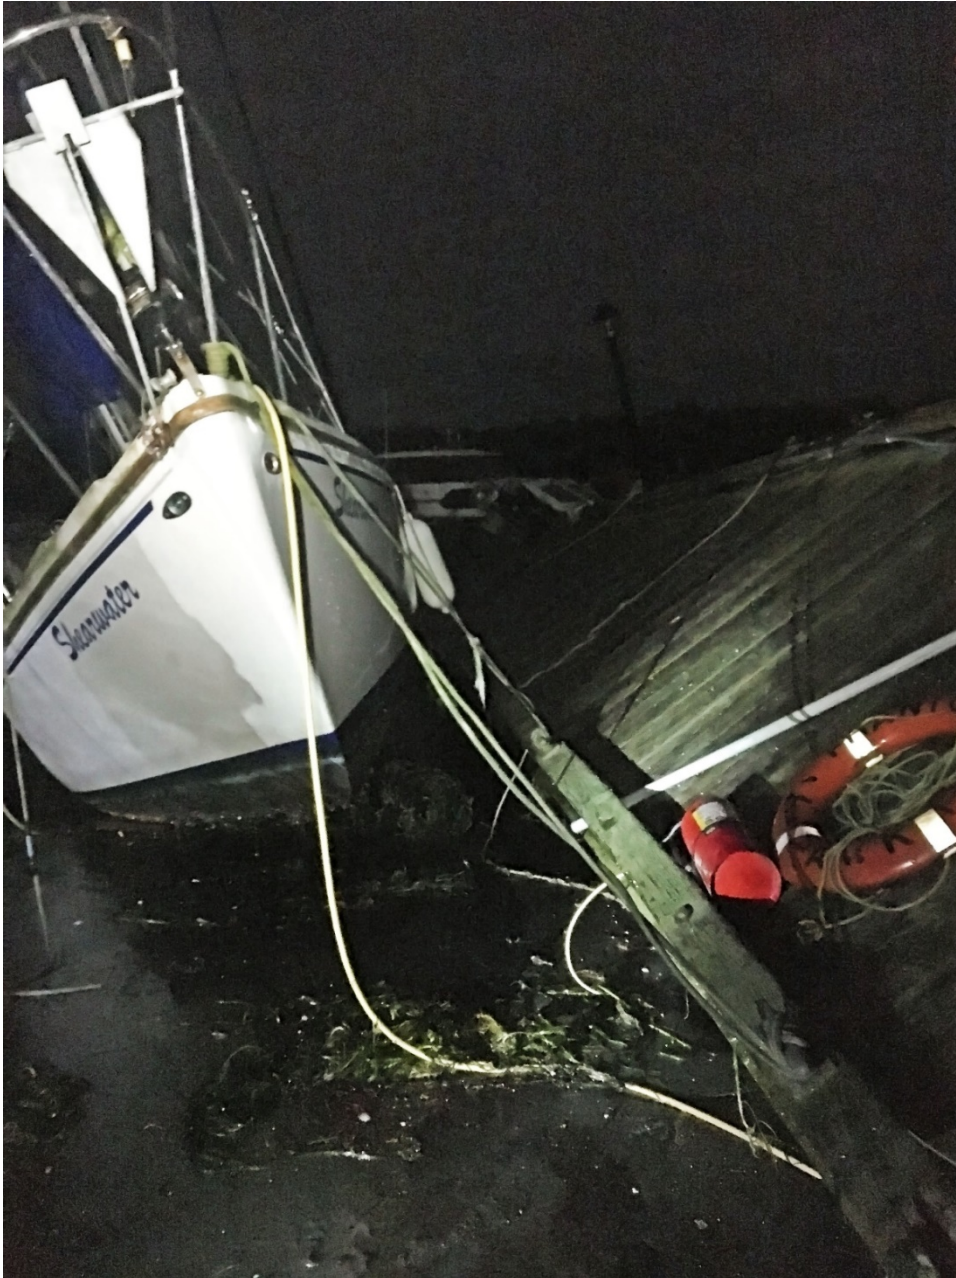
- Most sections of the West marina float have been dislodged from their moored position, rotated 90 degrees towards the shoreline and deposited on the beach (Photograph Nos. 4 and 5). The mooring piles have failed but are attached to the side of the float. The west gangway is supported by a small section of float that is still in place.

Photo 4: Failed section of West Marina Float

Photo 5: Failed section of West Marina Float

Replacement of the west marina float is recommended.

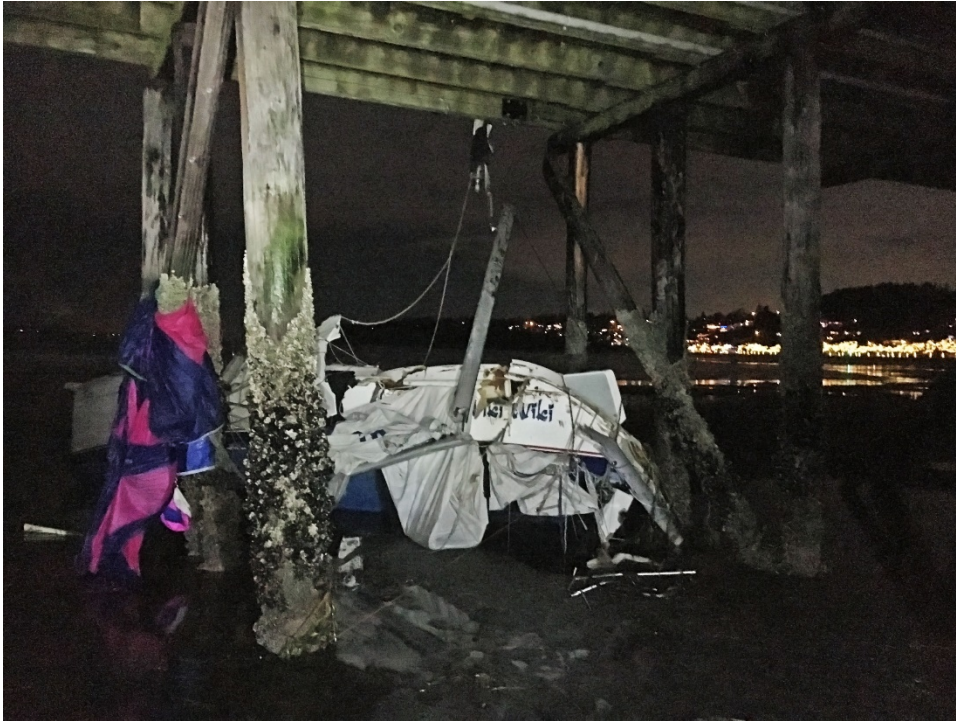
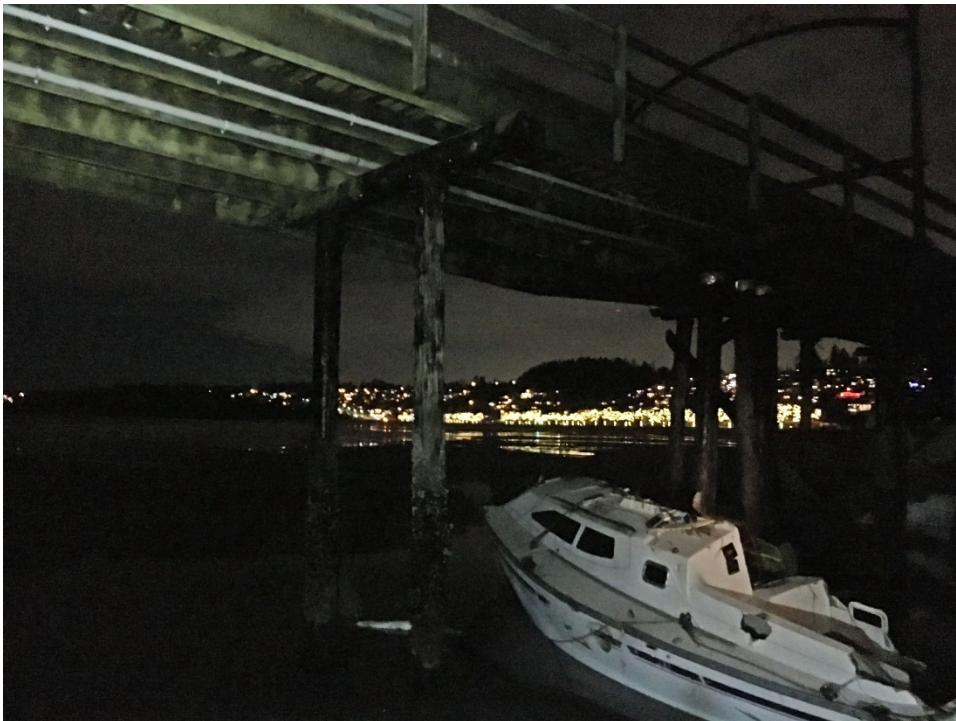
Photo 6: Boat debris lodged between pile bents

Photo 7: Boat debris lodged between pile bents

Removal of debris is recommended.

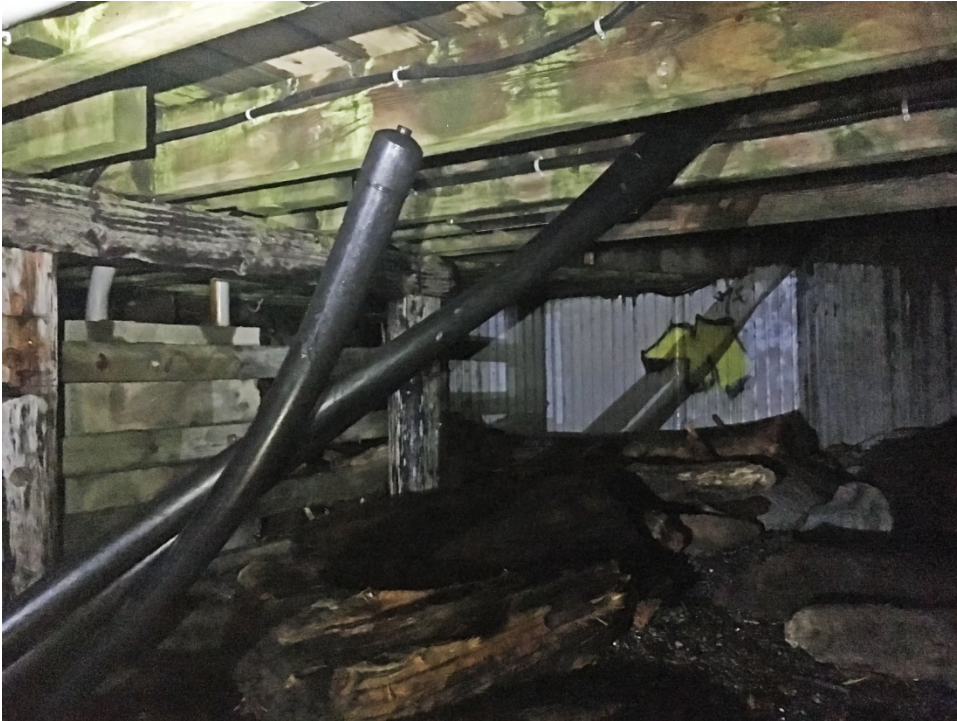
- The east float and gangway appear to be in a serviceable condition with no visible signs of major damage from the storm event.
- There is no observable damage to the new services that were installed beneath the shore abutment (Photograph No. 8). The construction fencing that was around this area is strewn around this area of the beach and partially covered with sand with some fence sections destroyed.

Photo 8: New services installed near shore abutment
