## ARBORIST REPORT

**JOB NAME:** City of White Rock 20230720

**RE:** Arborist Report for a Tree Risk Assessment

**SITE:** 975 Kent Street, White Rock, BC V4B 4S9

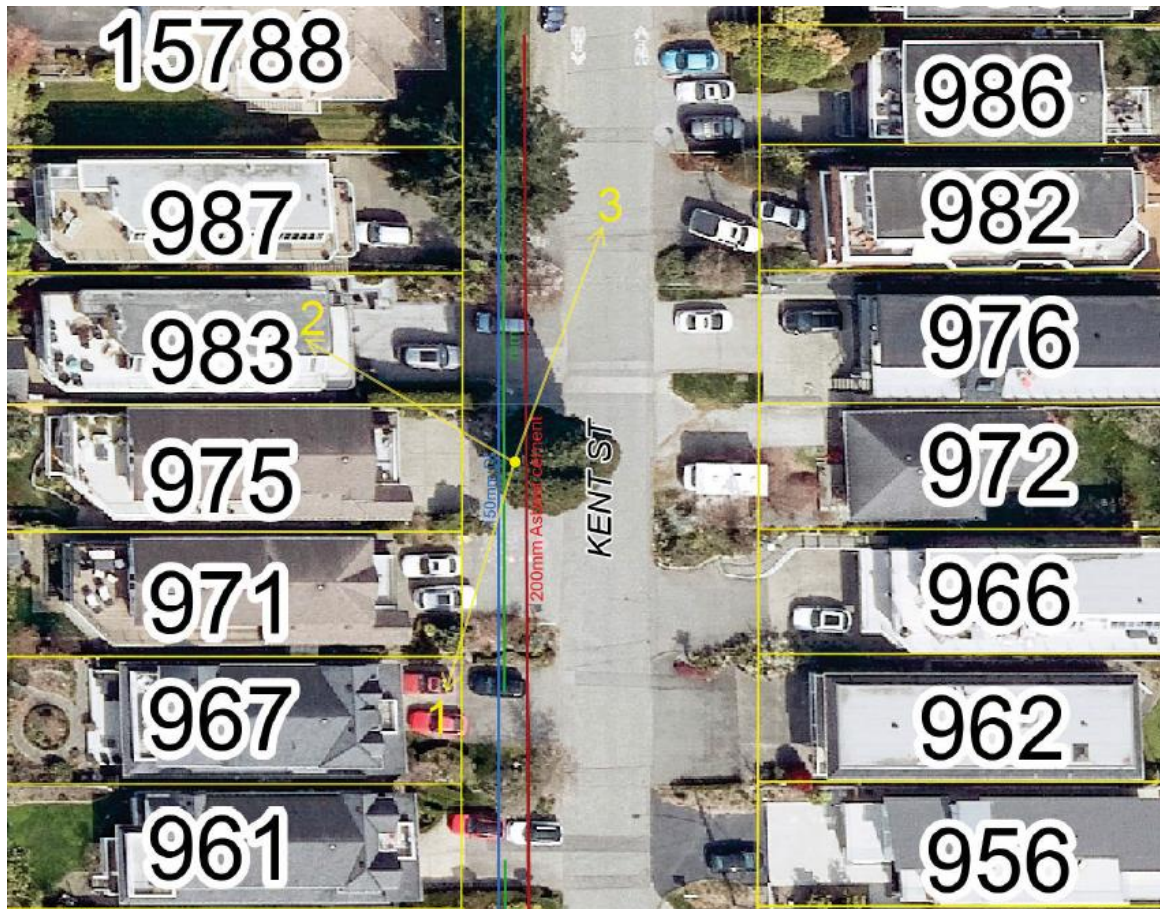
Figure 4. Orientation of 3 codominant stems

This tree is a dominant tree on the landscape and appears to be a mature specimen. It was measured 1.56 cm DBH and 1.4 m above the grade. It was measured to be approximately 26 m tall, having a crown spread of nearly 9 meters. It has 3 main codominant stems originating at about 4 m above grade with their individual crown masses oriented as follows:

- Stem 1 – oriented 195 degrees south-southwest
- Stem 2 – oriented 300 degrees northwest
- Stem 3 – oriented 20 degrees north-northeast

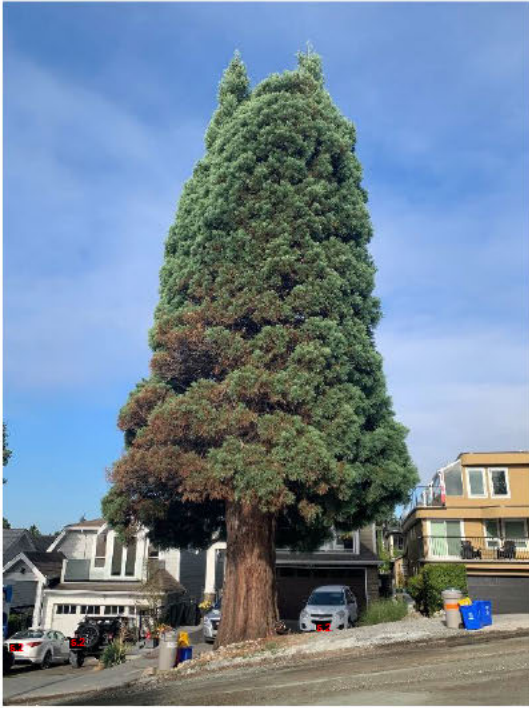
Photo 1. profile of tree viewed from the east

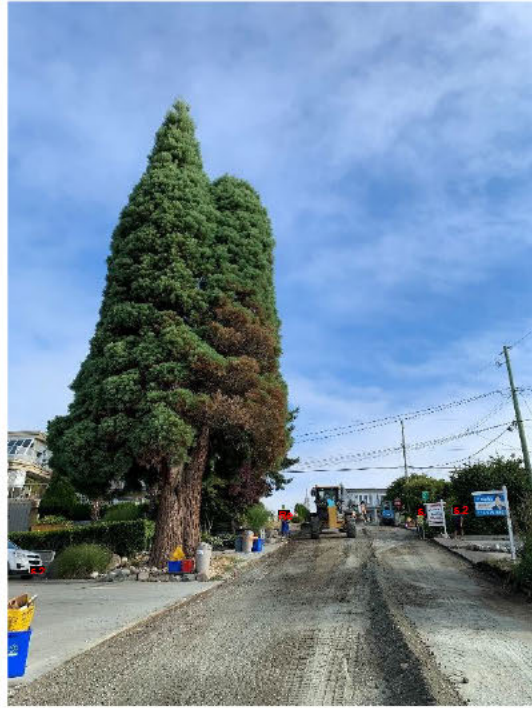
Photo 2. profile of tree viewed from the south

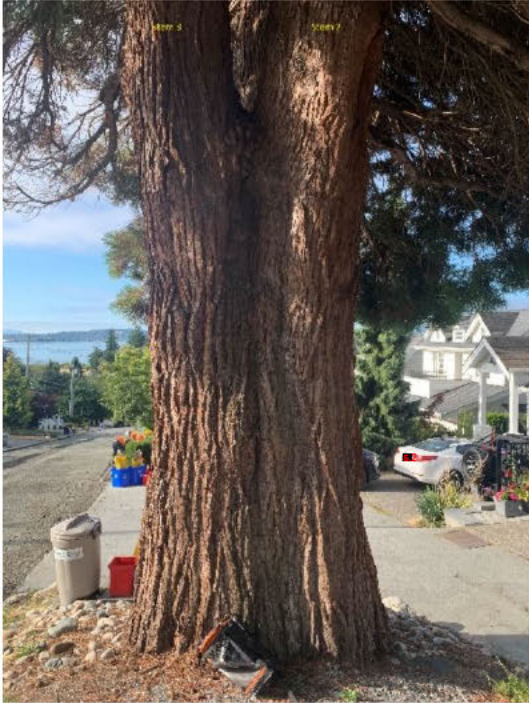
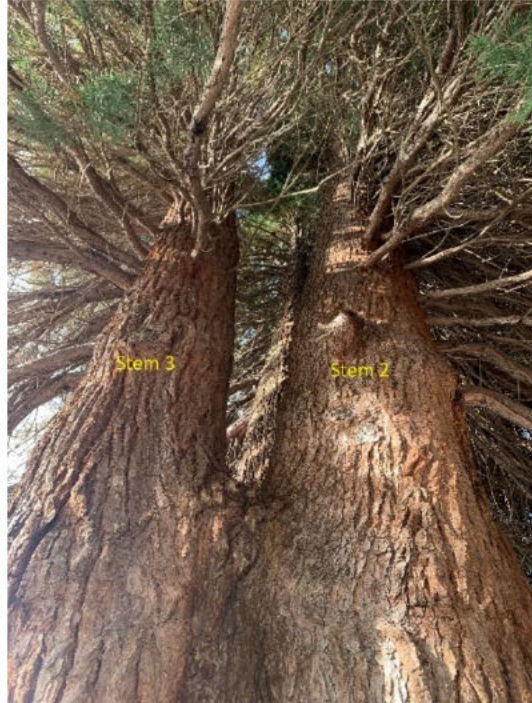
Photo 3. stem 3 (left), stem 2 (right) viewed from the north

Photo 4. stem 3 (left), stem 2 (right) viewed from the north

The 3 codominant stems varied in height; stem 2 was the tallest of the 3. Included bark was observed to varying degrees at each of the unions, however, none of the unions appeared to have cracks, splits, decay, or separation. Response growth (growth in compression and overlapping secondary growth) was evident at, below and above each stem, and the body language of the canopy did not suggest that the stems were moving away from each other or that environmental loads were causing significant strain on the unions.

- **Risk condition #1:** [3] codominant stems with included bark in the lower canopy. Stem 2 presented the greatest degree of concern due to its height and orientation relative to high value property.
  - Stem 1 oriented 195 degrees south-southwest targets vehicles and occupants at 975, 971 and 967 Kent St (frequent occupancy).
  - Stem 2 oriented 300 degrees northwest targets the house and occupants at 983 Kent St (constant occupancy)
  - Stem 3 oriented 20 degrees north-northeast targets Kent St (occasional occupancy) and overhead utility lines (constant occupancy).
- **Risk condition #2:** lower canopy scaffold branches on the south aspect of the tree with shear plane cracks.

- **Conditions of concern:** Stem 2 oriented 300 degrees northwest.
- **Likelihood of failure:** **Possible** – Whole tree failure may be expected in extreme weather conditions, but it is unlikely during normal weather conditions within 3 years.

- **Target:** house and occupants at 983 Kent Street, White Rock.
- **Likelihood of impacting the target:** **High** – the failed tree part is likely to impact the target. This is the case when there is a constant target with no protection factors, and the direction of fall is toward the target.

- **Consequences of failure:** **Severe** – serious personal injury or death, high-value property damage, or major disruption of important activities.
- **Risk rating:** **Moderate** – the tree risk assessor may recommend mitigation and/or retaining and monitoring. The decision for mitigation and timing of treatment depends upon the risk tolerance of the tree owner or manager.

- Install [3] static steel 7-strand 3/8-inch common grade cables with hand-spliced terminations to 5/8 inch through-bolts and 1/2 inch amon-eyes in a triangular pattern. The support system is to be installed in the upper 1/3 of the tree where stem diameters are 30-40 cm. Due to the fungal infection, pruning shall be minimized to prevent creating infection sites.
- Residual risk - LOF (improbable), LOI (low), CON (severe) - Low.

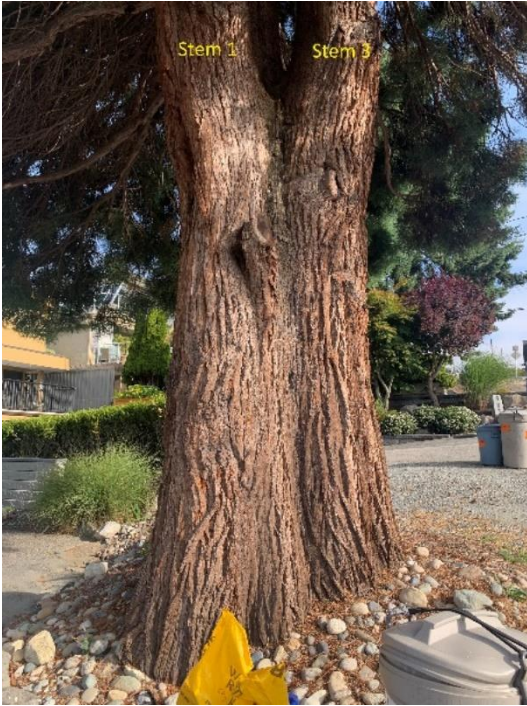
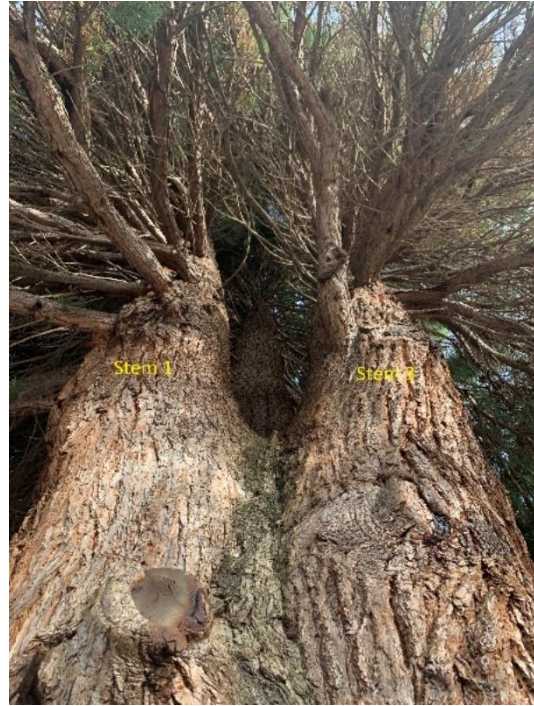
Photo 5. stem 1 (left), stem 3 (right) viewed from the south

Photo 6. stem 1 (left), stem 3 (right) viewed from the south

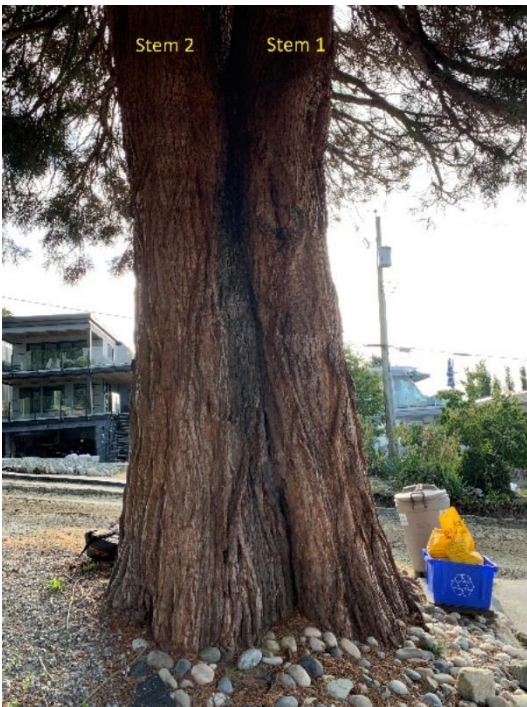
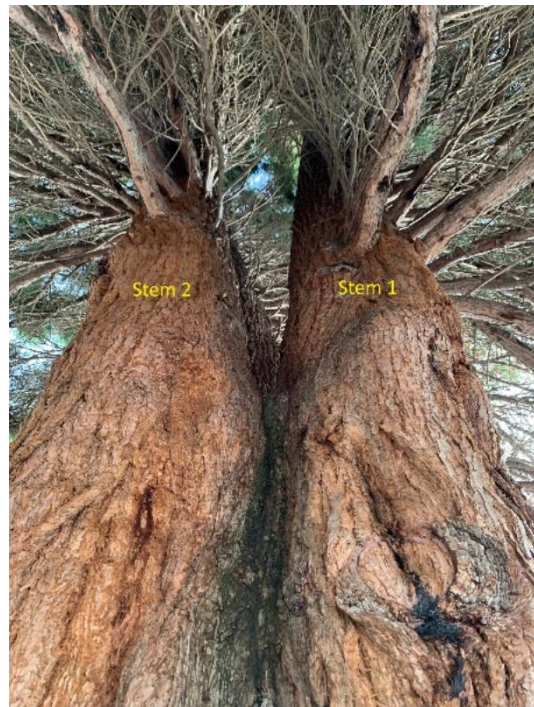
Photo 7. stem 2 (left), stem 1 (right) viewed from the west

Photo 8. stem 2 (left), stem 1 (right) viewed from the west

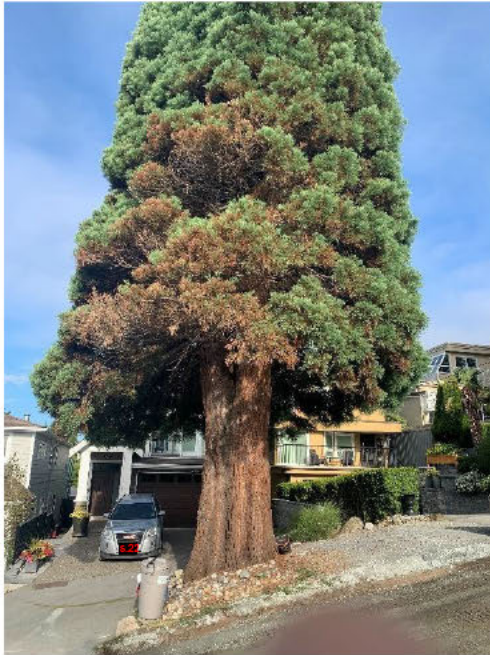
A fungal infection, possibly *Botryosphaeria dothidea*, was observed on the southeast side of the lower canopy, affecting approximately 10-15% of the live crown. Symptoms included foliar blight, die-back and sunken stem cankers.

Photo 9. disease symptoms viewed from the east

Regarding the fungal infection affecting the lower portion of the canopy, this report identifies a common biotic disease-causing agent of giant redwood to be *Botryosphaeria dothidea*, however, tissue samples and laboratory tests would be required for positive identification. Managing canker disease is primarily a matter of managing factors that predispose woody plants to the disease. Successive dry years (low rainfall) exacerbate canker diseases as plants grown under drought stress conditions have abundant dead branches that have not been pruned away, many containing fruiting bodies. Applying supplemental irrigation during low rainfall periods (such as summer or fall) or in the spring of low rainfall years may help plants resist these canker-forming fungi. When irrigating, don't let water hit the canopy or trunk of the tree. Water should be applied under the canopy but away from the main stem or trunk; this is a particular challenge on this site due to the encroachment of paved surfaced close to the base of the tree which limits permeable surfaces which could be watered. Consider using coarse wood chip mulches to slow evaporation from soil surfaces to conserve soil moisture.

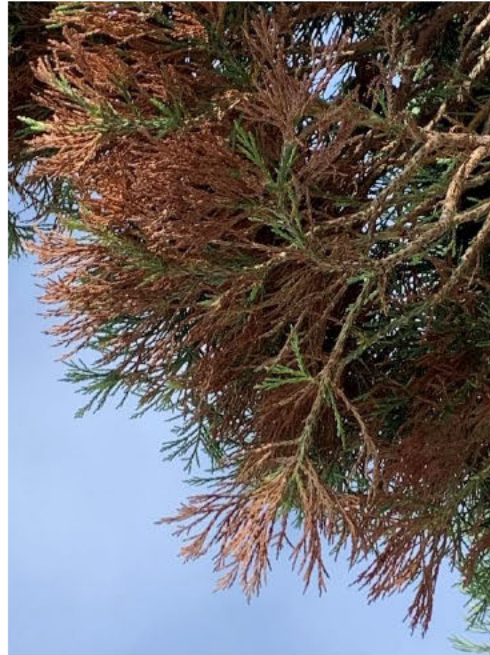
Photo 10. foliar blight

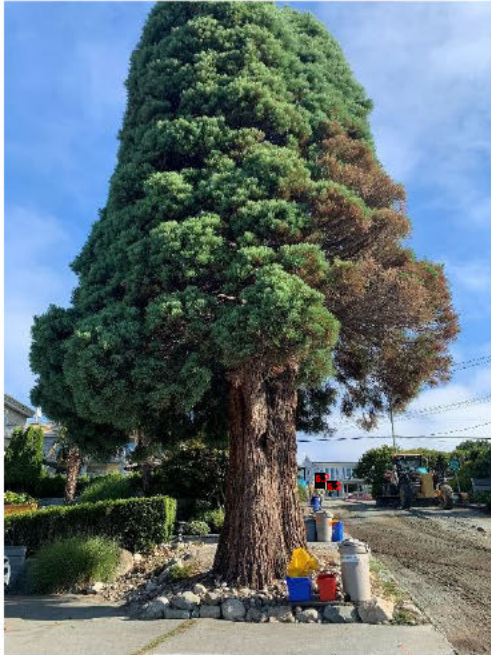
Photo 11. disease symptoms viewed from the south

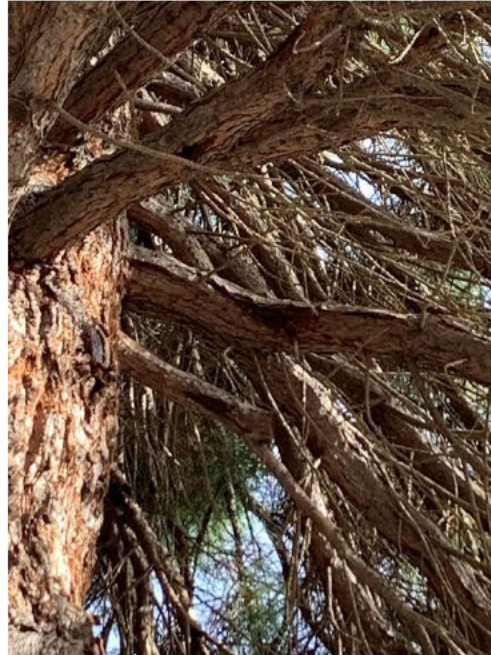
Photo 12. sunken stem cankers

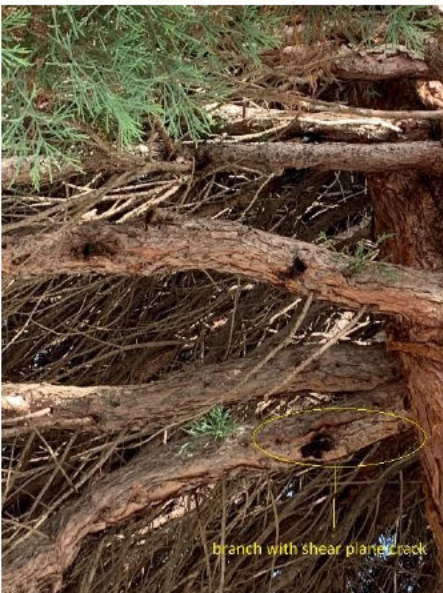
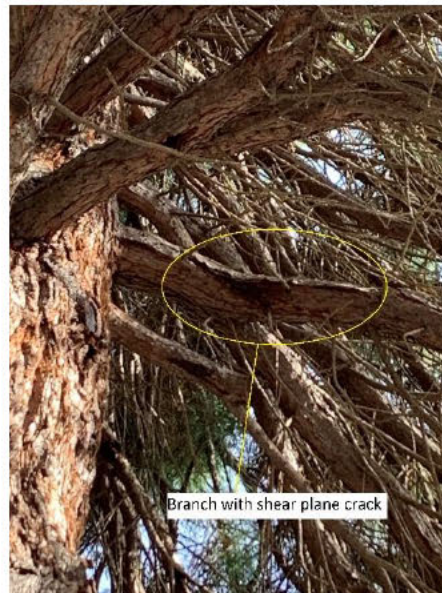
The tree also exhibited several scaffold branches in the lower canopy with shear plane cracks near the branch unions resulting from environmental loads (i.e., snow, winds, water) and/or the loss of supporting lower canopy branches from canopy raising pruning practices. The shear plane cracks appeared to somewhat recent in nature, none of which appeared to be actively failing.

Photo 13. shear plane cracks on lower canopy branches

Photo 14. shear plane cracks on lower canopy branches

- **Conditions of concern:** Lower canopy scaffold branches on the south aspect of the tree with shear plane cracks.
- **Likelihood of failure:** **Possible** – scaffold branch failure may be expected in extreme weather conditions, but it is unlikely during normal weather conditions within 3 years.

- **Target:** parked vehicles and occupants at 975 Kent Street, White Rock with frequent occupancy.
- **Likelihood of impacting the target:** **Medium** – the failed tree or tree part could impact the target but is not expected to do so. This is the case for people in a frequently used area when the direction of fall may or may not be toward the target.

- **Consequences of failure:** **Minor** – minor personal injury, low-to-moderate value property damage, or small disruption of activities.
- **Risk rating:** **Low** – some trees with this level of risk may benefit from mitigation and maintenance measures, but immediate action is not usually required. Tree risk assessors may recommend retaining and monitoring these trees, as well as mitigation that does not include removal of the tree.

- Remove defective branches, or thin end-weight of branches. Horticultural practices such as pruning of the infected branches should be done during dry periods to prevent infection by water splashed spores causing further foliar die-back and stem cankers.
- Residual risk - Low.
