City of White Rock Drainage Master Plan Update

Final Report

August 2019

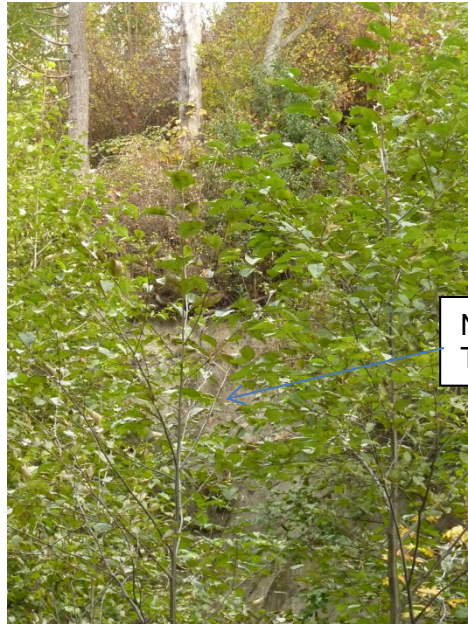
A landslide was noted in the Lower Coldicott Ravine during the 2012 assessment. It was observed that polyethylene sheeting has been placed to cover a section of the slope, which could indicate some instability. There was also a corrugated plastic pipe connected to a PVC pipe on the failed slope surface but the inflow and outflow locations could not be located. It was recommended that a detailed assessment be completed to determine the likelihood of further slope movement and risk to adjacent private properties.

Photo 1 Lower Coldicott Ravine - Near-vertical Soil Face on West Ravine Slope

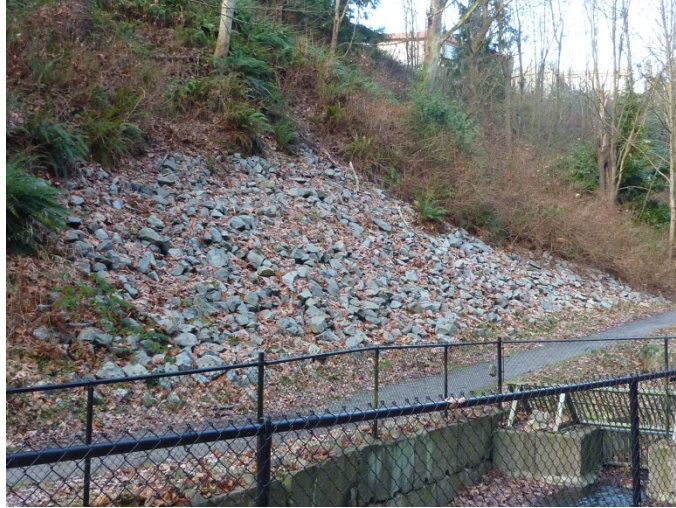
Photo 3 Duprez Ravine – Current Condition of Repaired Slide at Inlet Structure

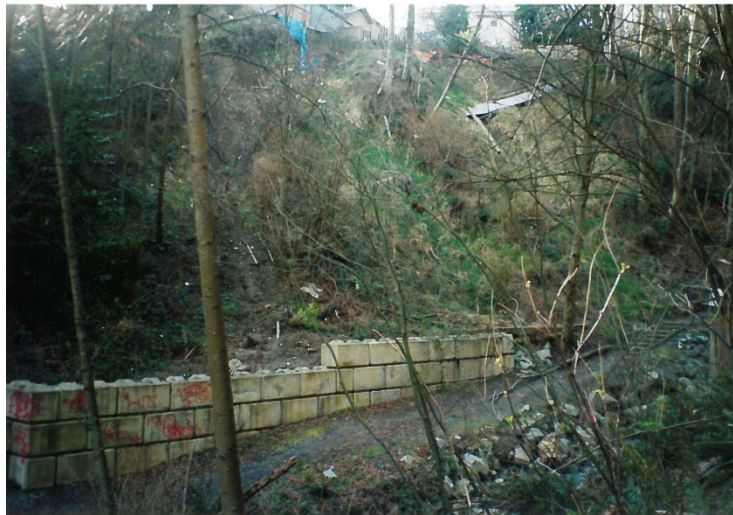
Photo 4 – Duprez Ravine– Landslide at Crest of Slope at 14517 Magdalen Avenue in 2000

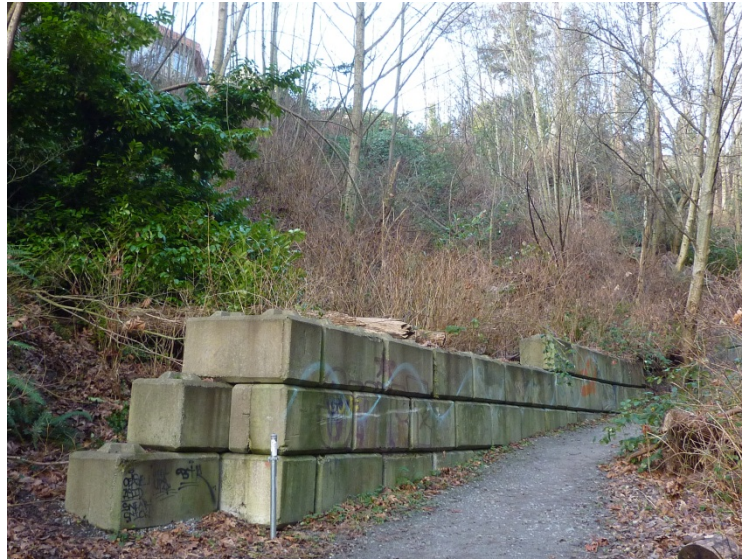
Photo 5 – Duprez Ravine – Current Condition of Slope

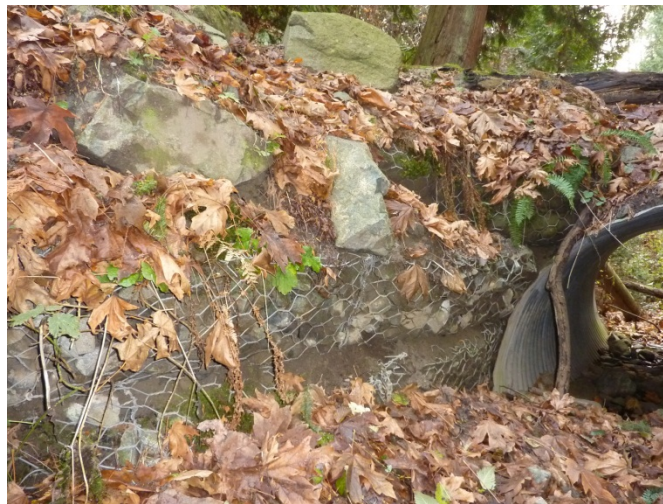
Photo 6 Duprez Ravine – Gabion Wing Wall at Culvert Footbridge Inlet

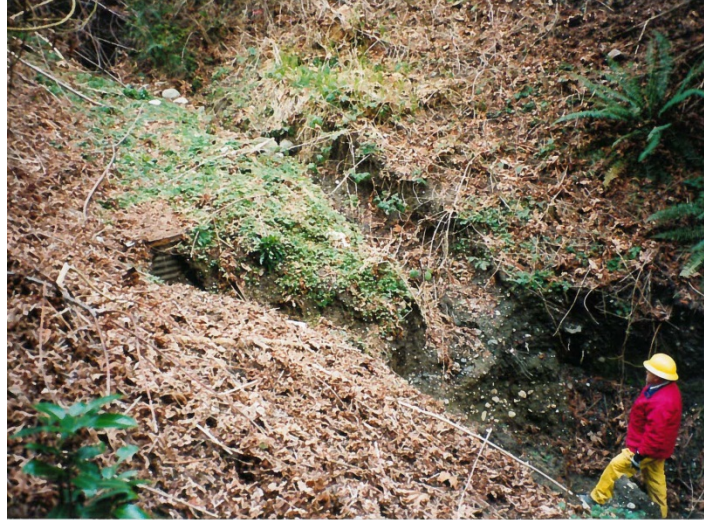
Photo 7 Everall Ravine – Creek Channel Damage in 2002

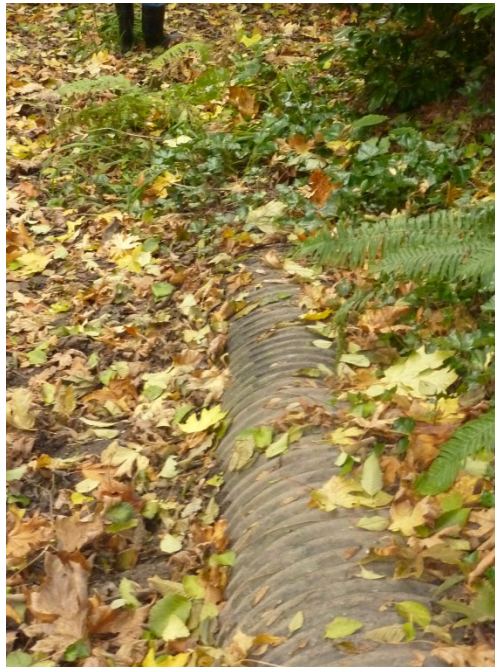
Photo 8 Everall Ravine – Storm Water Pipe Exposed in Ravine Floor

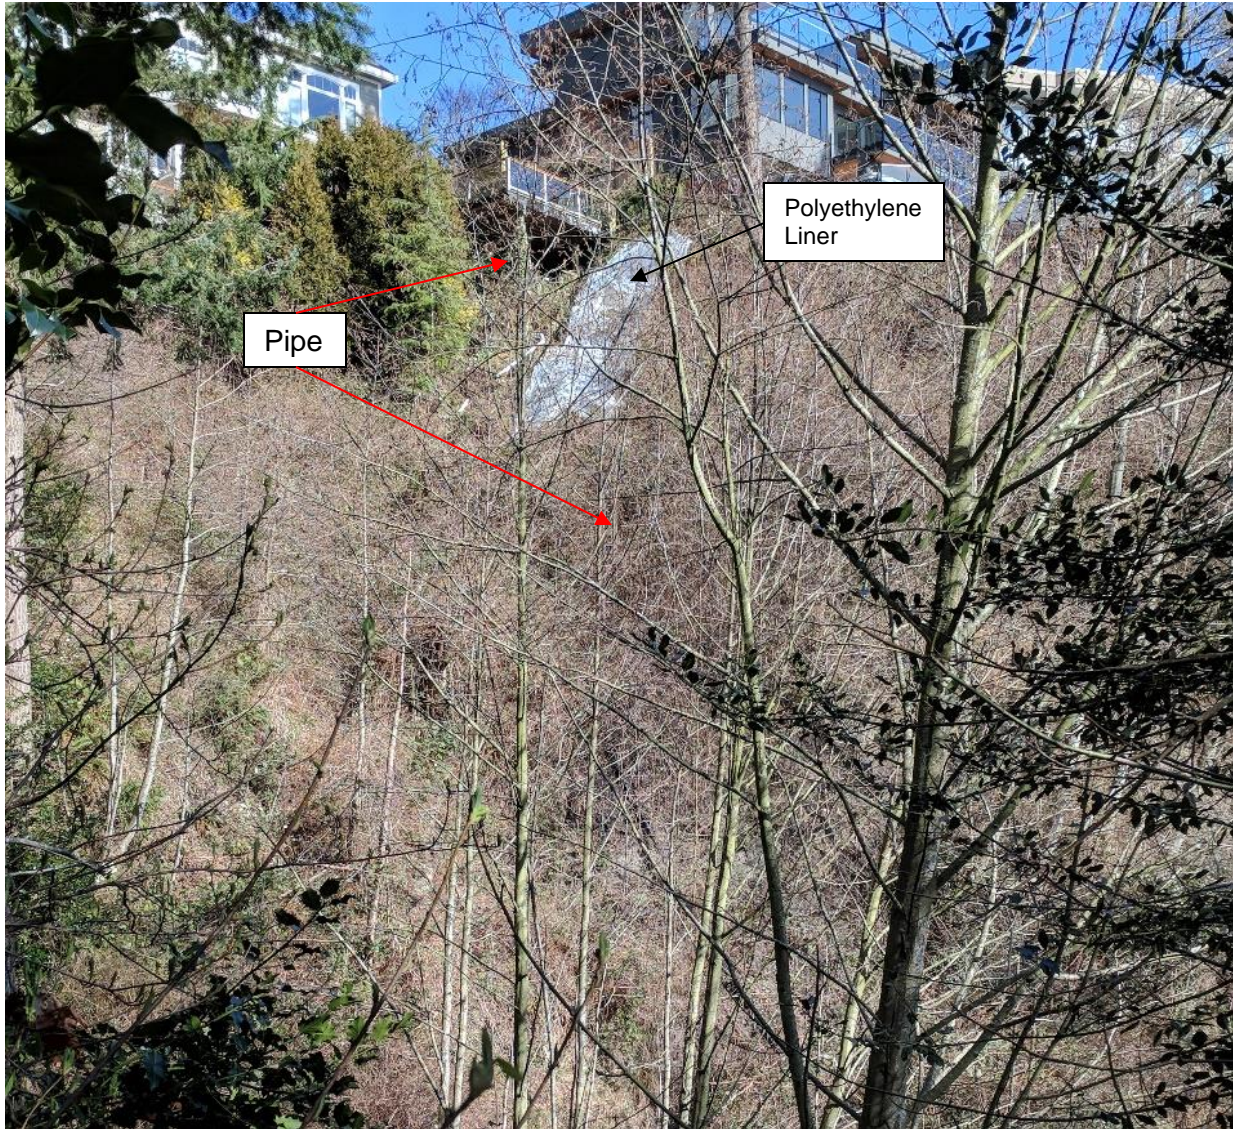
Photo 3 Lower Coldicott Ravine – Drainage Pipe and Poly Liner

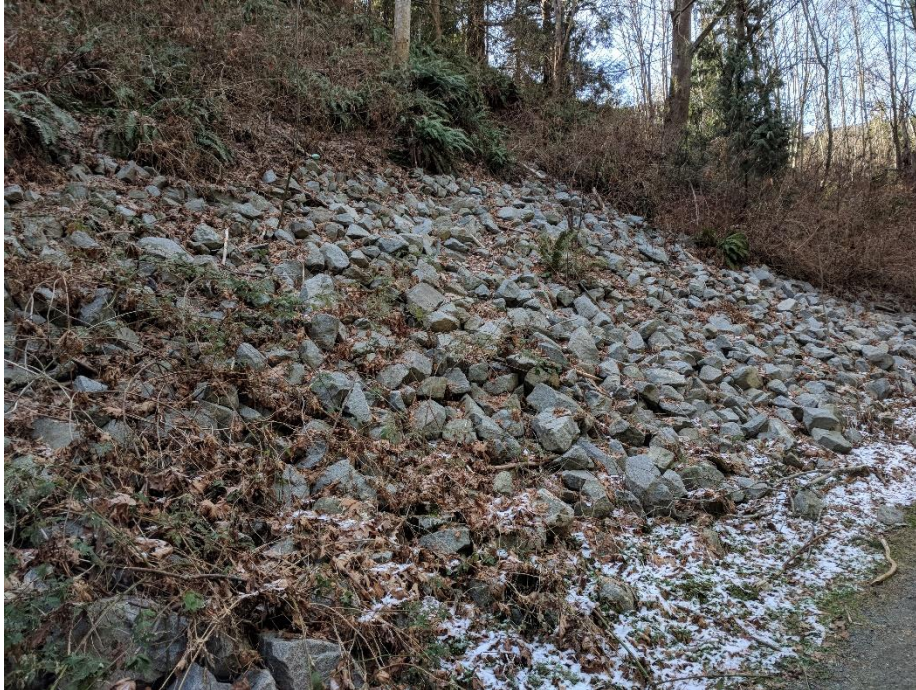
Photo 6 Duprez Ravine – Current Condition of Repaired Slide at Inlet Structure

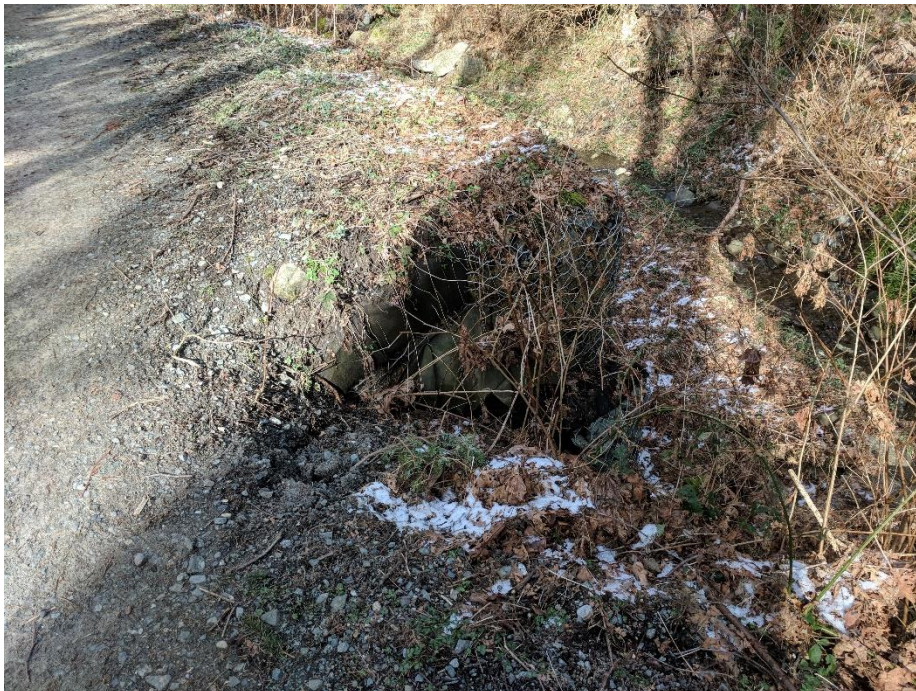
Photo 7 Duprez Ravine – Sinkhole Behind Gabion Wall at base of 14517

- Repair sinkhole observed behind the gabion wall below 14541 Magdalen Avenue.
- Surface erosion was observed on the west bank east of High Street and Blackburn Crescent. Slopes should be stabilized to mitigate further surface erosion. Thurber can provide further recommendation if needed.
- The gabion wall on the upstream end of the ravine appears to be bulging and the 1500 mm culvert is slightly out of round. It was recommended that the gabion wall should be monitored and the culvert should be structurally assessed to determine if remedial work is required.

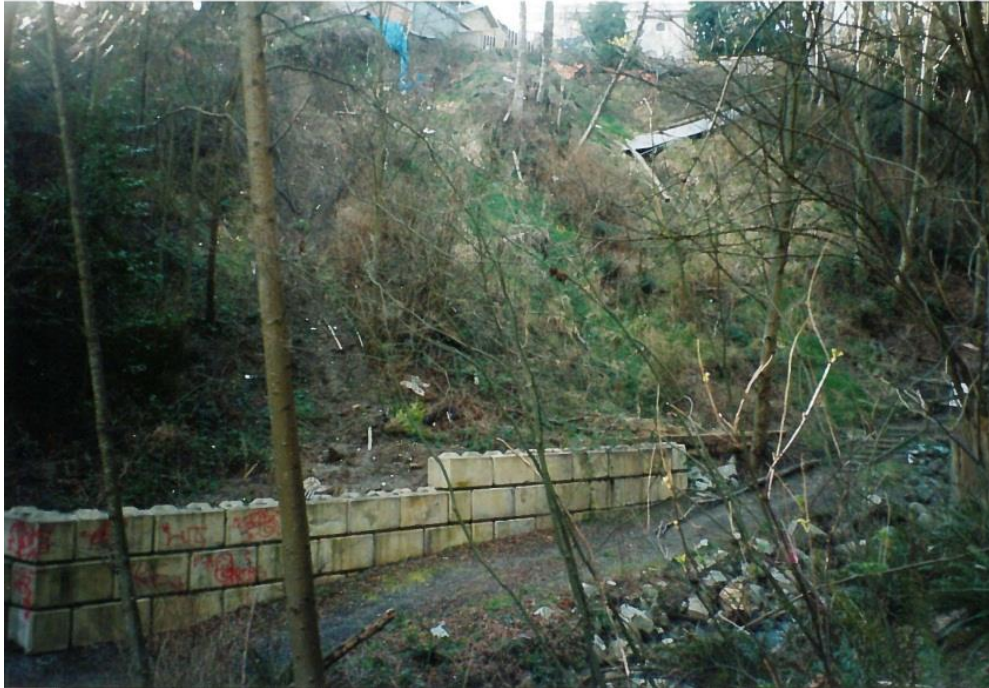
Photo 8 Duprez Ravine – Landslide at Crest of Slope at 14517 Magdalen Avenue in 2000

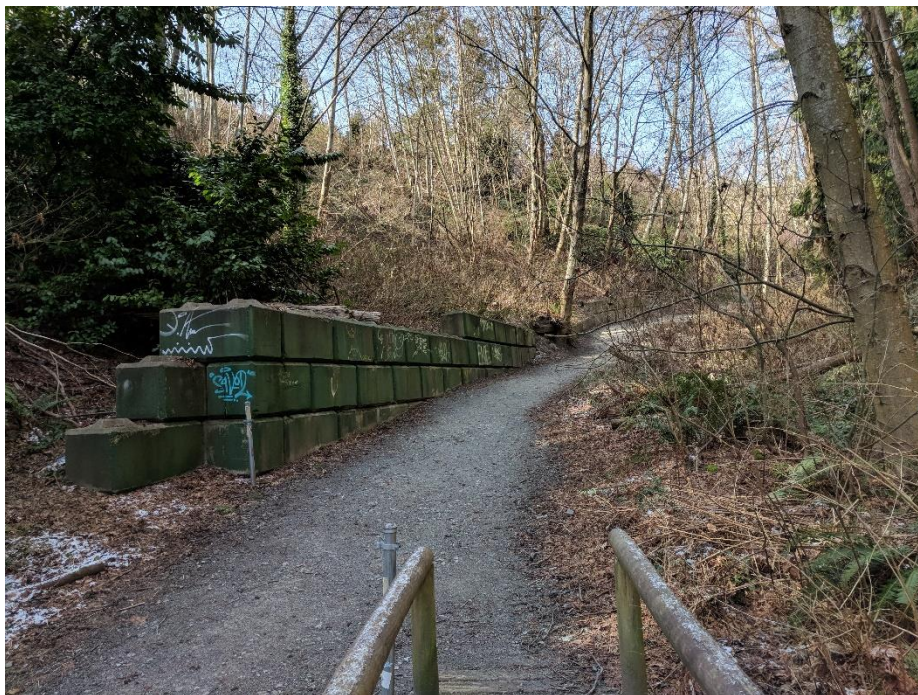
Photo 9 Duprez Ravine – Current Condition of Slope at 14517 Magdalen Avenue

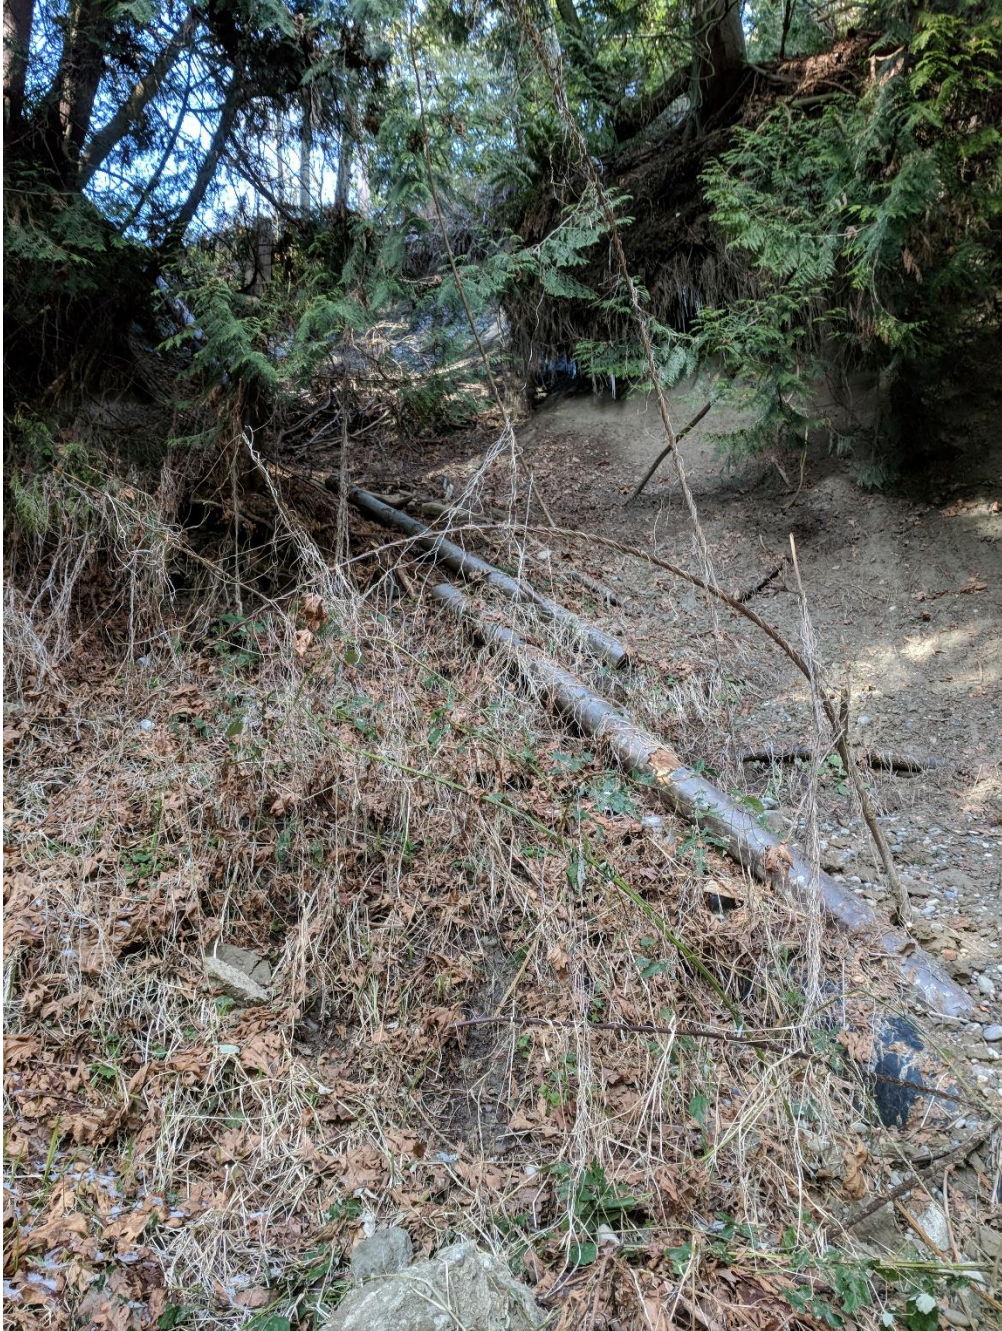
Photo 10 Duprez Ravine – Steep Right Bank East of Blackburn Cr./High St.

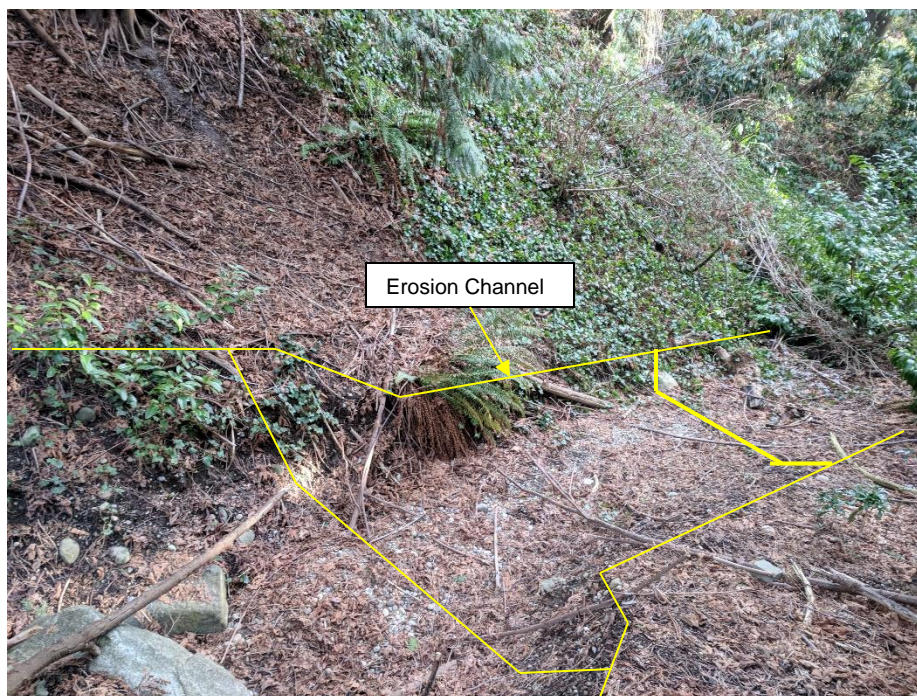
In the west branch of Everall Ravine, erosion channel was observed downstream of the 300 mm corrugated steel (CSP) pipe outlet. It was recommended that the CSP pipe should be extended to the bottom of the ravine to reduce further bank erosion. In the east branch, a significant portion of the ravine is located within private property. Thurber recommended that the debris buildup against the south property line fence should be removed to prevent the weight of the debris from causing the fence to topple, which could cause a sudden release of water and debris potentially damaging the creek channel downstream.

Photo 14 Everall Ravine West Brach – Erosion Channel below Pipe
(Looking downslope, 3 m below end of CSP)

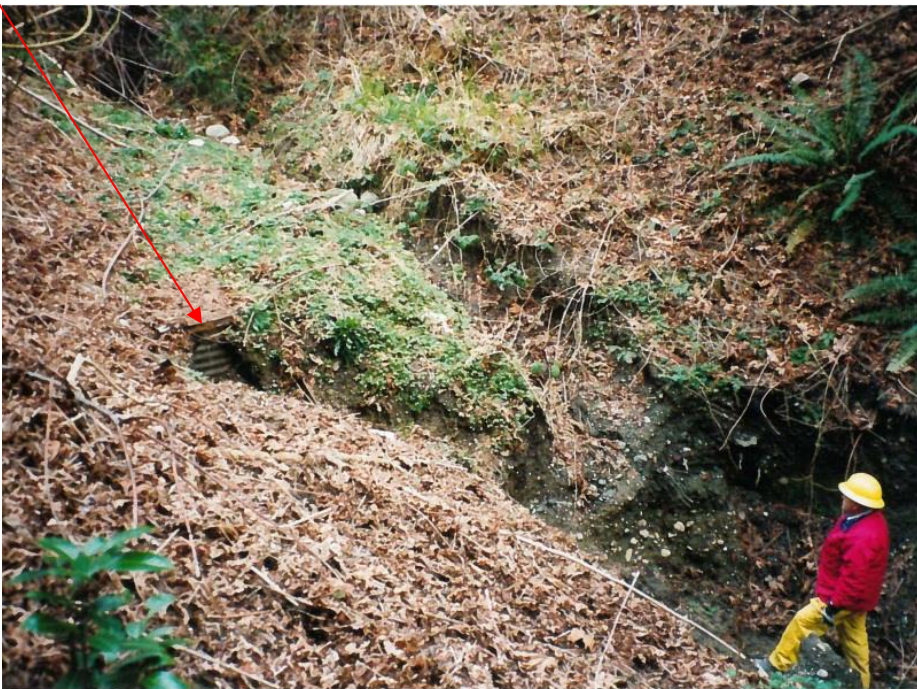
Photo 16 Everall Ravine – Creek Channel Damage in 2002

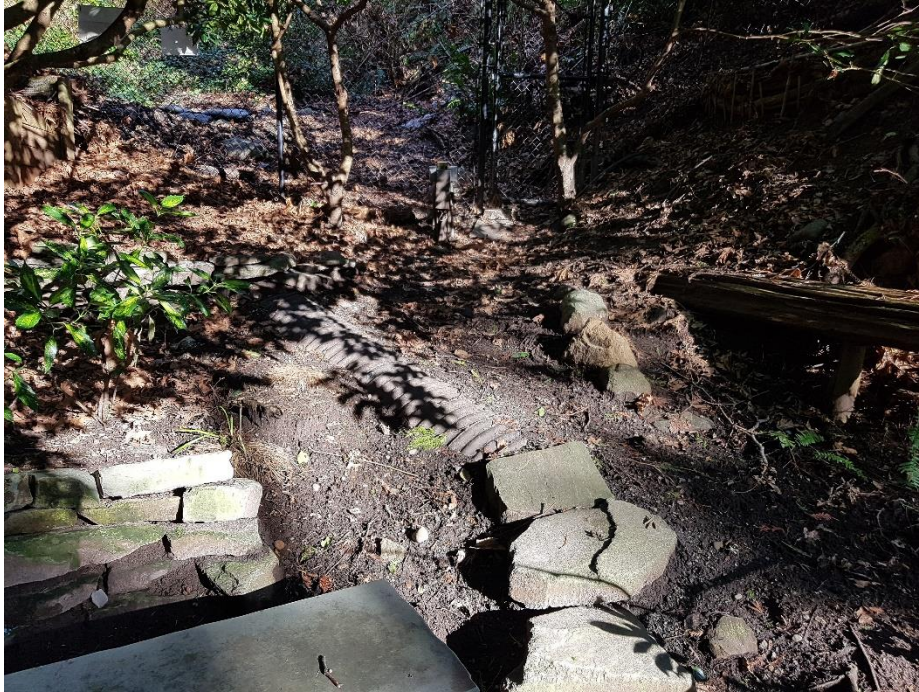
Photo 17 Everall Ravine – Storm Water Pipe Exposed in Ravine Floor

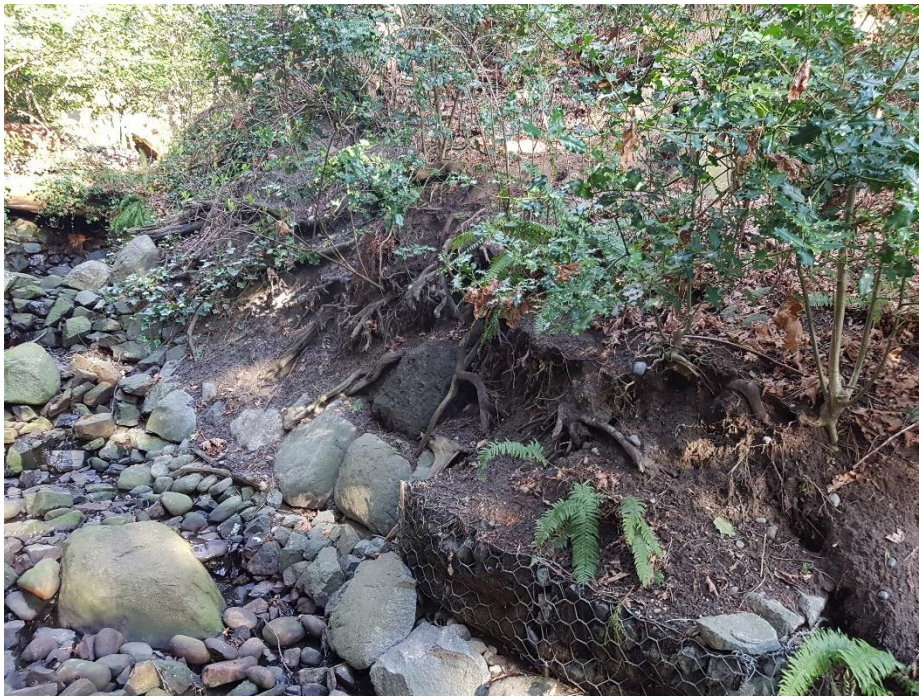
Photo 18 Everall Ravine – East Slope of Creek
