ARBORIST REPORT

VDZ-VIDAL ST.

**14937 THRIFT AVE.
&
1441 / 1443-45 / 1465 VIDAL ST.
WHITE ROCK, B.C.**

November 5, 2018

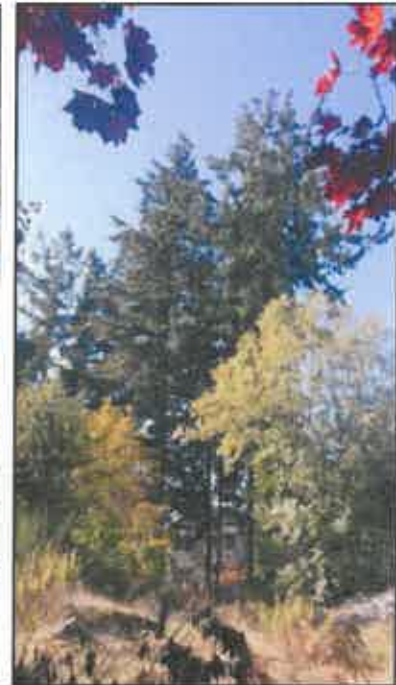
Fig. 5 – View of Trees OS2 – OS8

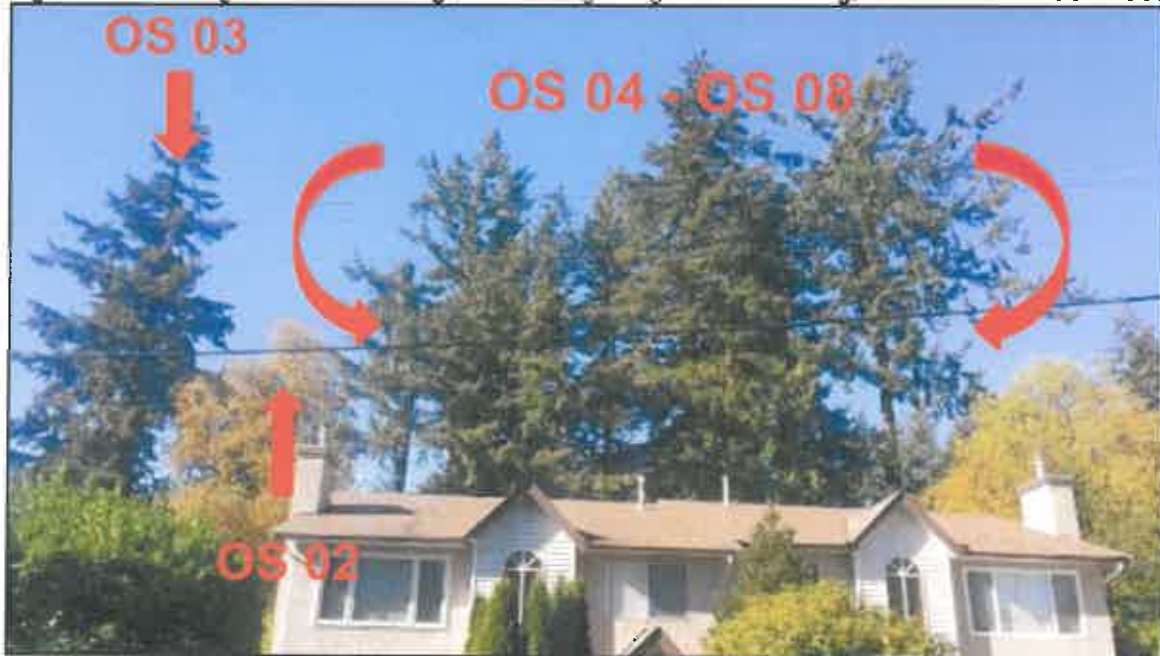
Fig. 6 – Stand of off-site conifers located directly west of 1441/1443-45/1465 Vidal Street.

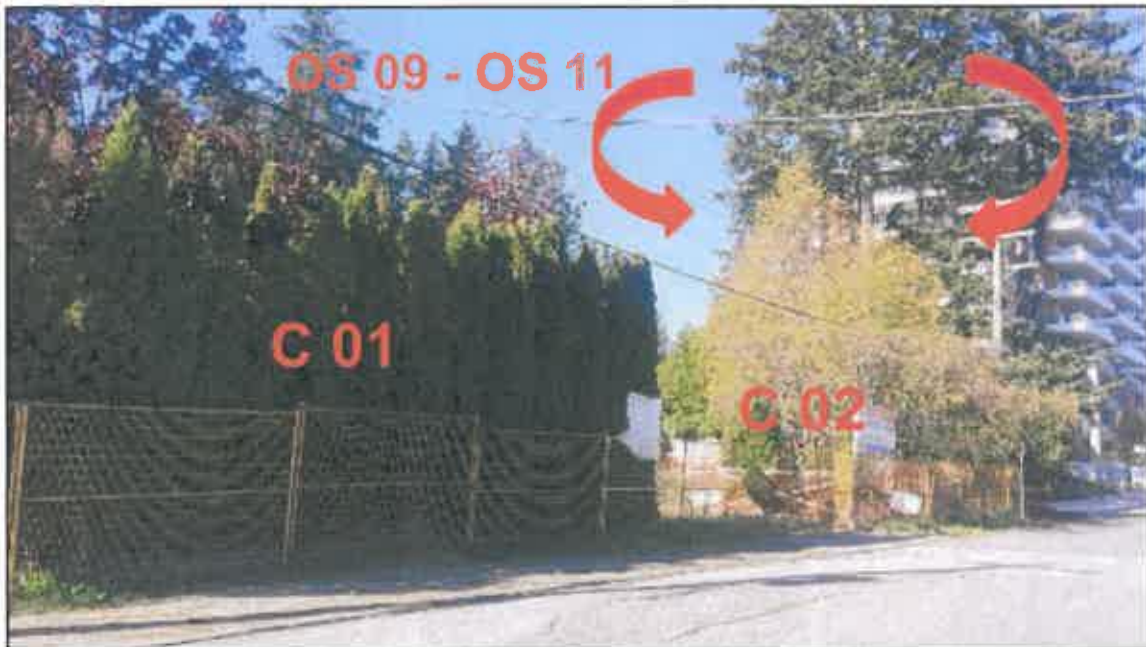
Tree #	Tag #	Common Name Botanical Name	Located on the Survey	DBH (m.)	C-Rad (m.)	LCR (%)	Comments	Retain / Remove
Trees OS 9 – OS 11 form the edge of a larger grouping of private off-site trees.								
OS 9	No tag	Douglas-fir <i>Pseudotsuga menziesii</i>	Yes	0.66	6.0	50	Good form and structure. Install tree barrier as detailed in Tree Protection and Removal Plan. Arborist to be present for all demolition and excavation works adjacent to tree protection barrier.	Retain
OS 10	No tag	Western redcedar <i>Thuja plicata</i>	Yes	0.36	4.0	80	Fair form and structure. TRUNK – Previously topped. Install tree barrier as detailed in Tree Protection and Removal Plan. Arborist to be present for all demolition and excavation works adjacent to tree protection barrier.	Retain
OS 11	No tag	Western redcedar <i>Thuja plicata</i>	Yes	0.36	4.0	80	Fair form and structure. TRUNK – Previously topped. Install tree barrier as detailed in Tree Protection and Removal Plan. Arborist to be present for all demolition and excavation works adjacent to tree protection barrier.	Retain

Fig. 7 – View facing north/northwest. OS 9 – OS 11 make up part of the edge of a larger grouping of conifers.

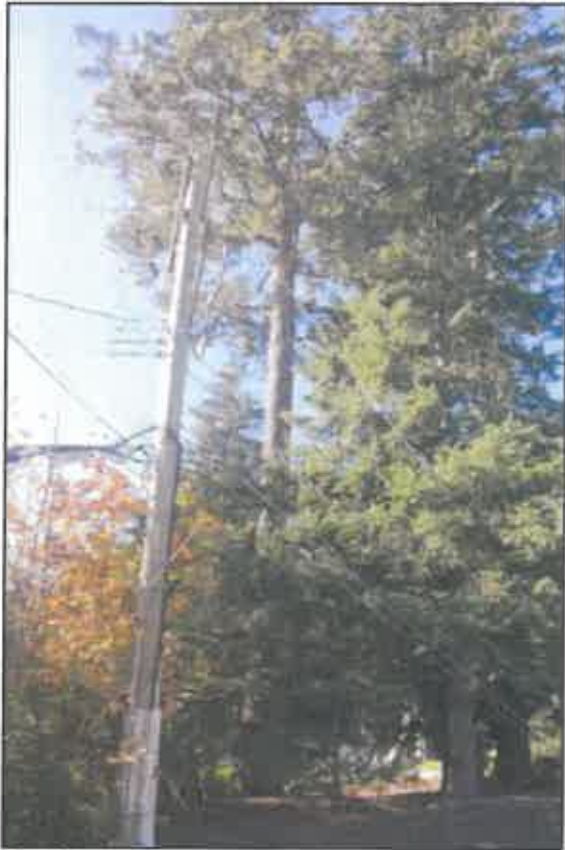
Fig. 8 – Alternate view of Trees OS 9 – OS 11

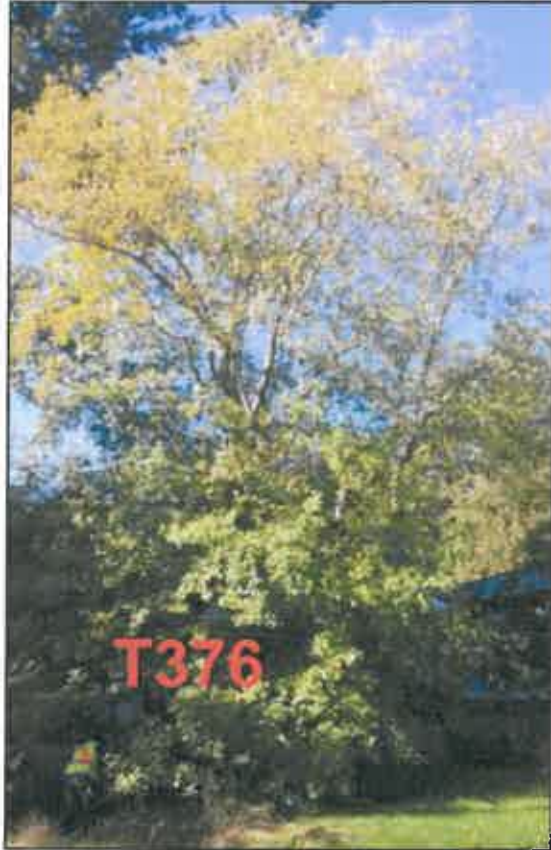
Tree #	Tag #	Common Name Botanical Name	Located on the Survey	DBH (m.)	C-Rad (m.)	LCR (%)	Comments	Retain / Remove
06	376	Red alder <i>Alnus rubra</i>	Yes	0.31 0.40 0.41	6.50	90	Poor form and structure. Mature tree in decline. TRUNK – (3) stems from base. Decay present in one stem (0.50 meters in length). Natural lean east. Not suitable for retention due to form and structure. Located within proposed building footprint. <i>BC Plant Health Care root radar results: Poor structure with multiple trunks and decay.</i>	Remove
07	377	Flowering plum <i>Prunus cerasifera</i>	No	0.13 0.18 0.27	5.50	80	HANDPLOTTED Fair form and structure, good vigor and vitality. Suitable for retention. Located within proposed building footprint.	Remove
08	378	Mountain ash <i>Sorbus aucuparia</i>	No	0.10 0.11 0.14	4.50	80	HANDPLOTTED Fair form and structure. Suitable for retention. Located within proposed building footprint.	Remove

Fig. 9 – Red alder located on 1465 Vidal Street.
