FOI No: 2023-48

Re: Request for Records  
Freedom of Information and Protection of Privacy Act

- *The following information is requested in regards to 15482 Semiahmoo Ave, White Rock and the request covers all information from Jan 1, 2014 to present day:*

van der zalm and associates have been retained by the client to prepare a report to assess the tree at civic address 15482 Semiahmoo Avenue, White Rock, BC. The Project Arborist performs a site review entailing identification and visual assessment of the tree(s) on site based on the tree survey provided by the client or representative(s). Provide recommendations for the retention or removal of tree(s) on this site based on the existing site conditions and the proposed use of the site. Mitigation of development impact on the tree(s) has been considered as part of the tree assessment process.

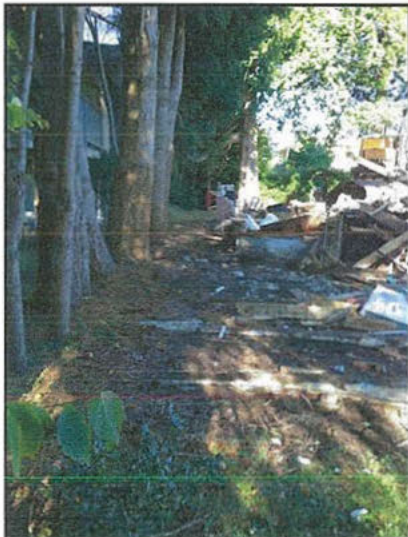
**Row of Douglas Fir along west side of property**

The requirements as outlined in the Arborist Report Addendum 01 (dated October 1<sup>st</sup>) regarding demolition and excavation around the protected trees have been met to the satisfaction of the Project Arborist.
