TACTILE WALKING SURFACE INDICATORS (TWSI)

Tactile Walking Surface Indicators in the United States and Internationally

Research, Standards, Guidance, and Practice

Published September 2021

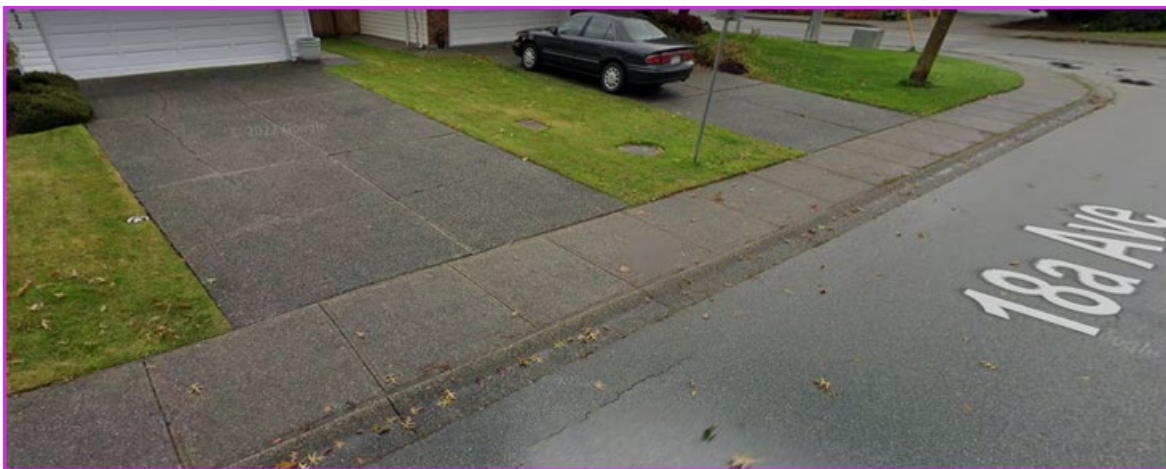
In the absence of boulevard, an alternative is to install **rollover** curb rather than barrier curb to keep the sidewalk flat as there is no need for driveway letdown, however, the alternative may compromise the safety of sidewalks. Some examples can be found in the City of Surrey as shown in the screenshot below, however, it is not the direction the City of Surrey is headed for. Otherwise, the sidewalk can hardly remain flat by the interruption of driveway letdown.

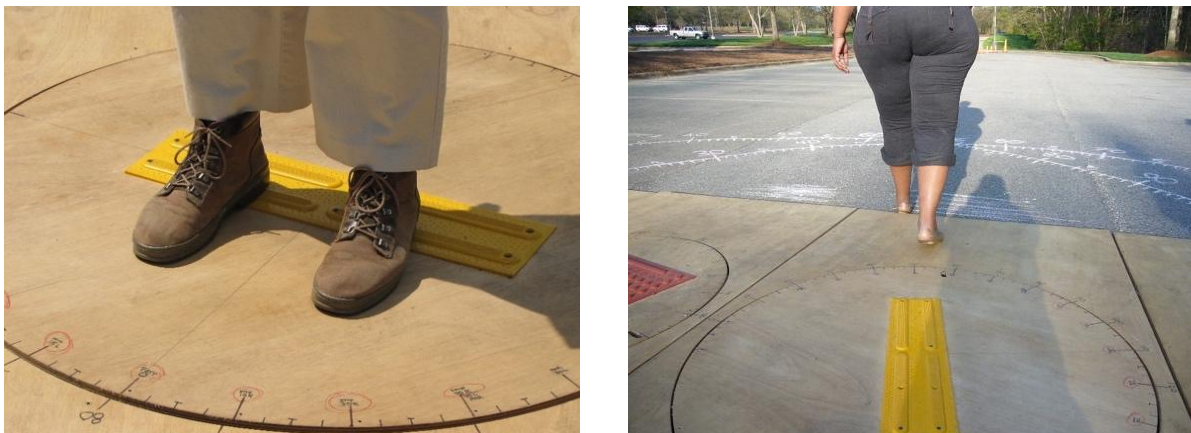
Figure 2. Examples of surfaces used for testing by Scott et al. (2011a).

Figure 2 depicts examples of the plywood ramps used for testing alignment based on the six different cues (Scott et al. 2011a). Each cue could be turned so that it was or was not oriented to indicate travel in the same direction as the ramp slope. Figure 2(a) shows a person taking a direction from bars perpendicular to the intended direction of travel. Figure 2(b) shows a person who has taken a direction from bars parallel to the intended direction of travel.

(a) Bars perpendicular to intended travel direction (b) Bars parallel to intended travel direction

The raised bars were all 1.28 inch (32.5 mm) wide at the base and 0.19 inch (4.8 mm) high. In the two conditions in which two parallel raised bars were oriented either parallel or perpendicular to the intended travel direction, the two bars were spaced 3.0 inches (76 mm) apart, on center.

The two surfaces that resulted in the most accurate alignment, even when the surfaces were not aligned with the ramp slope, contained bars that were perpendicular to the intended direction of travel on the crosswalk. Bars aligned parallel to the direction of travel on the crosswalk (a common arrangement internationally) resulted in significantly less accurate alignment. In a subsequent, unreported experiment, using the same plywood ramps, the same researchers investigated the accuracy of alignment with DWS, and found alignment to be significantly less accurate with DWS than with raised bars oriented perpendicular to the intended direction of travel (personal communication from A. Scott, 2012).

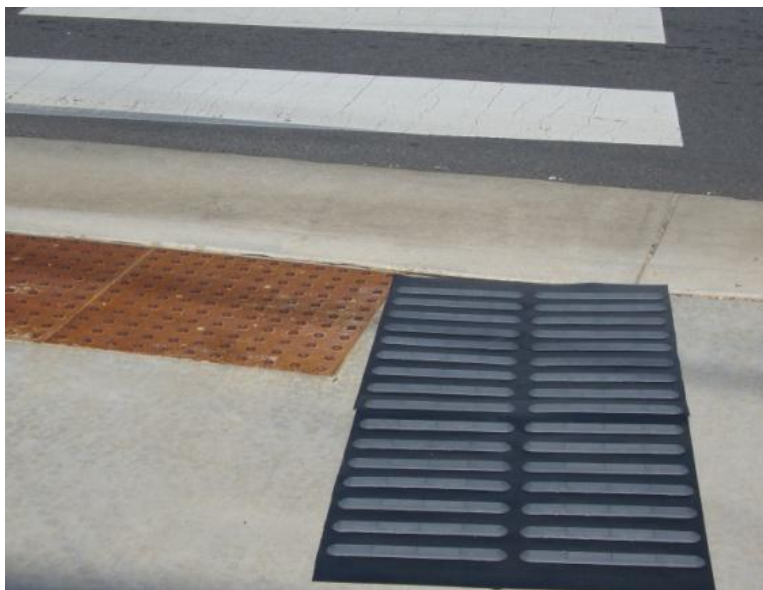
Based on the results of Scott et al. (2011a, 2011b), Bentzen et al. (2017) installed a temporary guidance surface prototype of raised bars at six non-corner crossings. The purpose of this study was to determine whether such a surface could aid wayfinding at crossings where there is otherwise insufficient detection and alignment information for pedestrians who are blind. The surface was installed across the width of the sidewalk and beside the DWS to indicate the location of the crosswalk and to provide a cue for alignment (see Figure 3). The bars of the guidance surface were oriented perpendicular to the direction of travel on the crosswalk. The dimensions and spacing of the bars were the same as in the previous laboratory research (Scott et al. 2011a). When used in other countries to indicate the location of crosswalks, the raised bar guidance surface typically orients the bars parallel to the direction of travel on the crosswalk. Because Bentzen et al. (2017) were interested in identifying a surface that could aid with both crosswalk detection and pedestrian alignment, they oriented the raised bars perpendicular to the direction of travel on crosswalks. This decision was based on prior research in both the U.S. (Scott et al. 2011a, 2011b) and Japan (Takeda et al. 2006) that found that direction-taking from raised bars perpendicular to the intended direction is more accurate than direction-taking from raised bars parallel to the intended direction.

Figure 3. Photo of a guidance surface with raised bars perpendicular to the direction of travel across the crosswalk (Bentzen et al. 2017).

Without the guidance surface, research participants who were blind passed crosswalks without detecting them on 17.9% of trials and aligned in a heading that would have resulted in crossing completion outside of the crosswalk on 47.9% of trials. The prototype guidance surface resulted in reducing passing the crosswalk without detecting it to 2.4% and decreased headings that would have resulted in crossing completion outside the crosswalk to 22.7% (both statistically significant).

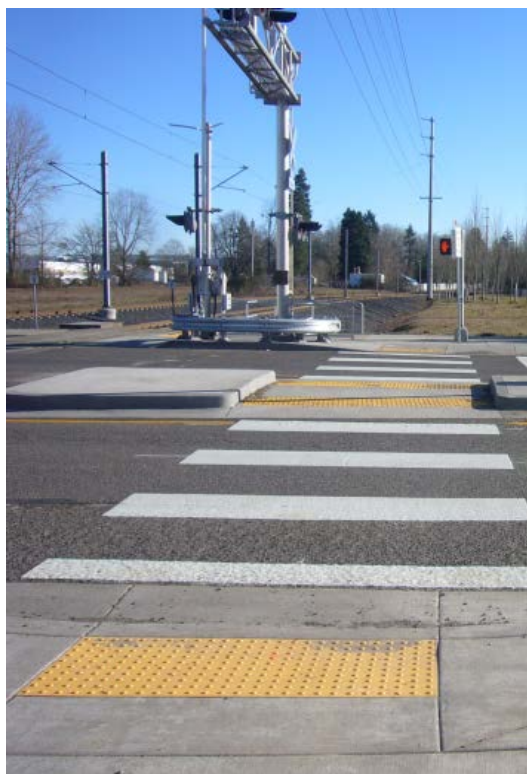
As of 2019, DWS are routinely installed at curb ramps in new or altered construction (see Figure 4), although not all installations meet the precise geometry specified in the *Proposed PROWAG*. DWS at blended transitions and pedestrian refuge islands are less consistently present or precisely positioned. All rail properties in the U.S. have installed DWS at most or all platform edges and installation of DWS at the remaining rail platforms is planned.

Figure 4. A DWS located at a curb ramp and a level crossing in Portland, OR.

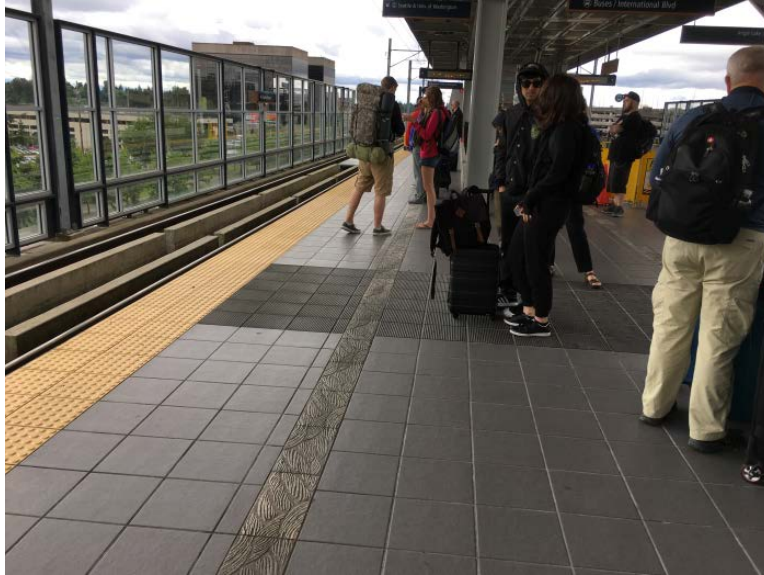
Figure 5 shows a DWS located at the edge of a high-level platform in Seattle. The photo also shows a sinusoidal surface intended to indicate the location of a train door and a unique artistic guidance surface intended to aid travelers who are visually impaired in traveling down the length of the platform. Figure 6 shows a DWS located at the edge of low-level platform in Seattle.

Figure 5. DWS and guidance surfaces at a high-level train platform in Seattle.

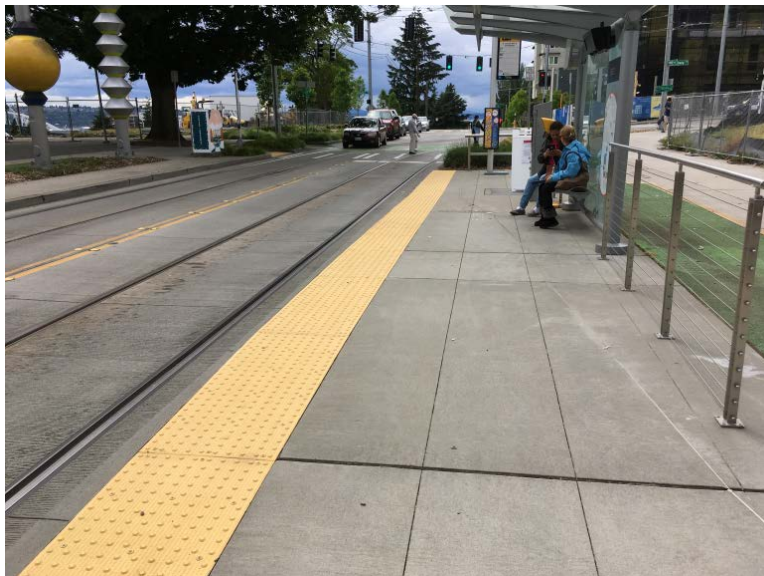
Figure 6. DWS at a low-level train platform in Seattle.

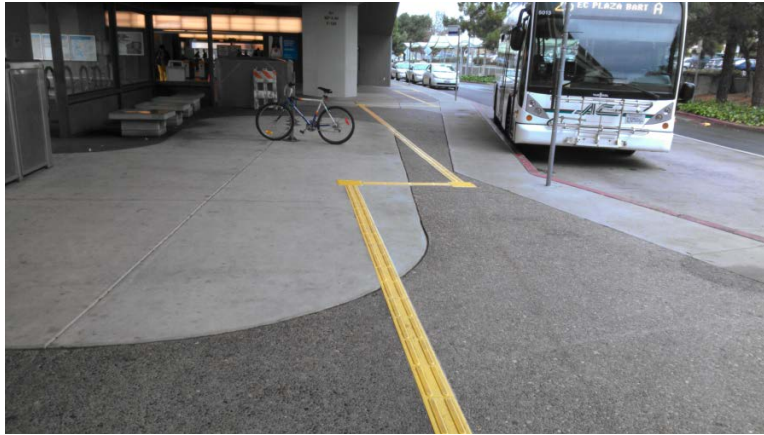
In recent years, guidance surfaces have been installed at a number of transit properties, including in and around some bus and rail stations. Most of these installations use a raised bar surface, but the surface geometry, surface width, and installation locations vary. Figure 7 shows a 6-inch (150-mm) wide raised bar guidance surface at a bus stop at the Warm Springs BART station in Fremont, CA. Figure 8 shows 6-inch (150-mm) wide raised bar guidance surfaces at a bus stop at De Anza College in Cupertino, CA.

Figure 7. Guidance surface at a bus stop in Fremont, CA.

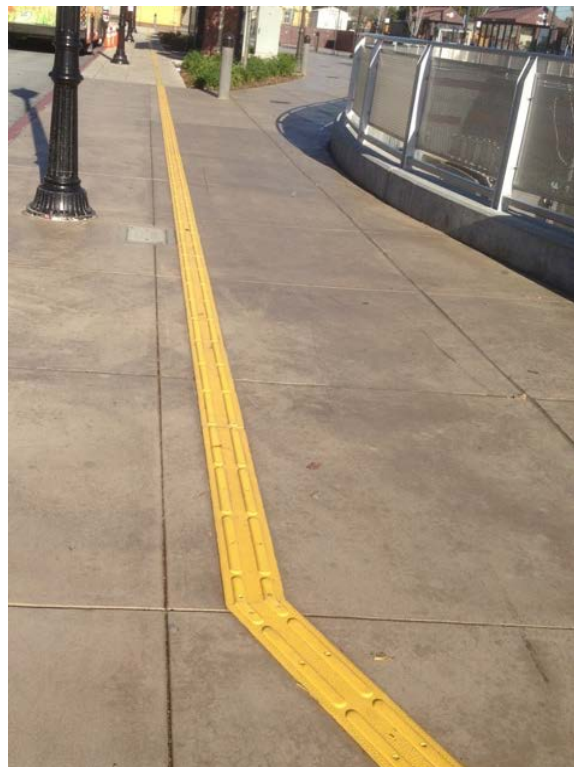
Figure 10. Guidance surface at a commuter rail station in Santa Clara, CA.

Photo courtesy of Armor Tile.

Figure 9 shows a 24-inch (600-mm) wide raised bar guidance surface in the parking garage at the Pleasanton BART station in Pleasanton, CA. Figure 10 shows a 6-inch (150-mm) wide raised bar guidance surface installed by Caltrain in Santa Clara, CA.

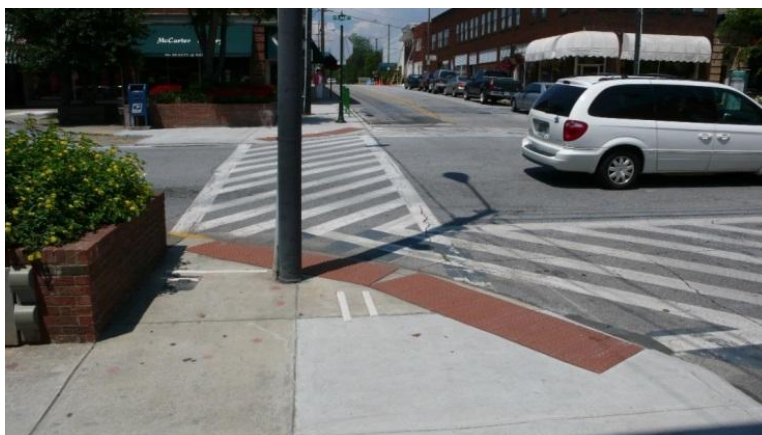
reported having difficulty aligning to cross at blended, large radius corners. Two strips of thermoplastic marking were installed perpendicular to the crosswalk travel direction. This installation may have worked for the individual requesting it after he became familiar with where to look for the two bars, but it never became a widely used solution. This cue has not been evaluated for detectability by pedestrians who are visually impaired, nor negotiability by travelers with mobility impairments.

Figure 11. A blended corner with detectable warnings preceded by thermoplastic strips intended to provide alignment information.

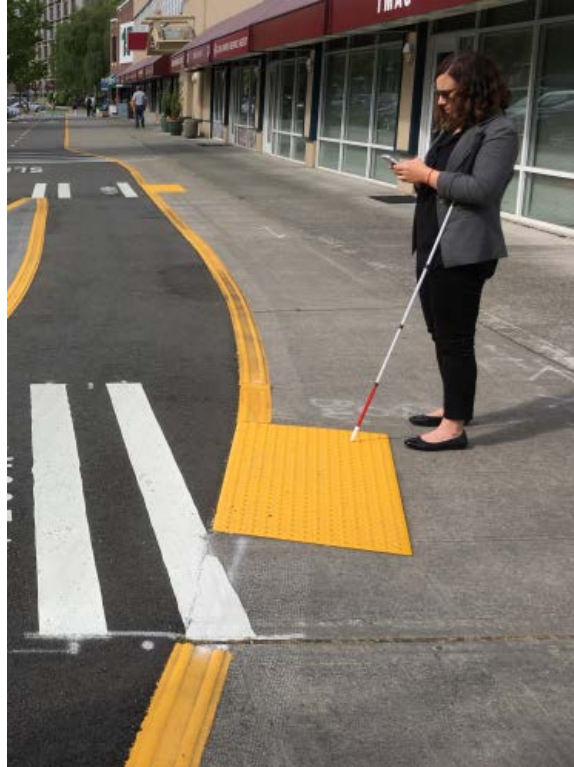
Figure 13. Guidance surfaces delineating bicycle and pedestrian areas and crossings in Seattle, WA.

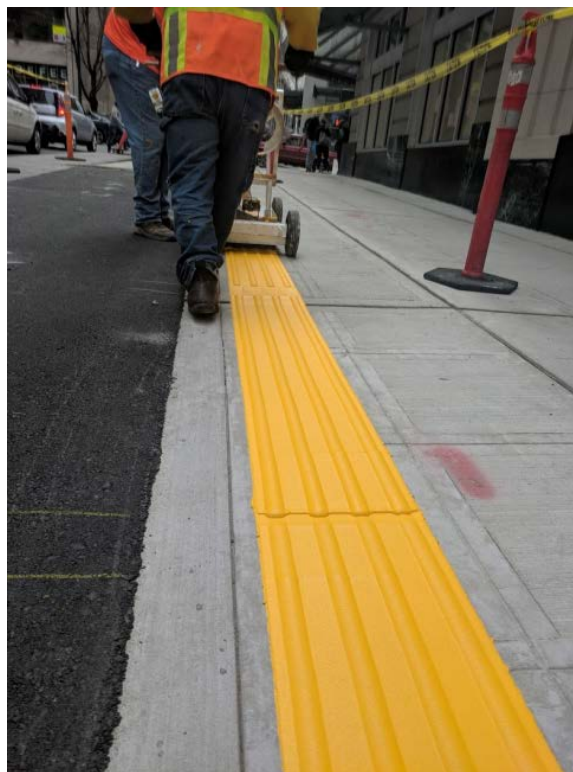
Figure 14. Installation of a guidance surface in Seattle, WA.

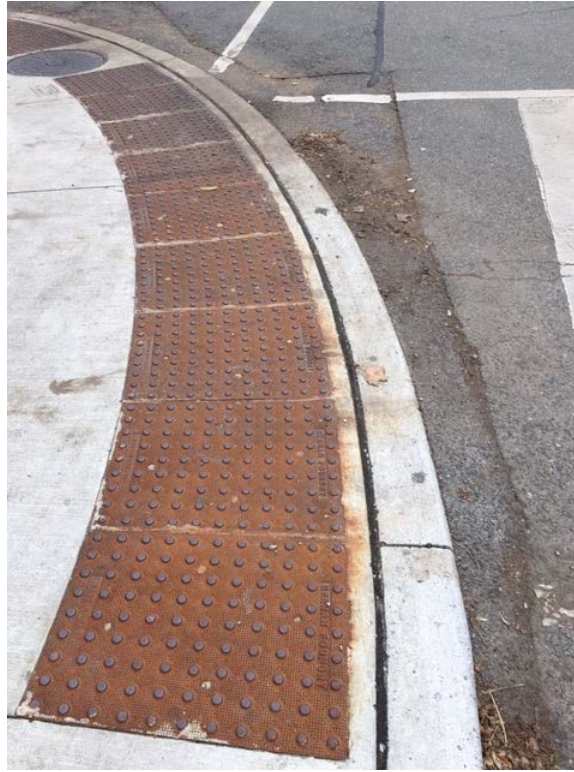
Figure 18. DWS along a blended curb in Toronto.

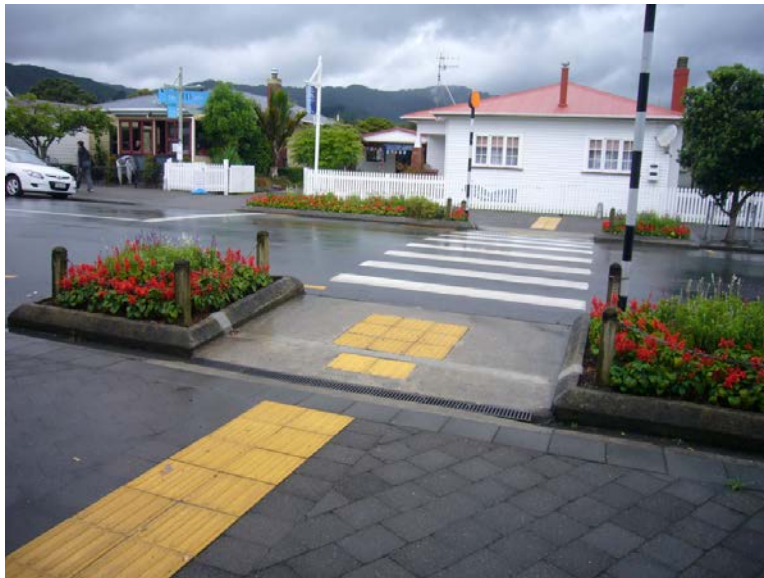
Figure 22 shows a guidance pattern of raised bars across a sidewalk in New Zealand which indicates the location of a mid-block crossing at a bulb-out. There is an attention field of truncated cones near the curb line. Figure 23 shows attention fields oriented perpendicular to the crossing directions in Auckland, New Zealand. One attention field is comprised of discrete elements, while the other is an integrated surface.

Figure 22. TGSIs at a bulb-out mid-block crossing in New Zealand.

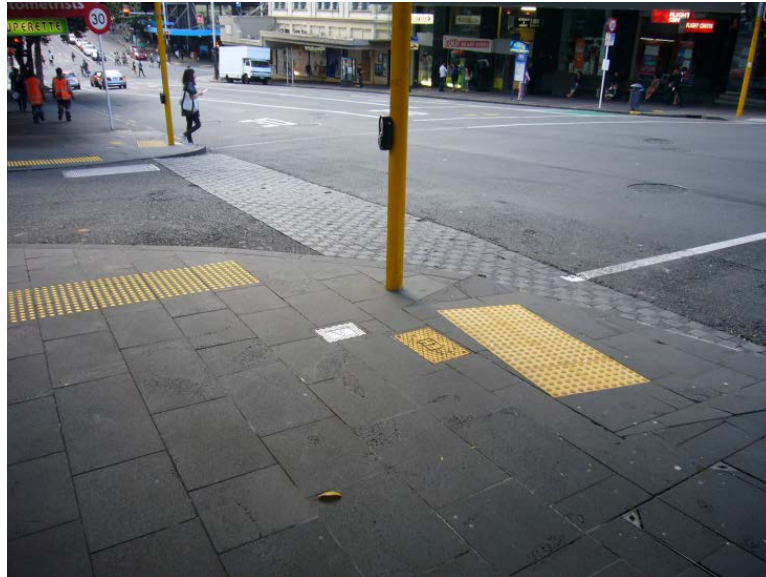
Figure 23. Attention fields oriented perpendicular to the crossing direction in Auckland, New Zealand. One attention field is comprised of discrete elements, while the other is an integrated surface.

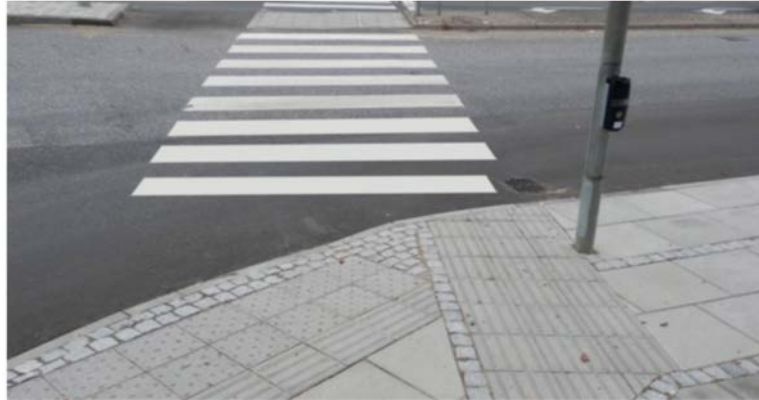
Note: The line of small pavers on the left side of the guidance surface is not standard.

At hard-to-find crossings, such as at roundabouts and channelized turn lanes, installation of 800 to 900 mm (32 to 36 inch) wide direction fields across sidewalks are recommended to help in locating the crossings. The direction fields lead to one end of the associated attention field near the curb line and are oriented with the bars parallel with the direction of travel on the crosswalk (see Figure 29).

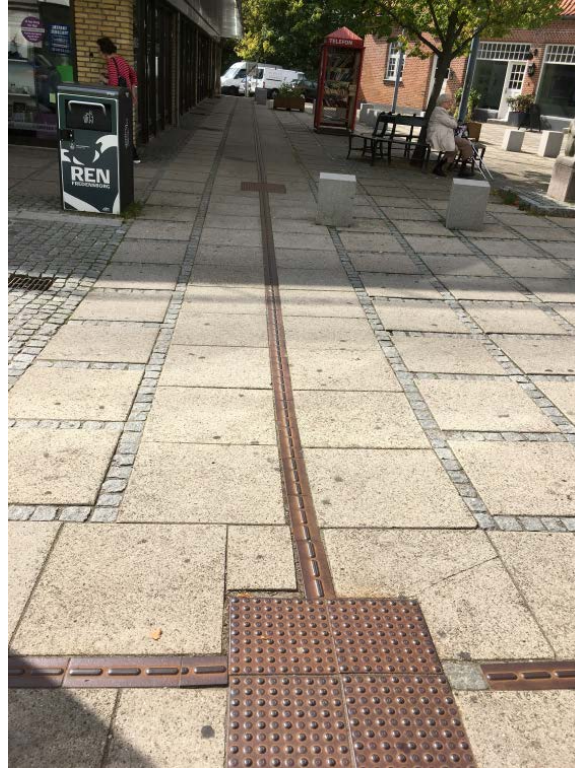
Figure 30 illustrates TWSIs indicating an intersection of two shared streets in Fredensborg, Denmark. The guiding pattern is a single line of short raised bars. The intersection of guiding patterns is indicated by a large rectangle of truncated domes. Figure 31 shows a location where the base walking surface is concrete for most of its length and the guiding pattern is four bars wide and composed of individual elements. Where the base walking surface changes to pavers, the guiding pattern changes to pavers with four raised bars. At the intersection of guiding patterns, a rectangle of truncated domes composed of individual elements is used.

Figure 30. Guidance pattern used at intersection of two shared streets in Fredensborg, Denmark.

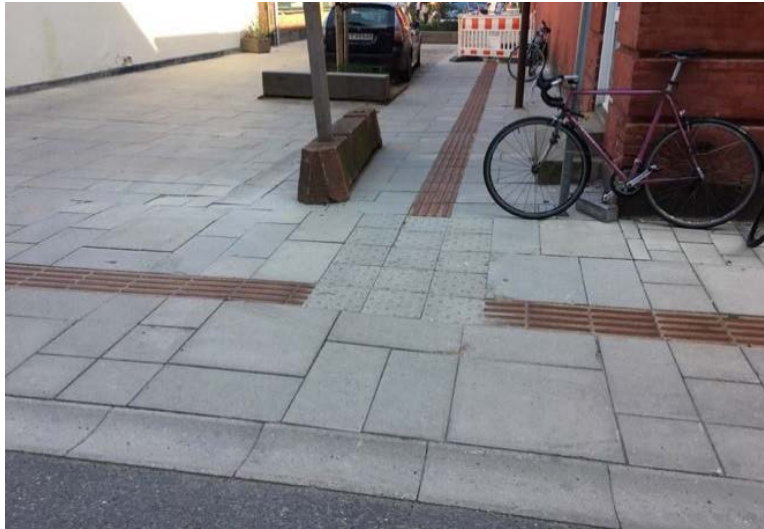
Figure 32. shows a shared street where the guiding pattern is red pavers with four raised bars contrasting nicely with the adjoining flat, gray, concrete pavers. At the intersection of the guiding patterns, a large rectangle of truncated dome pavers is the same color as the flat pavers. Figure 33. shows a mid-block curbside bus stop, where a small rectangle of the Danish direction field, comprised of raised bars perpendicular with the direction of travel along the sidewalk, leads to a similarly sized warning surface set back from the curb.

Figure 32. Non-contrasting attention field at the intersection of two guiding patterns.
