June 12, 2013

21-1-21664-001

RE: DOCUMENT REVIEW SERVICES, MARINE DRIVE BINWALL RETAINING STRUCTURES, CITY OF WHITE ROCK, WHITE ROCK, BRITISH COLUMBIA

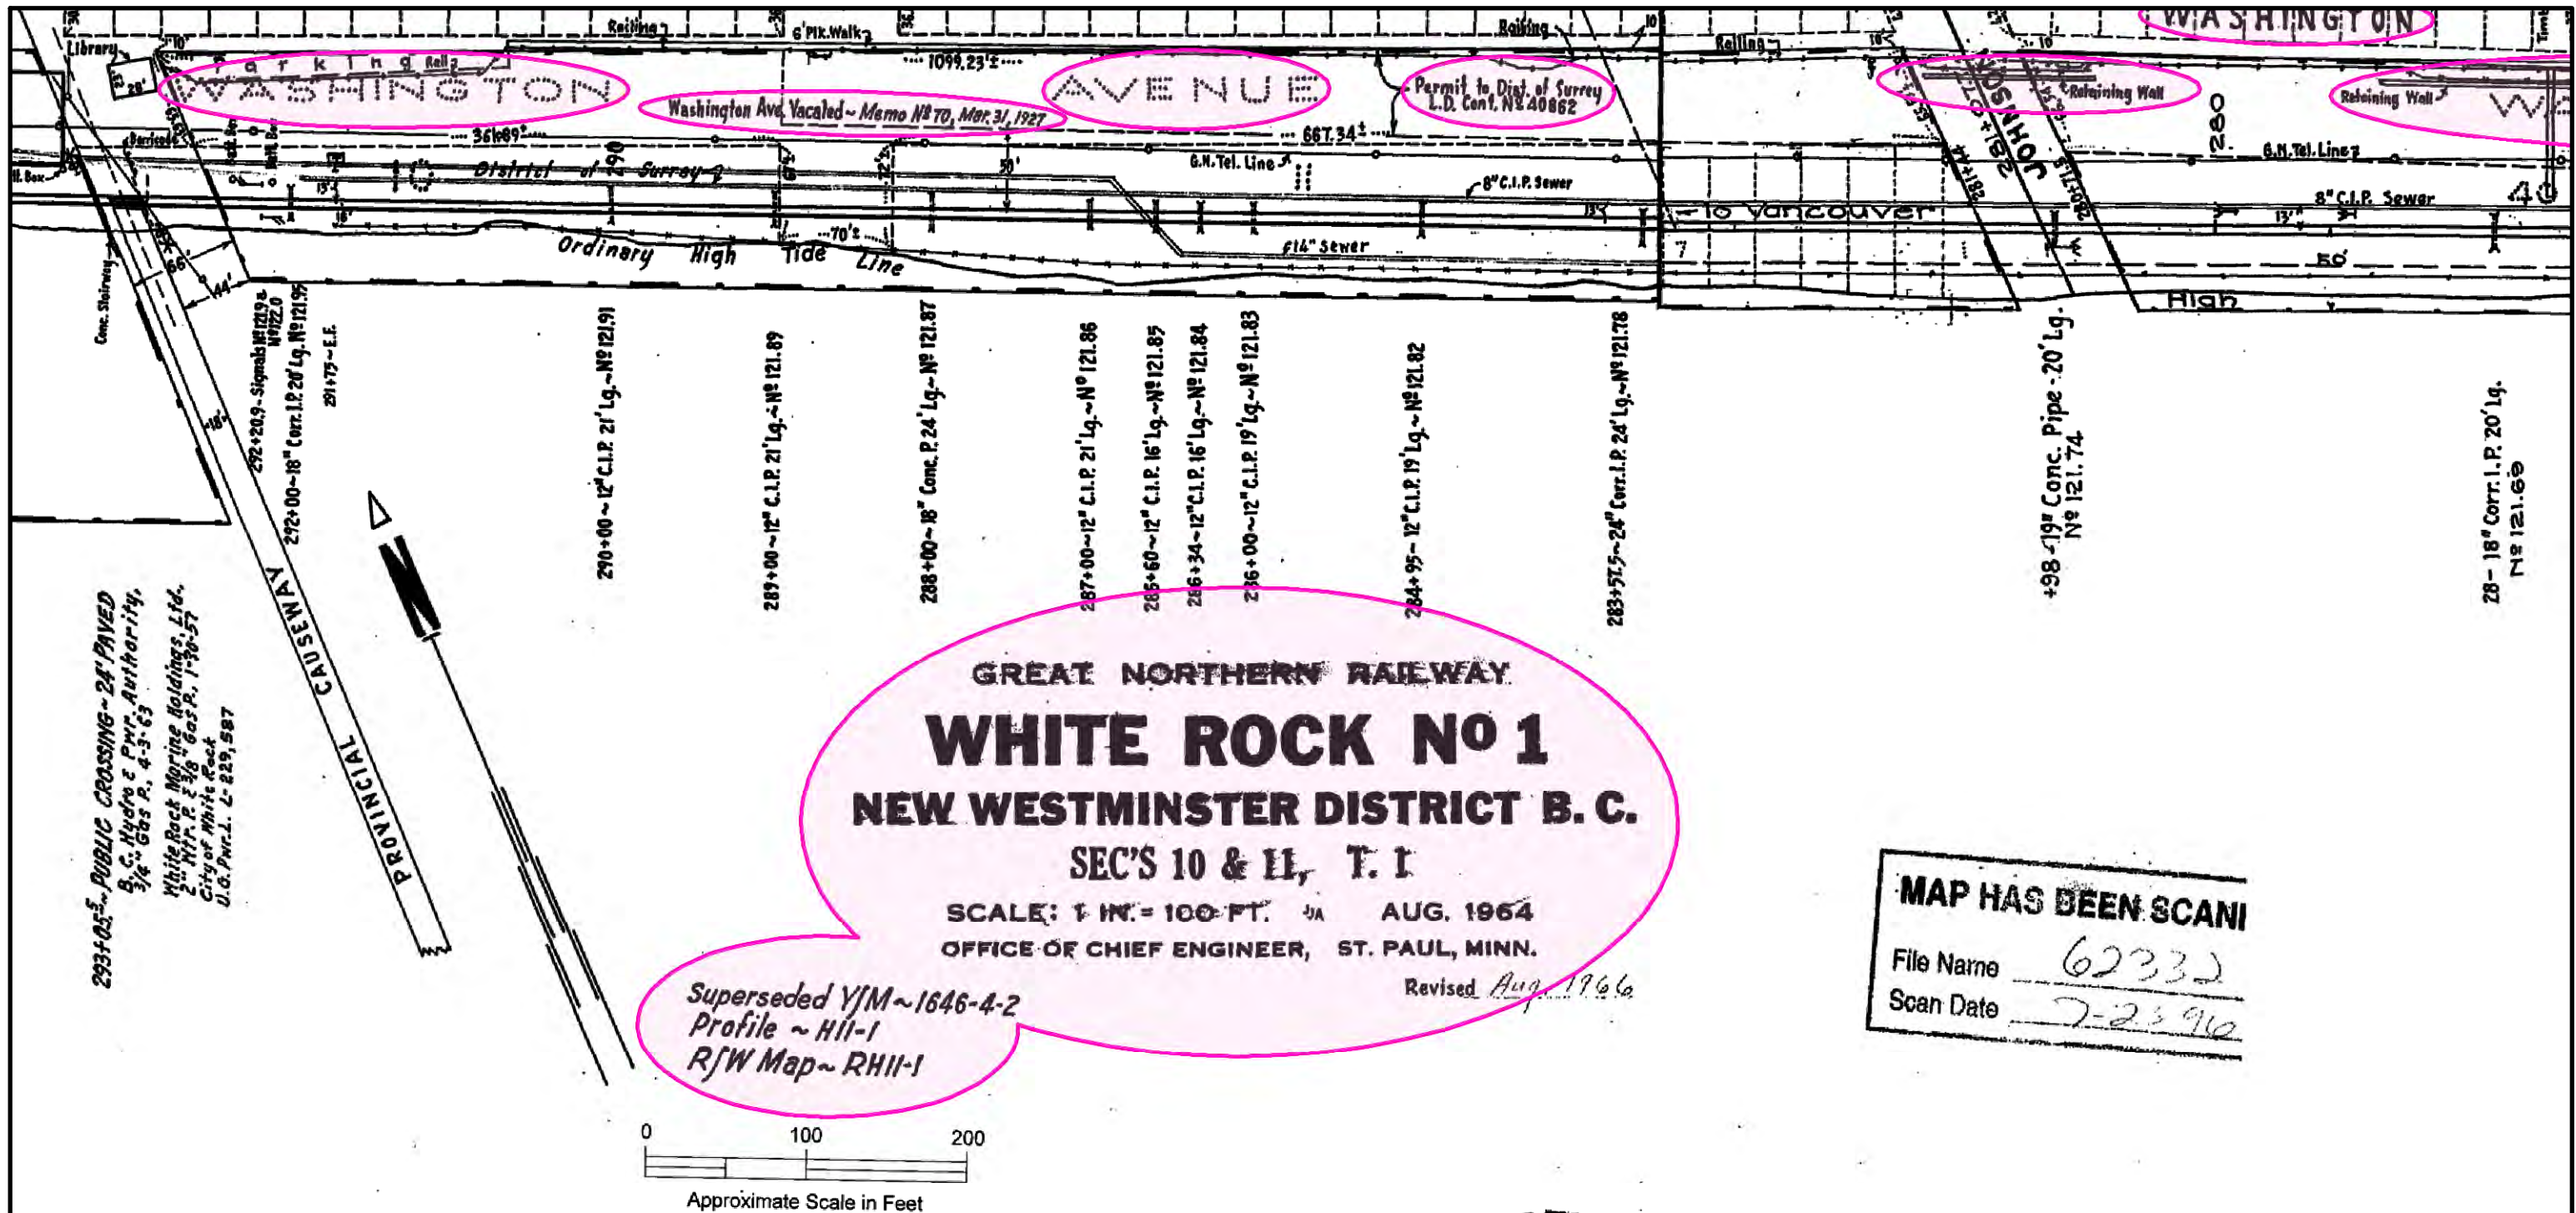
BNSF Railway Stability Review Services City of White Rock, White Rock, British Columbia	
BNSF STATION MAP EXCERPT	
May 2013	21-1-21664-001
SHANNON & WILSON, INC. <small>GEOTECHNICAL AND ENVIRONMENTAL CONSULTANTS</small>	FIG. 2 Sheet 1 of 3

The station map (Figure 2) shows the tracks, right of way boundary, city streets, parcel boundaries, utilities, and other railway and City features. Retaining walls shown on the map match the approximate locations of the three walls at the project site. To compare the features on the map to present site features, we overlaid the map onto an aerial photograph (Figure 3). The photo and map do not match exactly, and the features depicted in the map should be considered approximate.

We also noted a marking near the station map title block that says *Superseded V/M~1646-4-2, Profile~H11-1, R/W Map~RH11-1.*

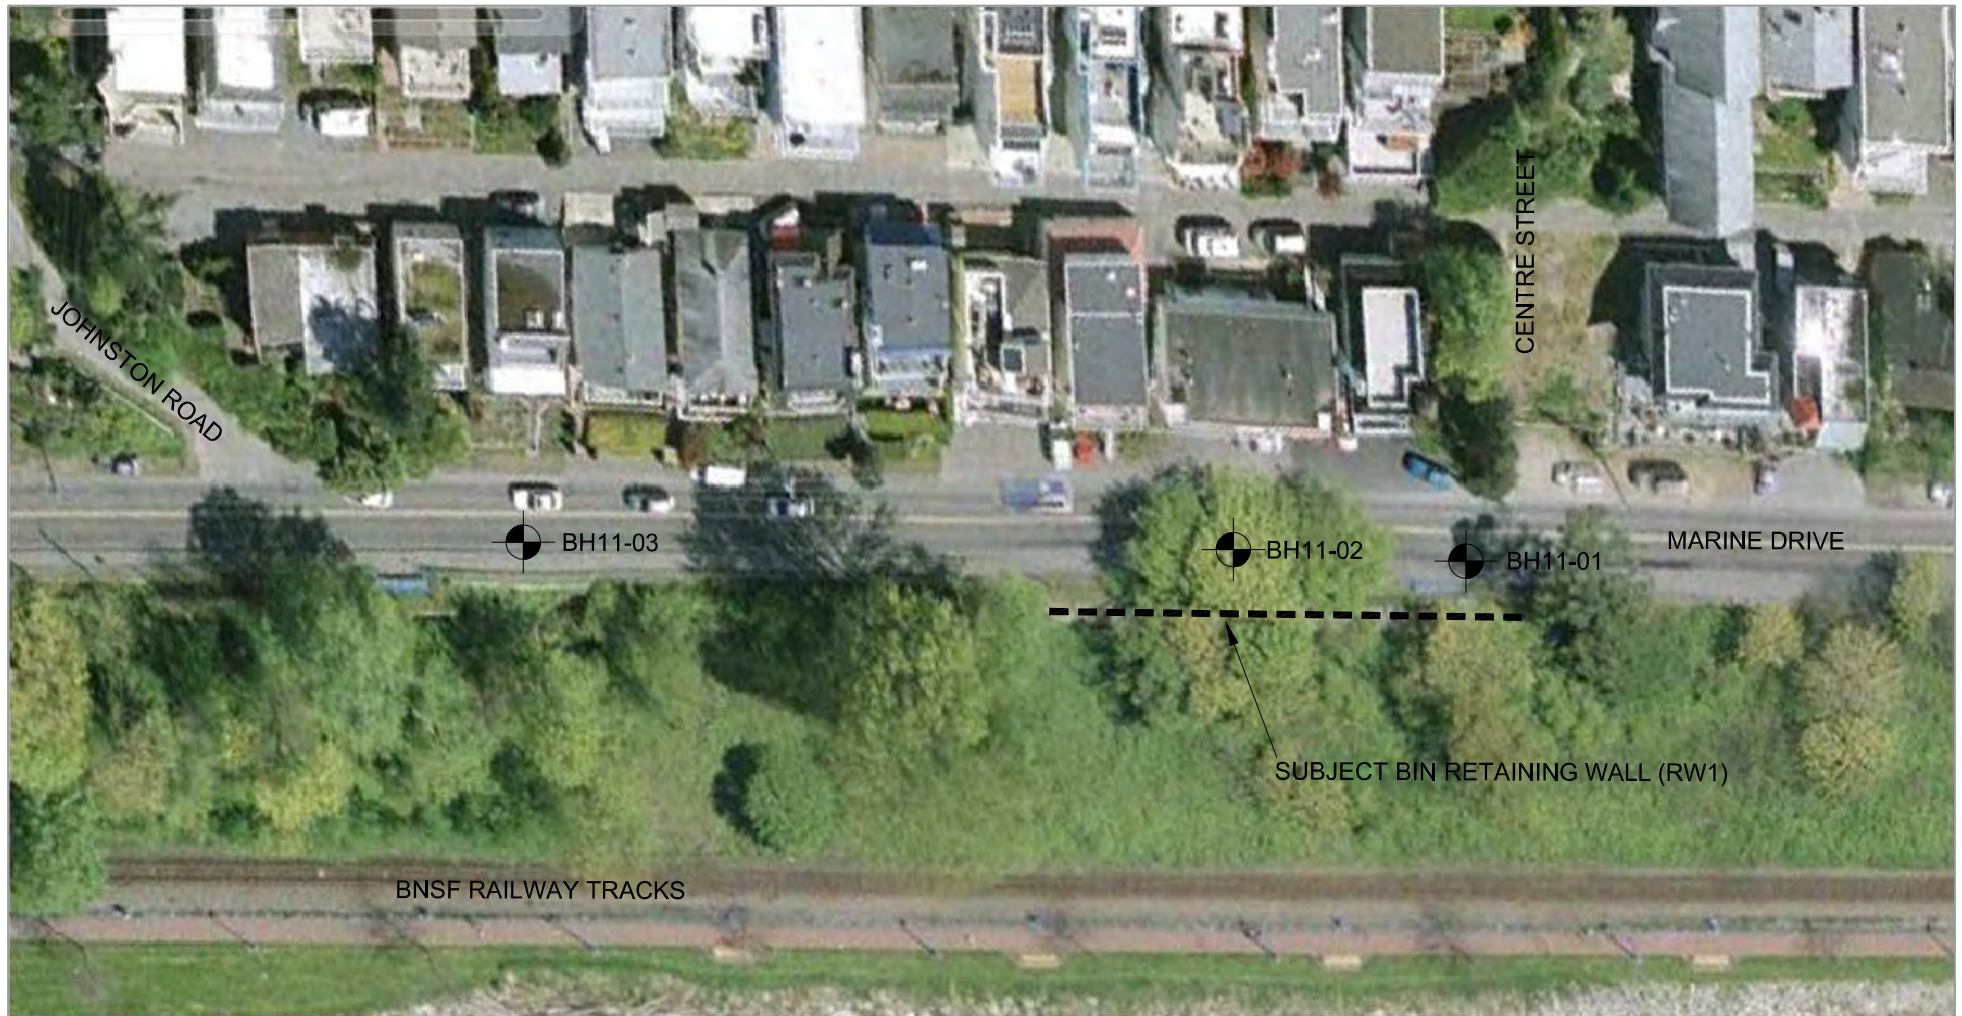
Note: All borehole locations are approximate

from the slope a distance of approximately 6 m. The borehole locations are identified on Figure 2 attached to this report.

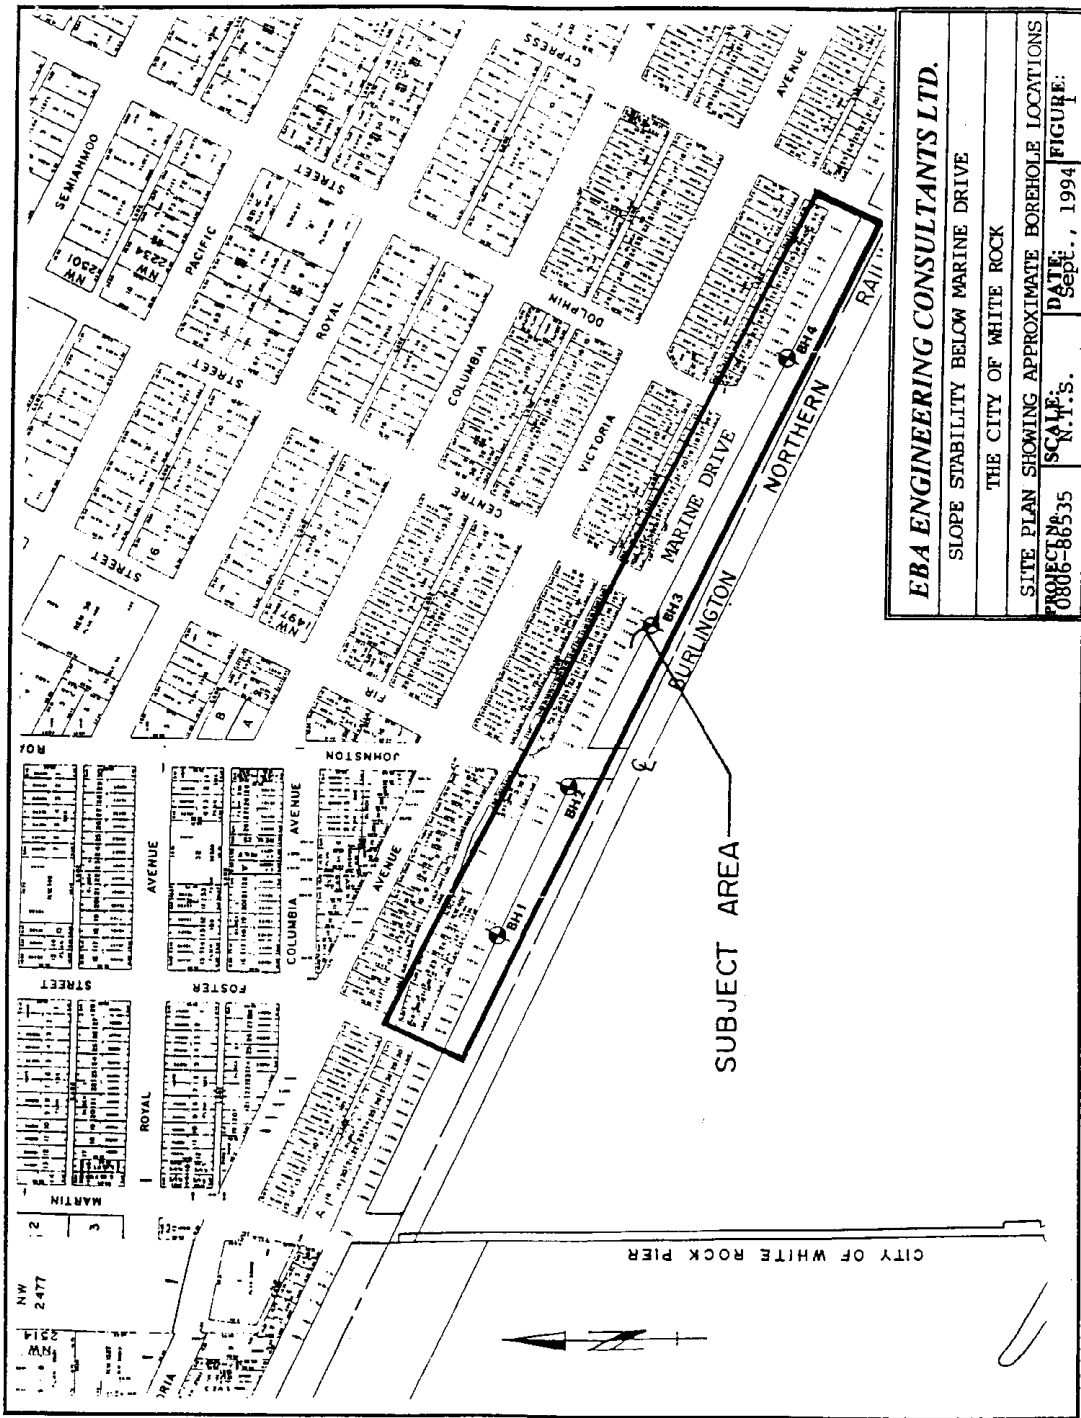
FIGURE 1

Four boreholes (BH1 to BH4) were drilled to depths varying from 12.2 m to 15.2 m at the top of slope at approximate locations shown in Figure 1. During the course of drilling, Dinamac Holdings Ltd. was retained to control the traffic along Marine Drive.
