City of White Rock Drainage Master Plan Update

Final Report

August 2019

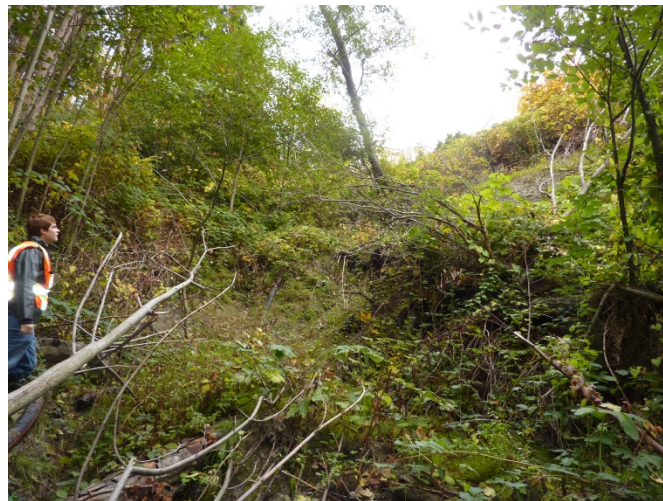
Photo 2 Lower Coldicott Ravine - Recent Landslide on West Ravine Slope Below Private Properties

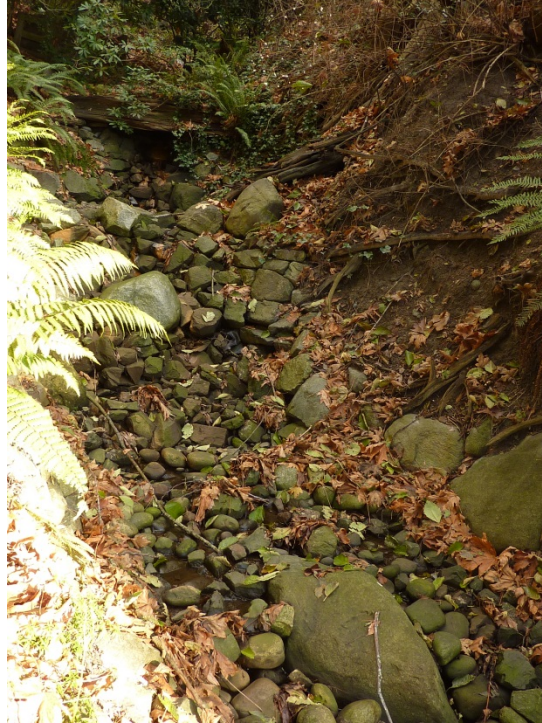
Photo 9 Everall Ravine – Cobble and Boulder Lined Channel within Private Property

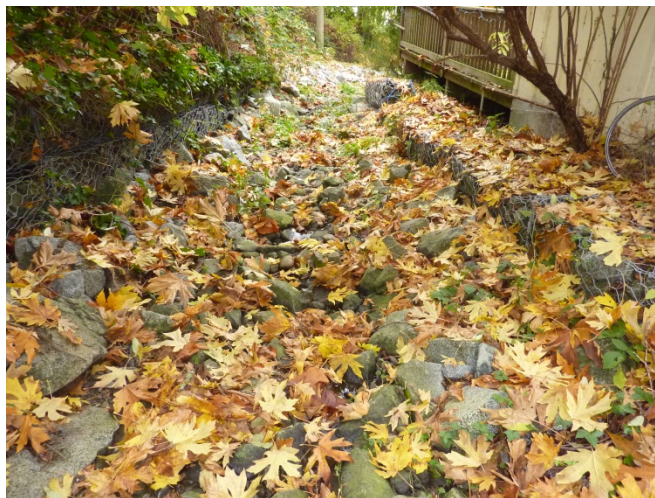
Photo 10 Everall Ravine – Rip Rap Armour and Gabion Wall Lined Channel above Inlet Structure

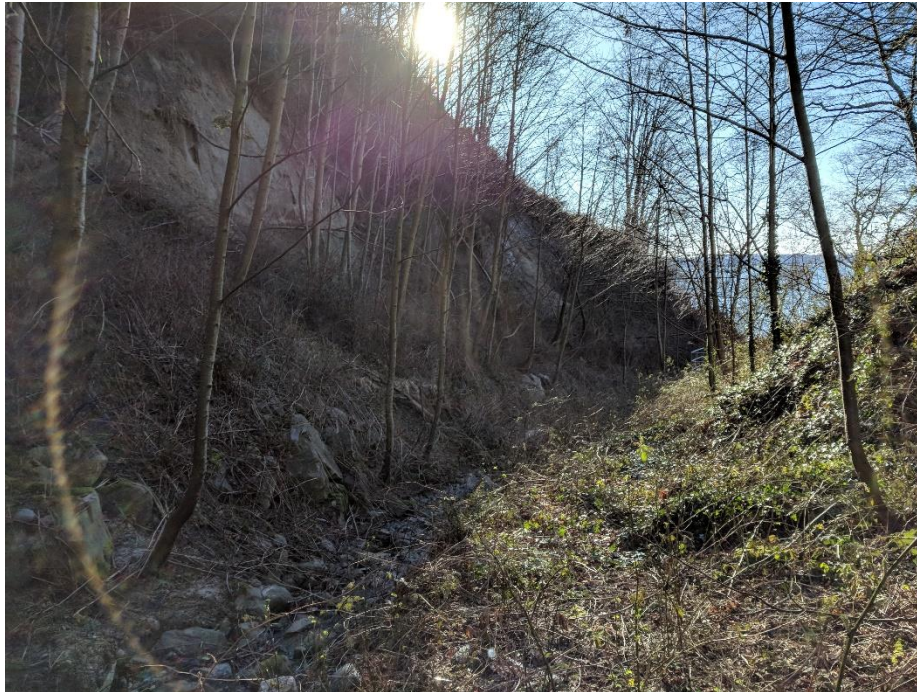
Photo 1 Lower Coldicott Ravine - Near-vertical Soil Face on East Ravine Slope

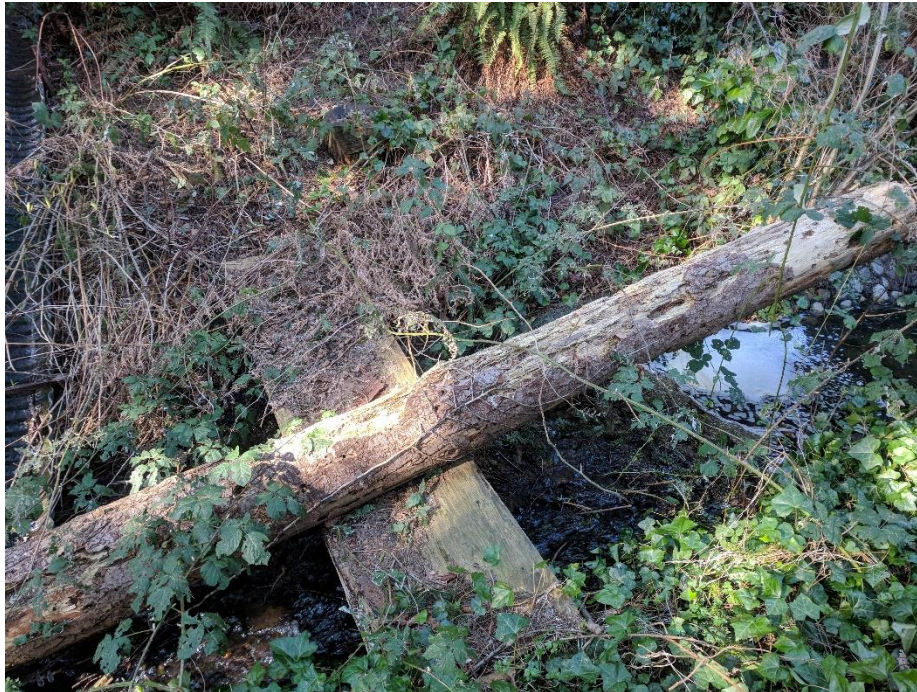
Photo 4 Collingwood Ravine – Foot Bridge Collecting Debris

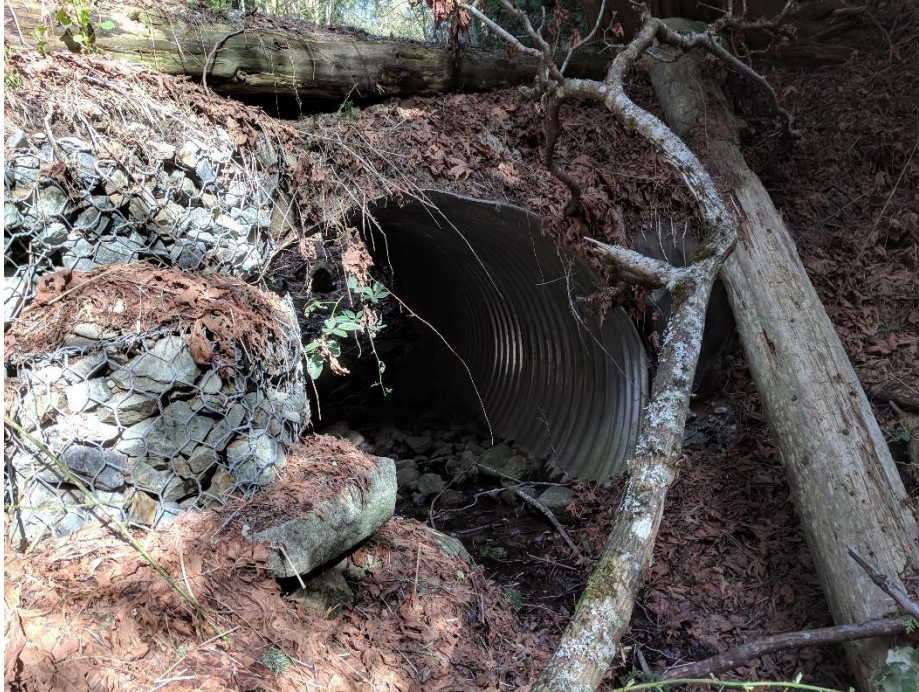
There is an approximately 1500 mm diameter CSP culvert which serves as a footbridge near the head of the ravine. The gabion wing wall on the upstream, left bank appears to be bulging and the culvert is slightly out of round, as shown in Photo 11. Gabion baskets are quite tolerant of

Photo 11 Duprez Ravine – Gabion Wing Wall at Culvert Footbridge Inlet

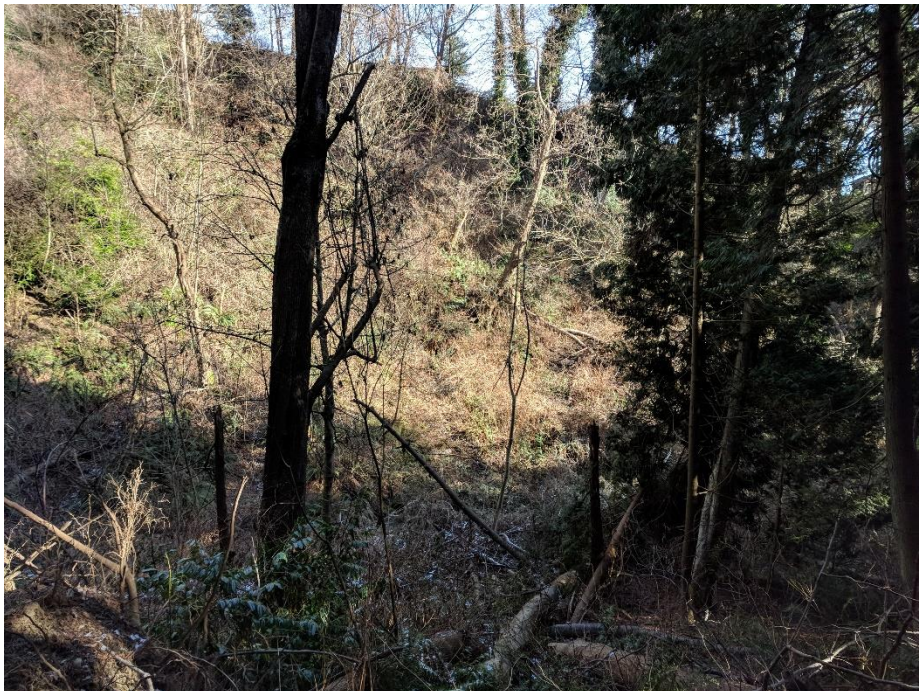
The ravine slopes are high and, in some locations, relatively steep, as shown on Photo 12. However, there was no evidence of major instabilities.

Photo 12 Anderson Ravine – Steep Slope at End of Oxenham Avenue

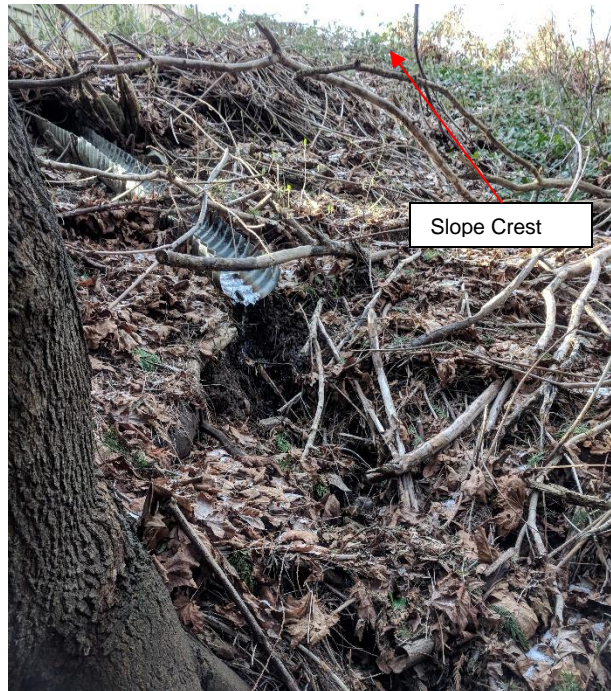
Photo 13 Everall Ravine West Branch – CSP Pipe near Crest

Everall Ravine has two branches, the west and east. The west branch extends from the south end of 1351 Vidal Street to about Everall Street at Prospect Avenue. The majority of the west branch is within private property, so it was accessed from the west side along the Roper Avenue right of way. A 300 mm diameter open-top CSP pipe exits the slope near Everall Lane and extends partway down the slope, as shown in Photo 13. An erosion feature is present below the outlet of the CSP pipe to the bottom of the ravine as shown in Photos 14 and 15, and Photo 16 shows the condition at the base of ravine in 2002. Flows in the ravine were minimal at the time of inspection. We recommend that the CSP pipe be extended to bottom of the ravine to reduce bank erosion.

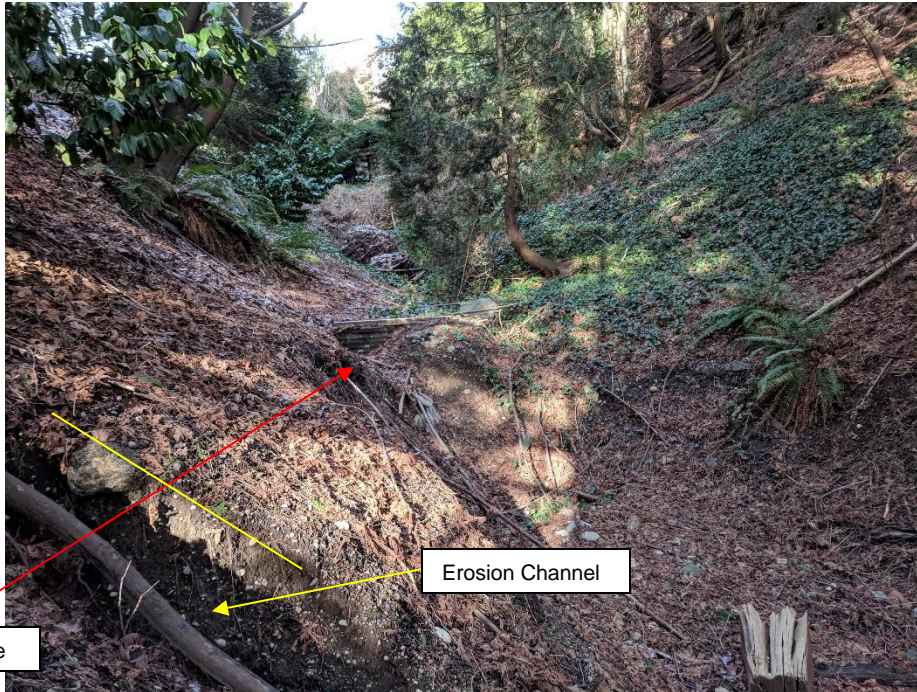
Photo 15 Everall Ravine West Branch – Erosion at bottom of Ravine

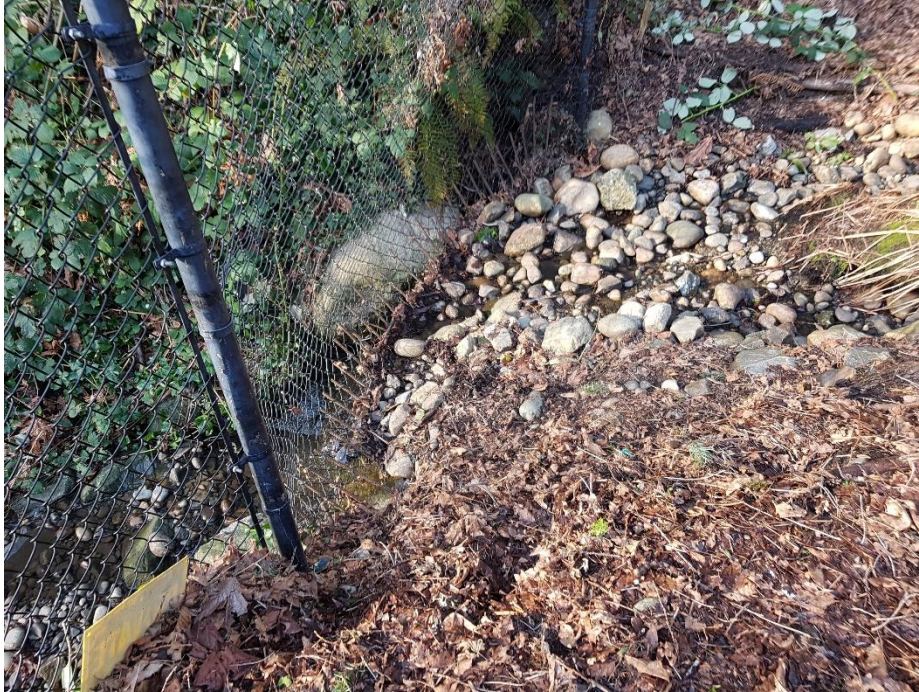
Debris has accumulated in the channel against the south property line fence, which has a noticeable bulge in it where the creek exits the private property. It appears that the fence has been reinforced with rebar, as shown in Photo 19. We recommend that the Owner be notified of the buildup and that the debris be removed before the weight of the debris causes the fence to

Photo 19 Everall Ravine – Rebar Reinforcement for Fence

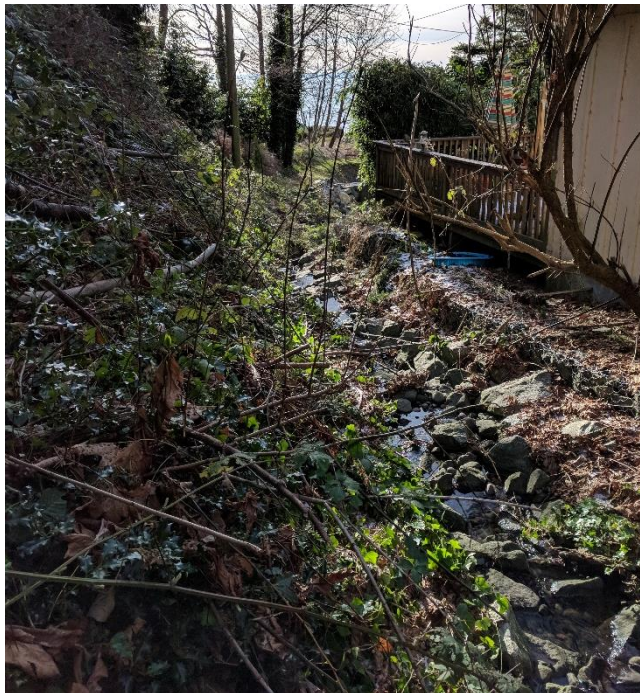
Below the private property, the lower reaches of the channel are lined with angular rip rap rock armour and a gabion wall has been constructed to constrain flow in the channel near the house at the bottom of the ravine, as shown in Photo 20.

Photo 20 Everall Ravine – Gabion and Rip Rap Armour Lined Channel above Inlet Structure
