From: [Krista Baronian](#)
To: [Neethu Syam](#); [Anne Berry](#)
Cc: [Parb Rehal](#)
Subject: RE: 1441 Vidal Street - Items to be addressed prior to scheduling Public Hearing
Date: July 5, 2023 10:43:35 AM
Attachments: [image001.jpg](#)
[image002.jpg](#)
[image003.png](#)

RESIDENTIAL DEVELOPMENT
 1441-1465 VIDAL STREET & 14937 THRIFT AVENUE, WHITE ROCK, B.C.
EROSION & SEDIMENT CONTROL PLAN

RESIDENTIAL DEVELOPMENT
1441-1465 VIDAL STREET & 14937 THRIFT AVENUE, WHITE ROCK, B.C.
EROSION & SEDIMENT CONTROL DETAILS (1 OF 2)

RESIDENTIAL DEVELOPMENT
1441-1465 VIDAL STREET & 14937 THRIFT AVENUE, WHITE ROCK, B.C.
EROSION & SEDIMENT CONTROL DETAILS (2 OF 2)

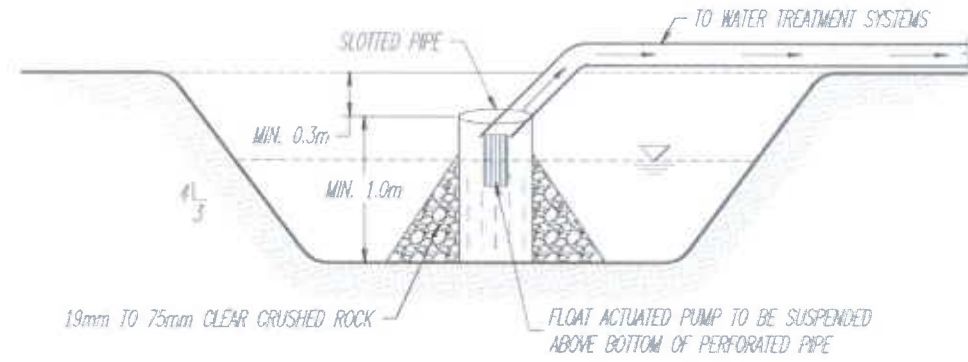
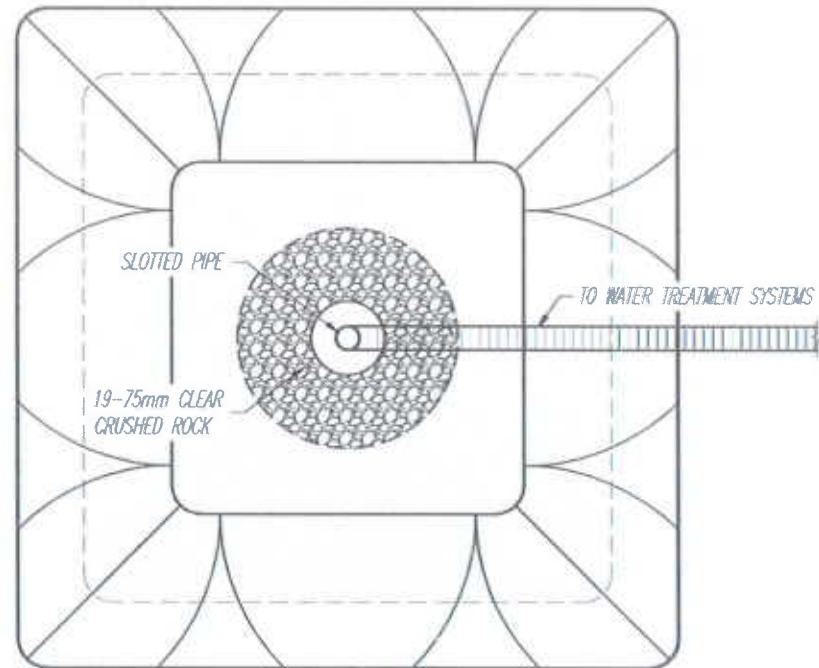
TYPICAL CROSS SECTION

TYPICAL PLAN VIEW

SUMP WITH SEDIMENT TRAP DETAIL - BMP C240

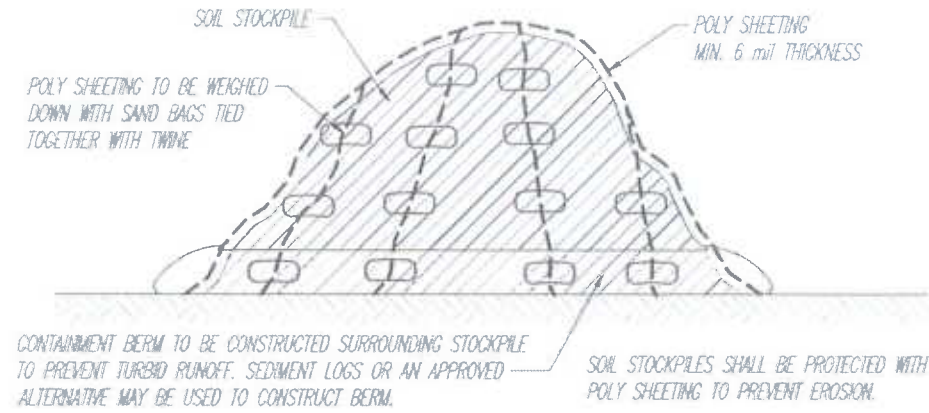
PLASTIC SHEETING - BMP C123

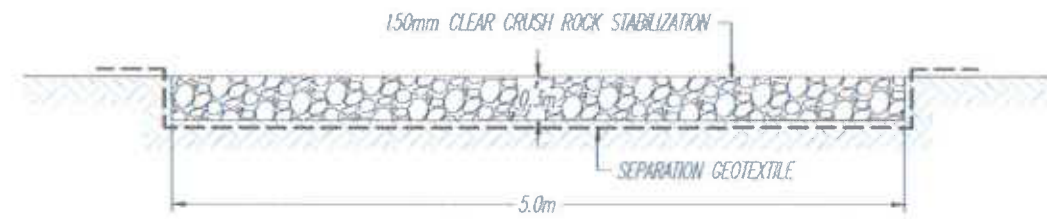
GEOTEXTILE SEPARATION SPECS

GRAB TENSILE STRENGTH (ASTM D4751)	200psi MIN.
GRAB TENSILE ELONGATION (ASTM D4632)	30% MAX.
MULLEN BURST STRENGTH (ASTM D3786 - 80A)	400psi MIN.
AVERAGE OPENING SIZE (ASTM D4751)	20 - 45 (U.S. STANDARD SIZE)

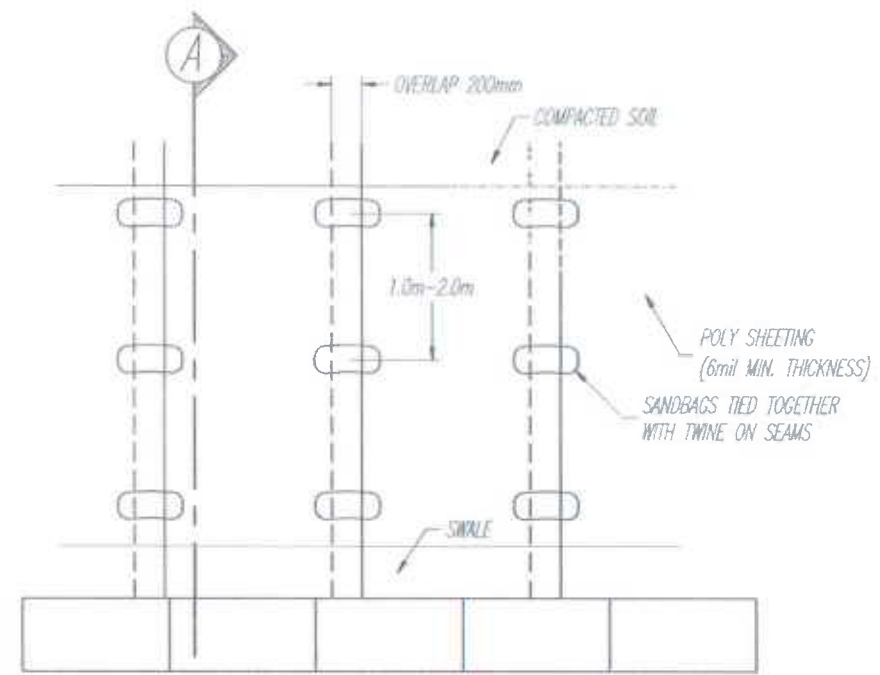
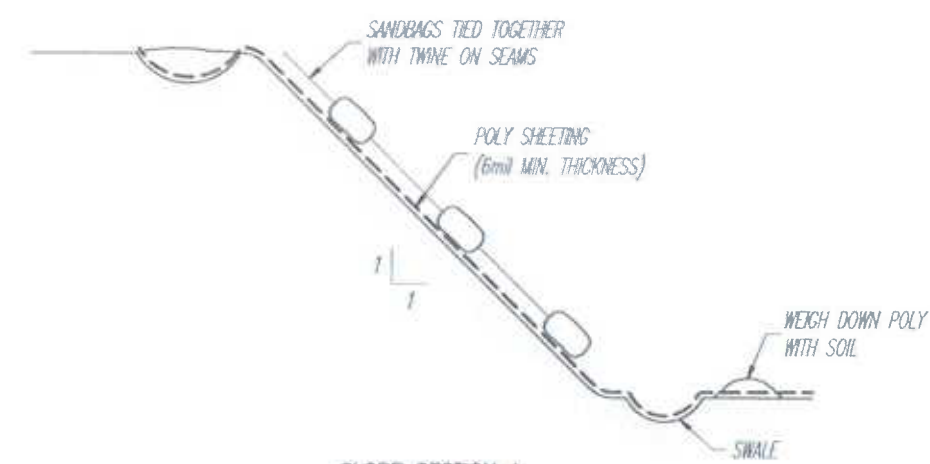
SLOPE PLAN VIEW

SLOPE SECTION A

PLASTIC COVERING - BMP C123
N.T.S.

- NOTE:**
1. POLYETHYLENE SHEETING WITH A MINIMUM THICKNESS OF 6mil TO BE USED.
 2. SHEETING TO BE PLACED PARALLEL TO THE SLOPE WITH A MINIMUM 200mm OVERLAP BETWEEN SHEETS.
 3. TRENCH TO BE EXCAVATED AT THE HEAD OF THE SLOPE TO ALLOW SHEETING TO BE SECURED UNDER COMPACTED SOIL.
 4. TRENCH TO BE EXCAVATED AT THE TOE OF THE SLOPE, TO A DEPTH OF 300mm, WHICH WILL ACT AS A SWALE.
 5. BURLAP OR GEOTEXTILE BAGS FILLED WITH SAND TO BE PLACED AT 1.0m TO 2.0m INTERVALS ALONG SEAMS. BAGS TO BE TIED TOGETHER WITH TWINE TO HOLD IN PLACE.
 6. REGULAR INSPECTION OF THE SHEETING IS REQUIRED. TORN SHEETS MUST BE REPLACED AND OPEN SEAMS MUST BE SEALED.

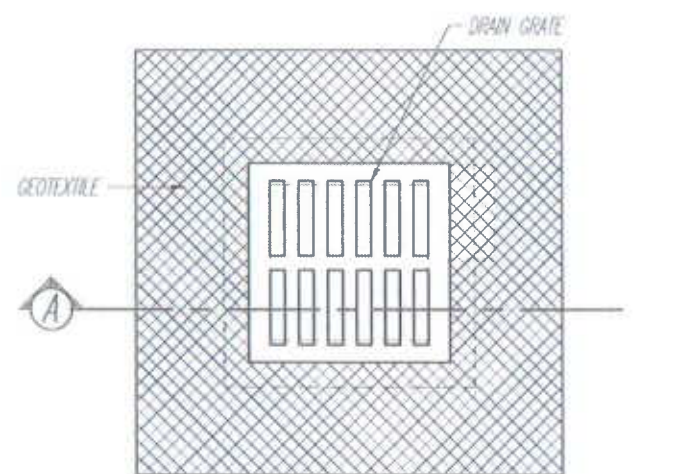
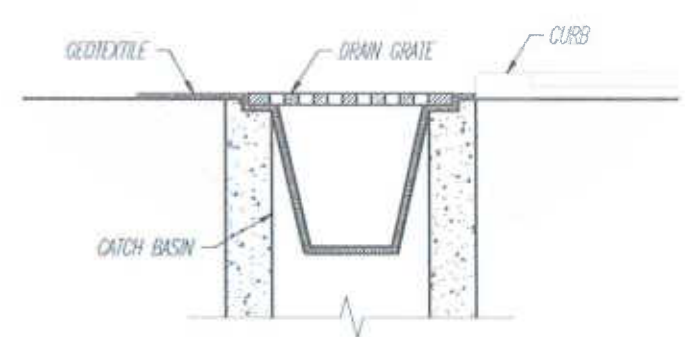
PLAN VIEW

SECTION A

- STORE SPARE CATCH BASIN PROTECTION ONSITE AT ALL TIMES.
- INSPECT CATCH BASIN PROTECTION WEEKLY, AND DAILY DURING STORM EVENTS. CLEAN OR REPLACE WHEN 1/3 FULL, CLOGGED, OR SIGNS OF WEAR OCCUR.
- CATCH BASIN PROTECTION TO BE USED ON ALL CATCH BASINS WITHIN 150m OF SITE EXIT ALONG HAUL ROUTE.

CATCH BASIN SEDIMENT SACK DETAIL - BMP C220
N.T.S.

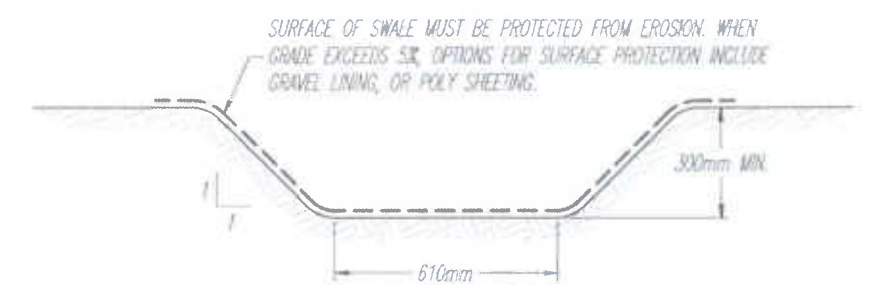
INTERCEPTOR SWALE DETAIL - BMP C200
1:20

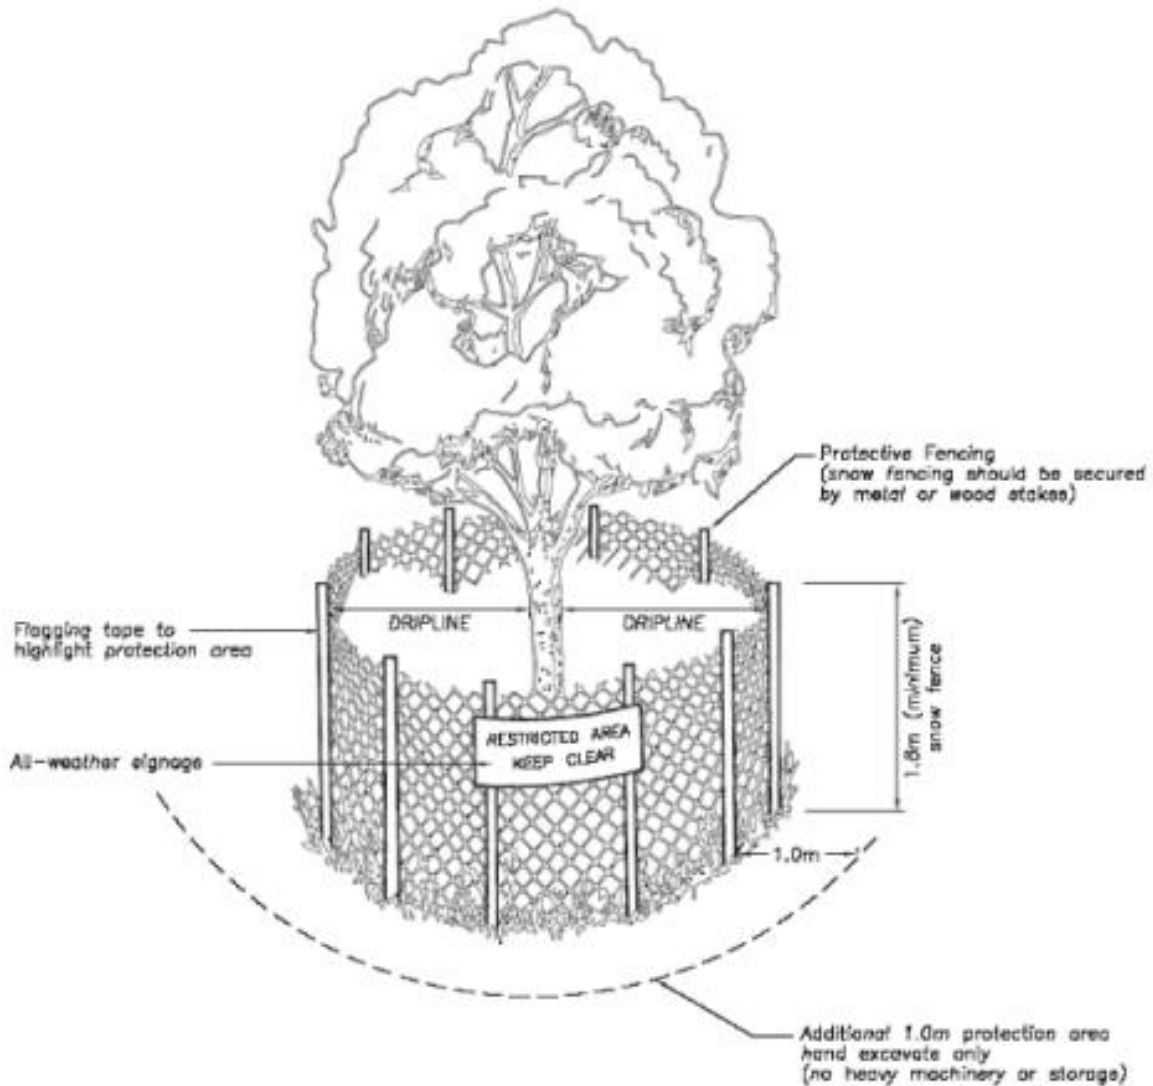
Prior to construction activity you should erect temporary fencing at the dripline of the tree to protect the roots and canopy.

GENERAL REQUIREMENTS AND LIMITATIONS FOR OPERATIONS WITHIN THE TREE PROTECTION ZONE

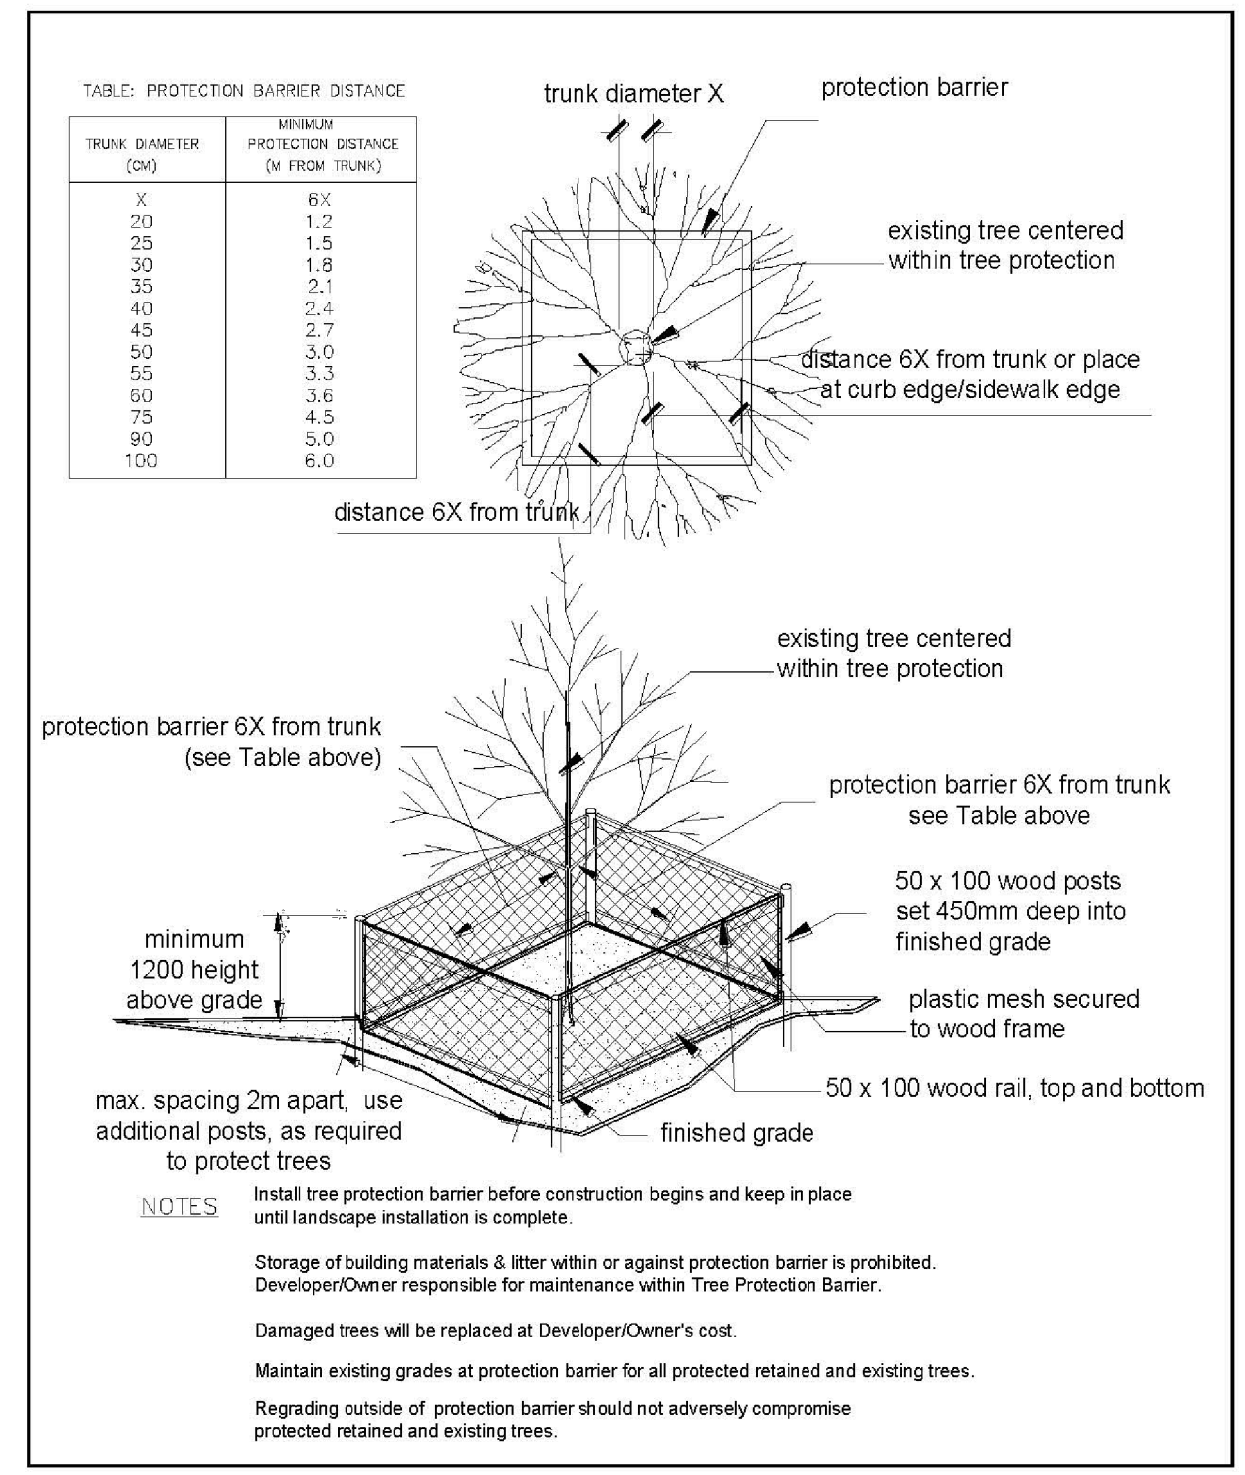
SCHEDULE "A"
Specifications for Tree Protection Barriers

- Contact Arborist (Glyn Romaine, 604 841 9977, glyn@vdz.ca) for inspection 72 hrs prior to any grading or excavation within the tree protection zone. (typ) If during excavation it is found that it cannot be completed without severing roots that are critical to the trees health or stability it may be necessary to remove additional trees.

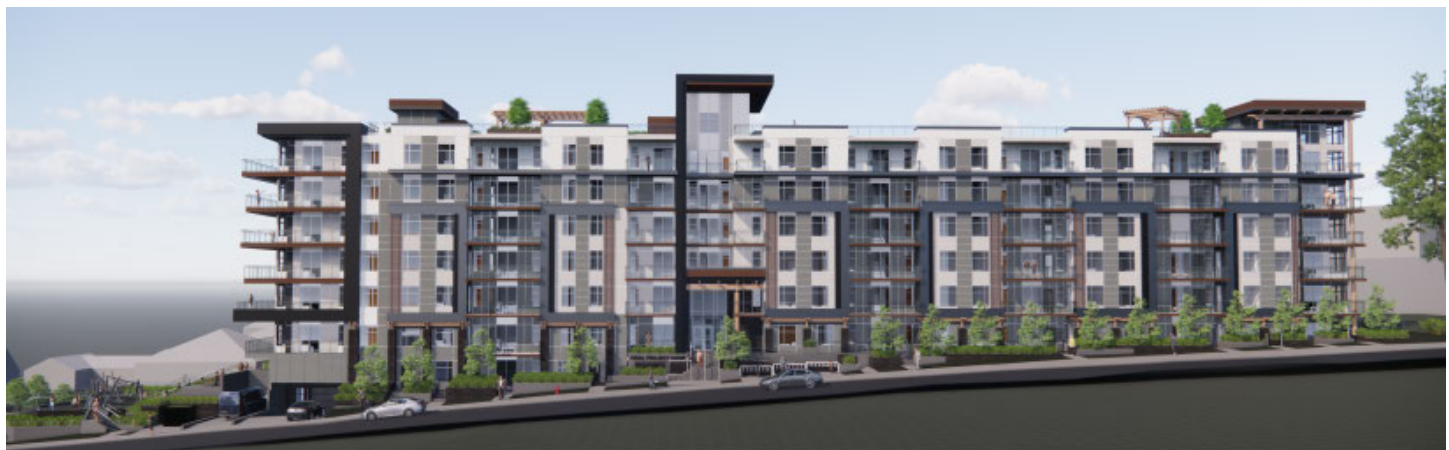
The building site is sloped such that it tiers down towards Thrift Street as follows:

east perspective elevation

A small portion of the middle parkade level protrudes above grade level facing Thrift Ave, and is deemed to be the first storey of the south building. As such the entire south building is technically considered “seven storeys in height”. The deck, elevator lobby, and stairwell enclosures at roof level are not considered storeys.

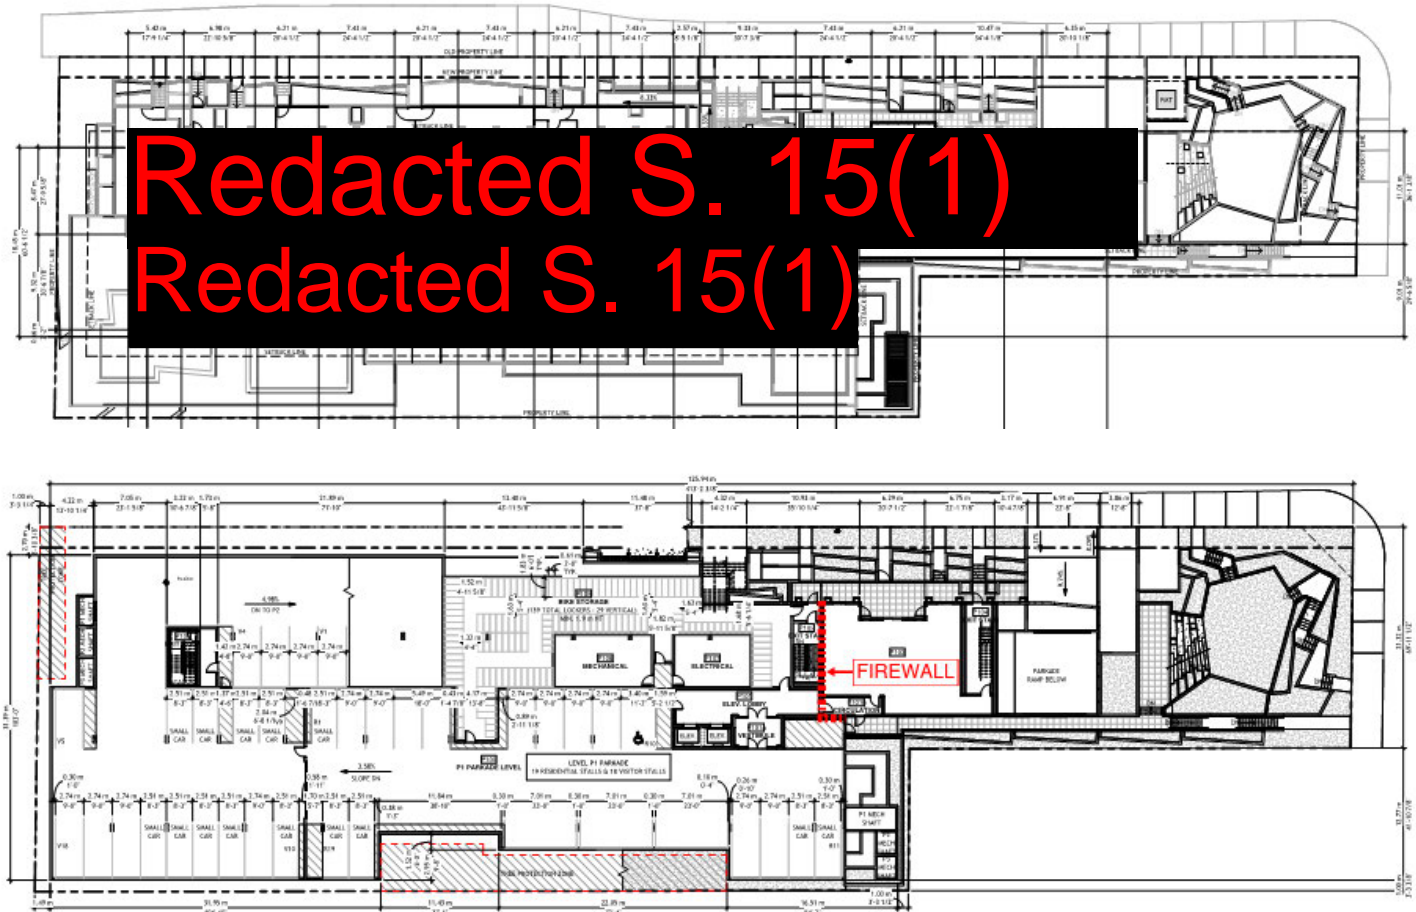
Where the firewall terminates at the Level 2 concrete slab, it will jog horizontally to another firewall at the level below, before terminating above the common parkade as follows:

The horizontal portions of concrete slab joining each firewall will be designed substantially in conformance with the same requirements for vertical firewalls as follows:

- The horizontal portions of firewall will be constructed entirely of concrete or masonry construction,
- The horizontal portions of firewall will be constructed with not less than a 2 h fire-resistance rating

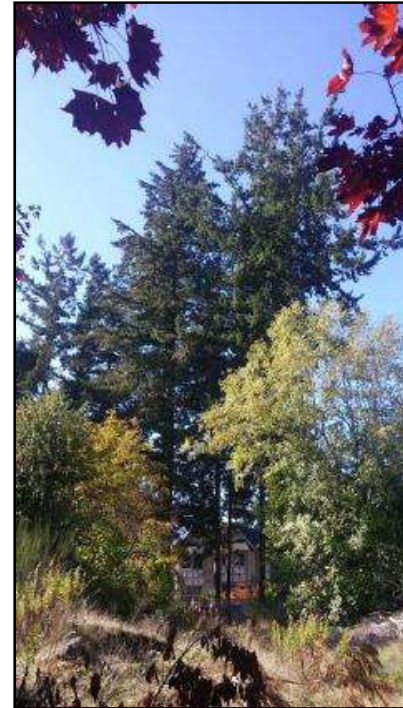
Fig. 4 – Tree 03 growing within S4

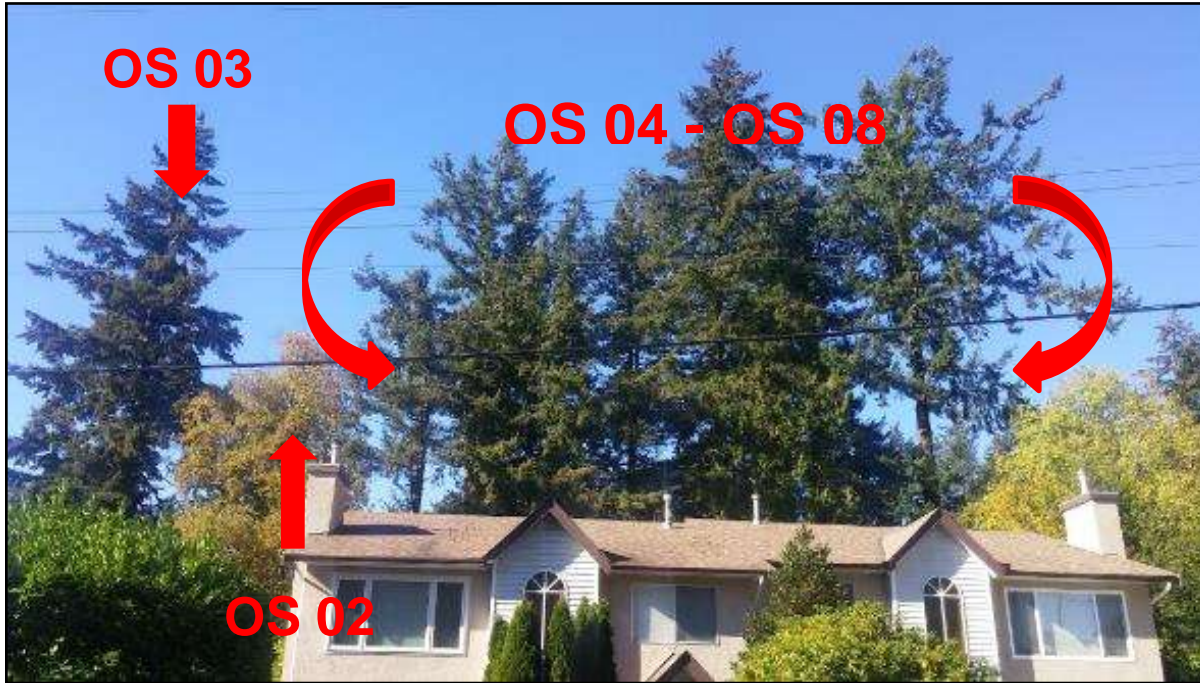
Fig. 5 – View of Trees OS2 – OS8

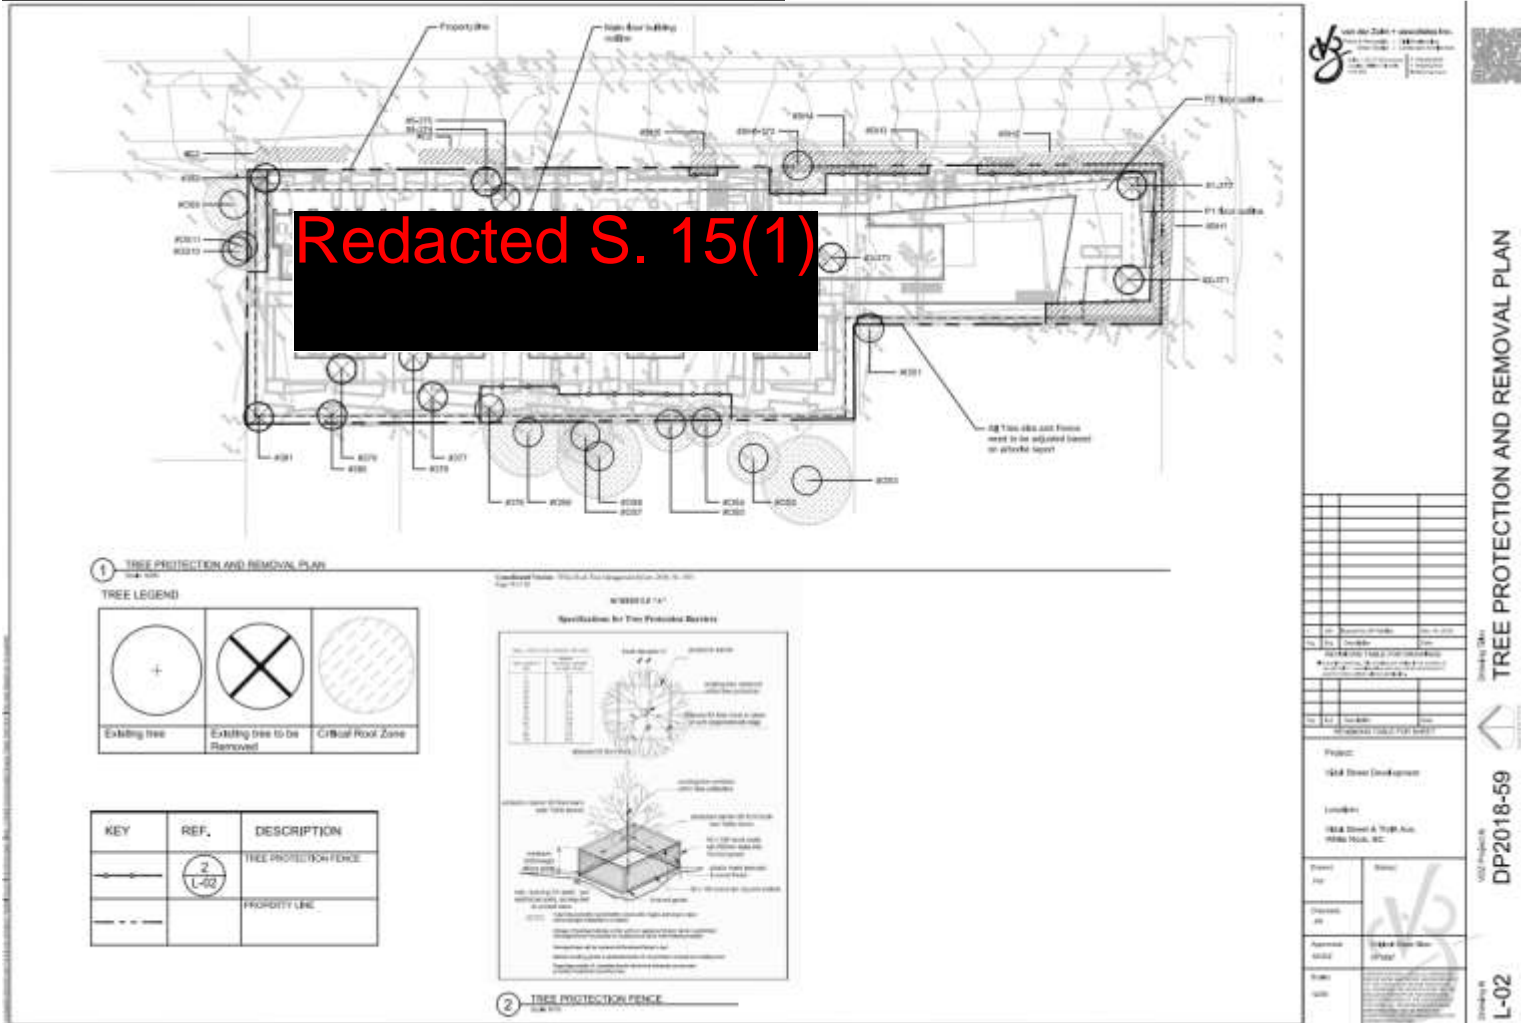
APPENDIX C – TREE RETENTION AND REMOVAL PLAN

TREE PROTECTION AND REMOVAL PLAN

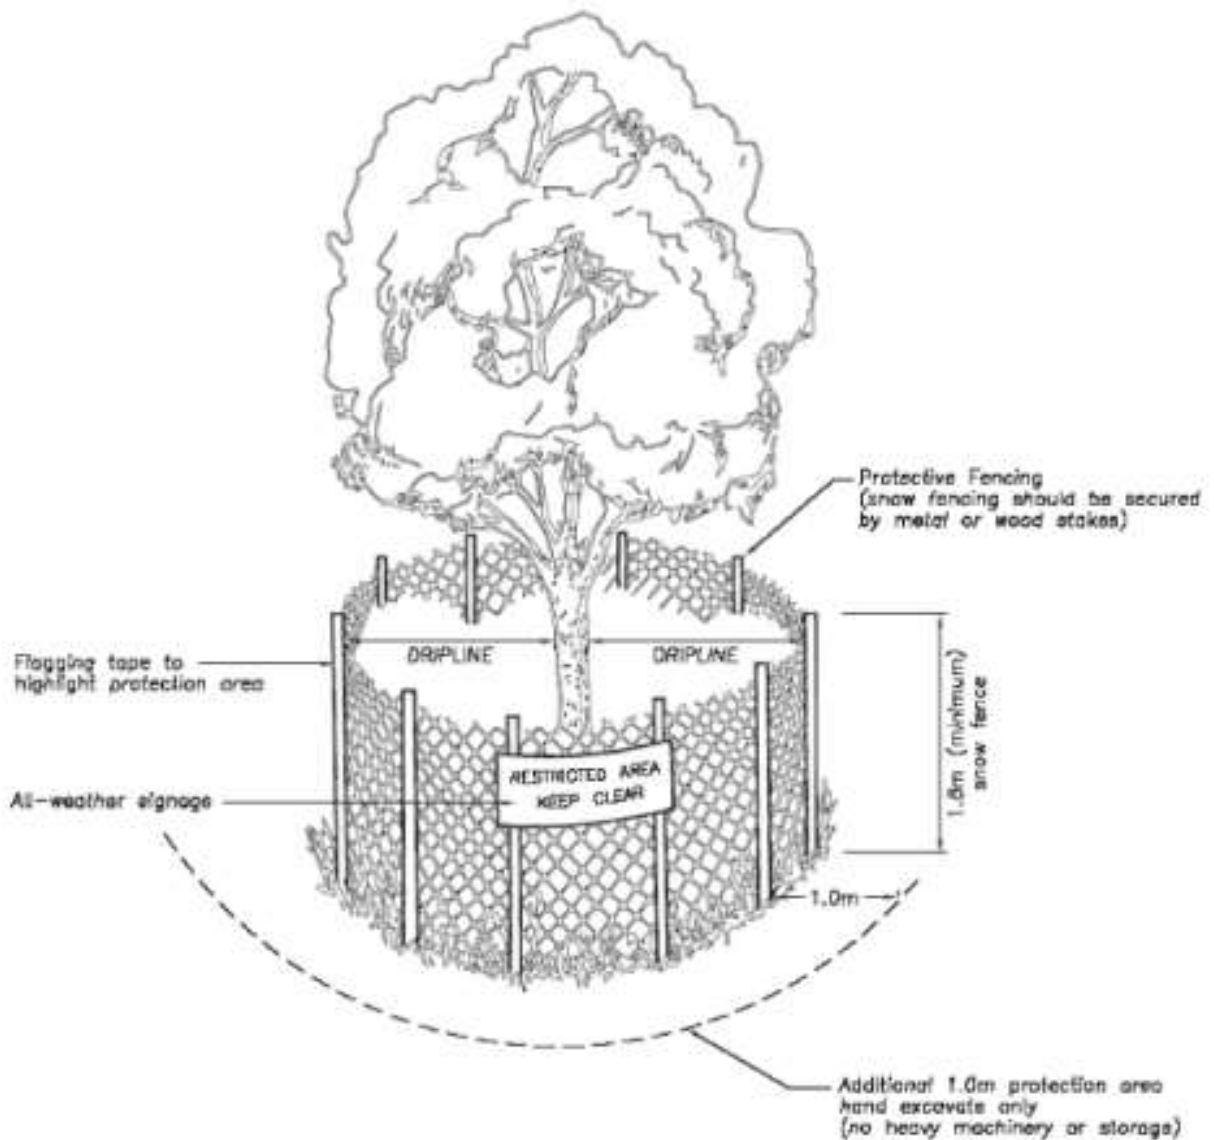
Prior to construction activity you should erect temporary fencing at the dripline of the tree to protect the roots and canopy.

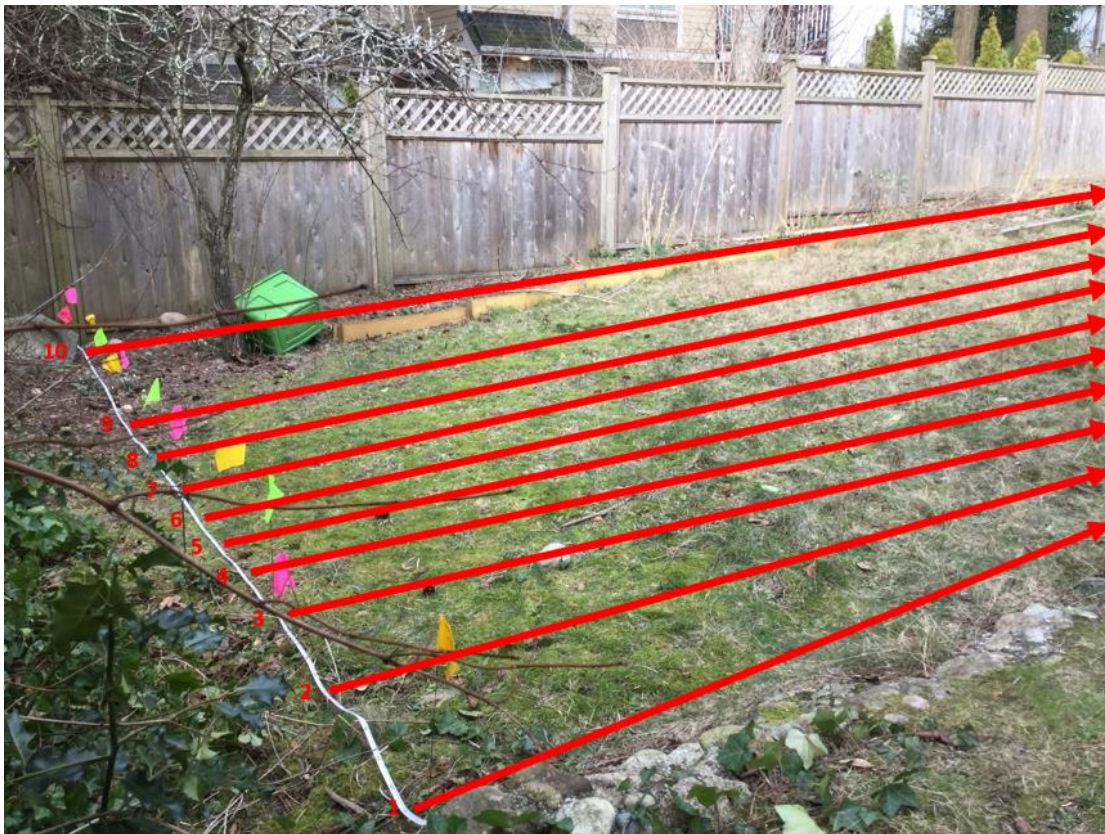
Figure 8. Location of Measurements 1.1 to 1.10.

GPR testing was conducted on the soil surface at the east of trees OS2 and OS3 at 1441 Vidal St, White Rock:

- Measurement 1.1 – 16.4 m in length, 12.0 m from centre of tree OS2 at nearest point
- Measurement 1.2 – 16.6 m in length, 11.4 m from centre of tree OS2 at nearest point
- Measurement 1.3 – 16.7 m in length, 10.8 m from centre of tree OS2 at nearest point
- Measurement 1.4 – 16.8 m in length, 10.2 m from centre of tree OS2 at nearest point
- Measurement 1.5 – 14.6 m in length, 9.6 m from centre of tree OS2 at nearest point
- Measurement 1.6 – 15.1 m in length, 9.0 m from centre of tree OS2 at nearest point
- Measurement 1.7 – 17.3 m in length, 8.4 m from centre of tree OS2 at nearest point
- Measurement 1.8 – 17.1 m in length, 7.8 m from centre of tree OS2 at nearest point
- Measurement 1.9 – 17.1 m in length, 7.2 m from centre of tree OS2 at nearest point
- Measurement 1.10 – 16.7 m in length, 6.0 m from centre of tree OS2 at nearest point

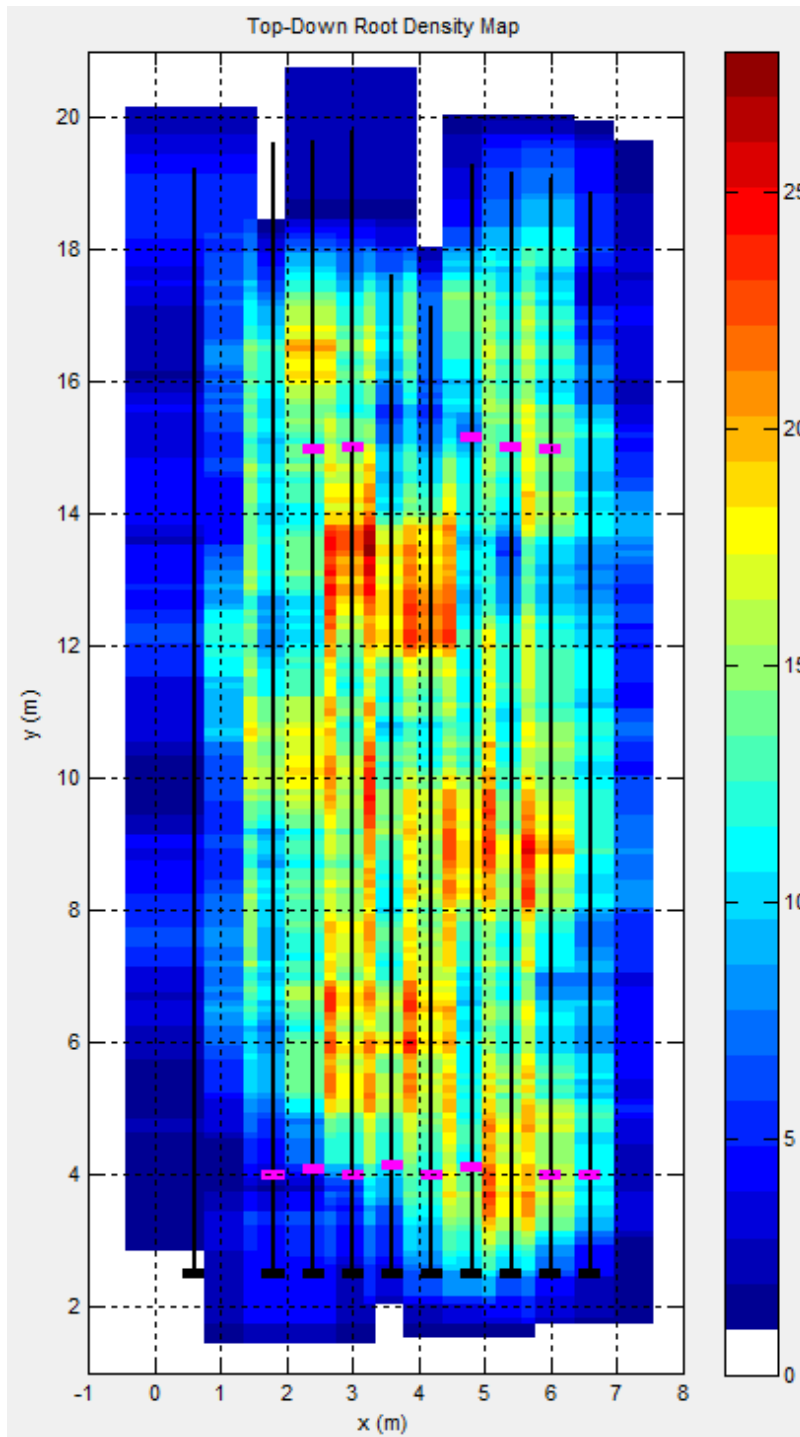
Figure 9. Top-down root density map at 0-60 cm depth of Group 1.

Root density maps have been produced for Group 1, and for each depth range. The color scale indicator on the right-hand side of the graph illustrates the concentration or number of roots within the given area.

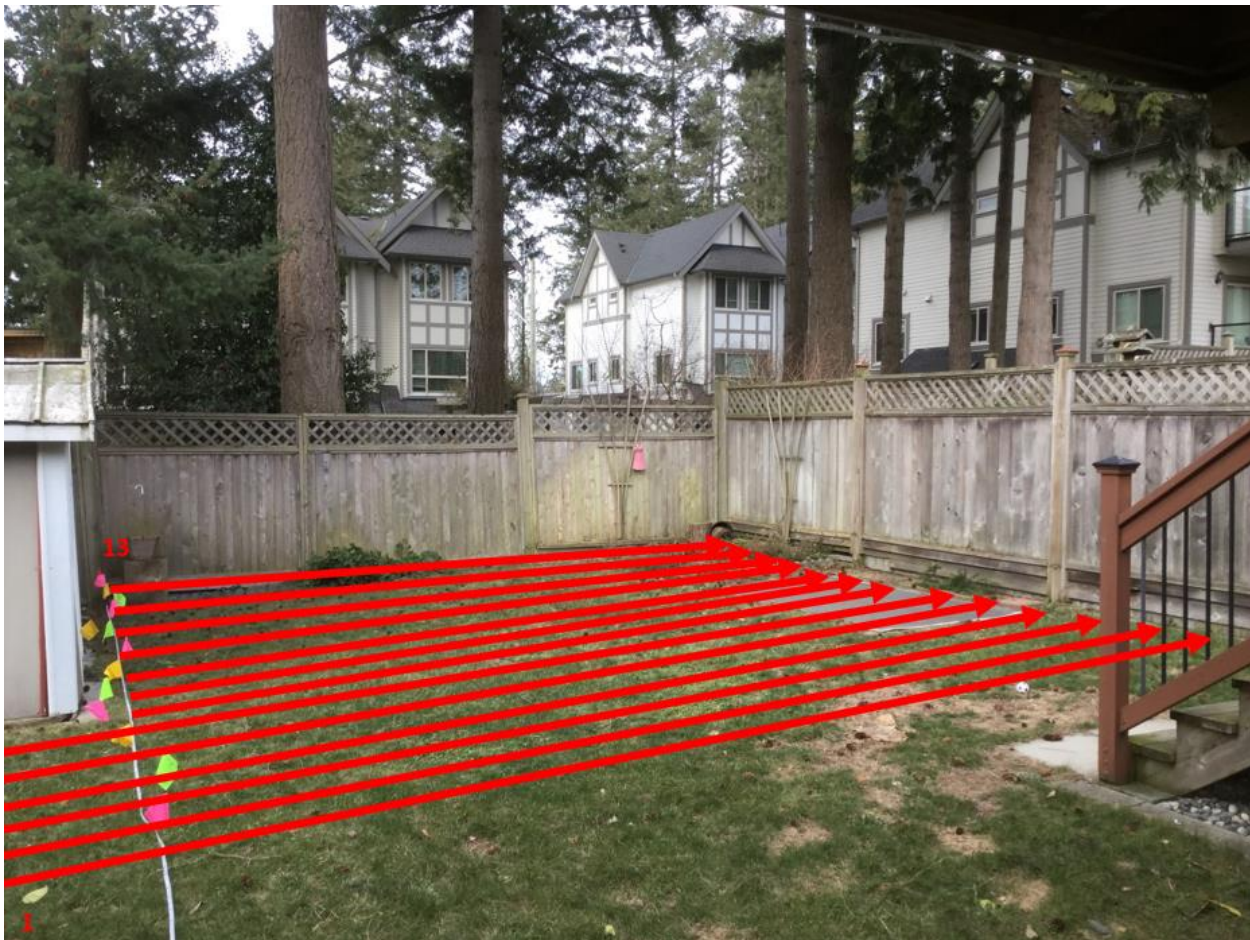
Figure 13. Location of Measurements 2.1 to 2.13.

- Measurement 2.11 – 4.0 m in length, 2.3 m from centre of tree OS5 at nearest point
- Measurement 2.12 – 4.1 m in length, 1.7 m from centre of tree OS5 at nearest point

- Measurement 2.13 – 4.1 m in length, 1.1 m from centre of tree OS5 at nearest point

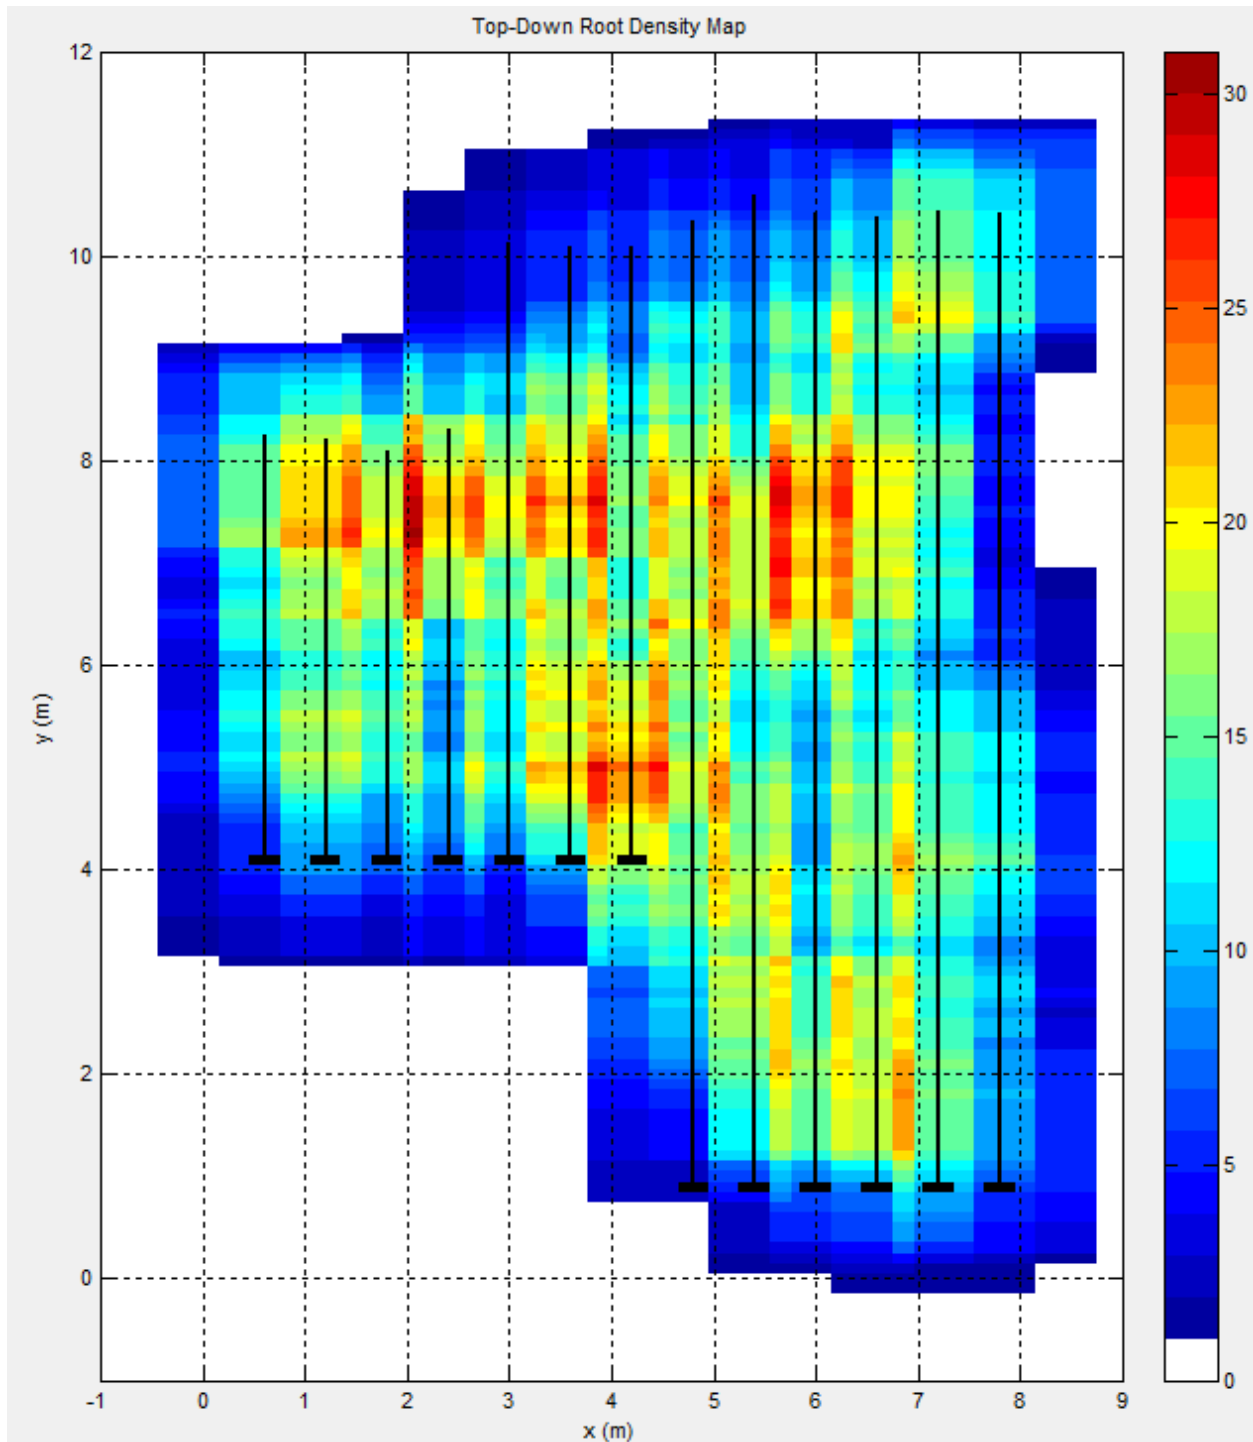
Figure 14. Top-down root density map at 0-60 cm depth of Group 2.

Root density maps have been produced for Group 2, and for each depth range. The color scale indicator on the right-hand side of the graph illustrates the concentration or number of roots within the given area.

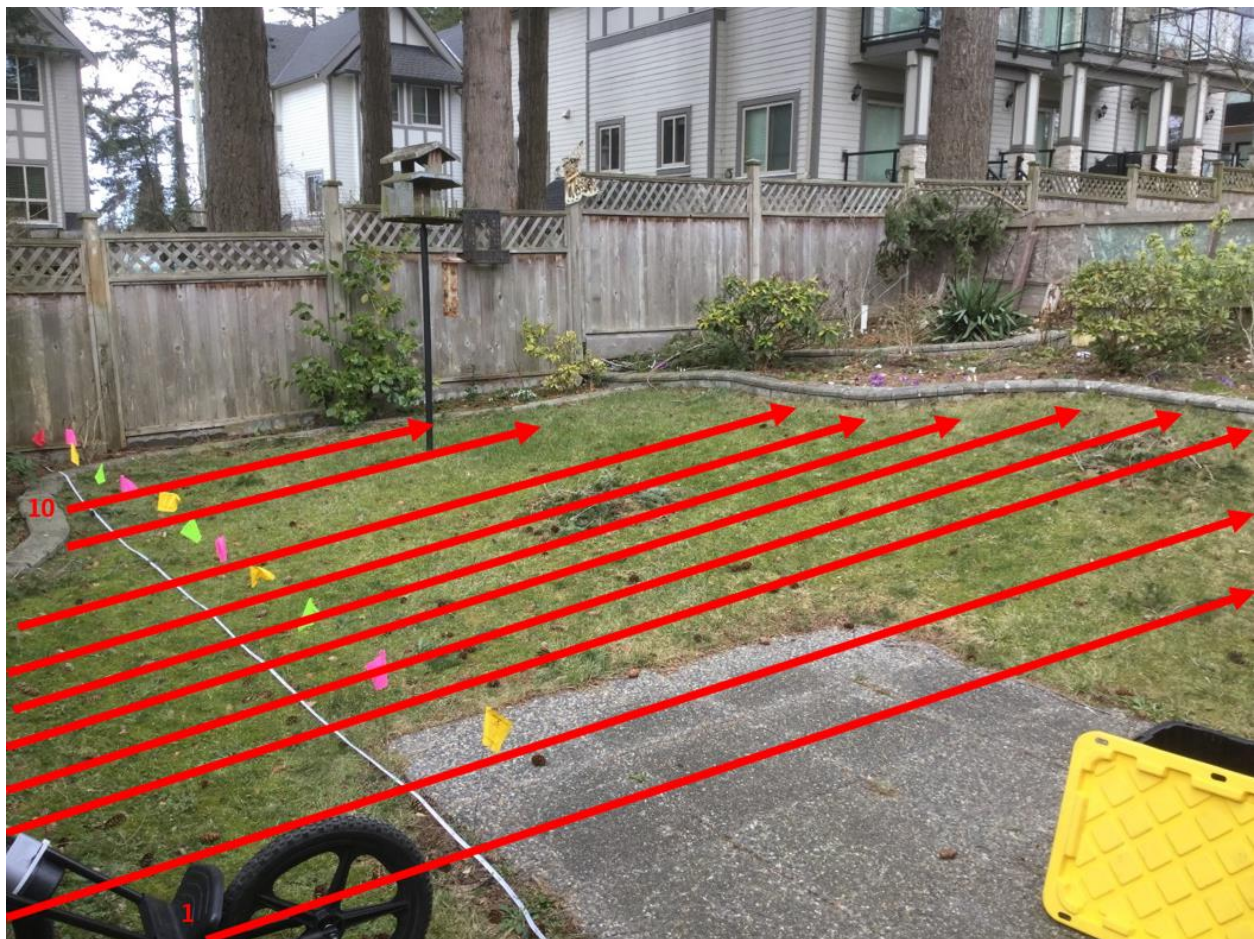
Figure 18. Location of Measurements 3.1 to 3.10.

GPR testing was conducted on the soil surface at the east of trees OS6 and OS7 at 1445 Vidal St, White Rock:

- Measurement 3.1 – 9.5 m in length, 12.1 m from centre of tree OS6 at nearest point
- Measurement 3.2 – 9.5 m in length, 11.5 m from centre of tree OS6 at nearest point
- Measurement 3.3 – 9.5 m in length, 10.9 m from centre of tree OS6 at nearest point
- Measurement 3.4 – 9.5 m in length, 10.3 m from centre of tree OS6 at nearest point
- Measurement 3.5 – 9.5 m in length, 9.7 m from centre of tree OS6 at nearest point
- Measurement 3.6 – 9.5 m in length, 9.1 m from centre of tree OS6 at nearest point
- Measurement 3.7 – 9.5 m in length, 8.5 m from centre of tree OS6 at nearest point
- Measurement 3.8 – 9.5 m in length, 7.9 m from centre of tree OS6 at nearest point
- Measurement 3.9 – 9.5 m in length, 6.7 m from centre of tree OS6 at nearest point
- Measurement 3.10 – 9.5 m in length, 6.1 m from centre of tree OS6 at nearest point

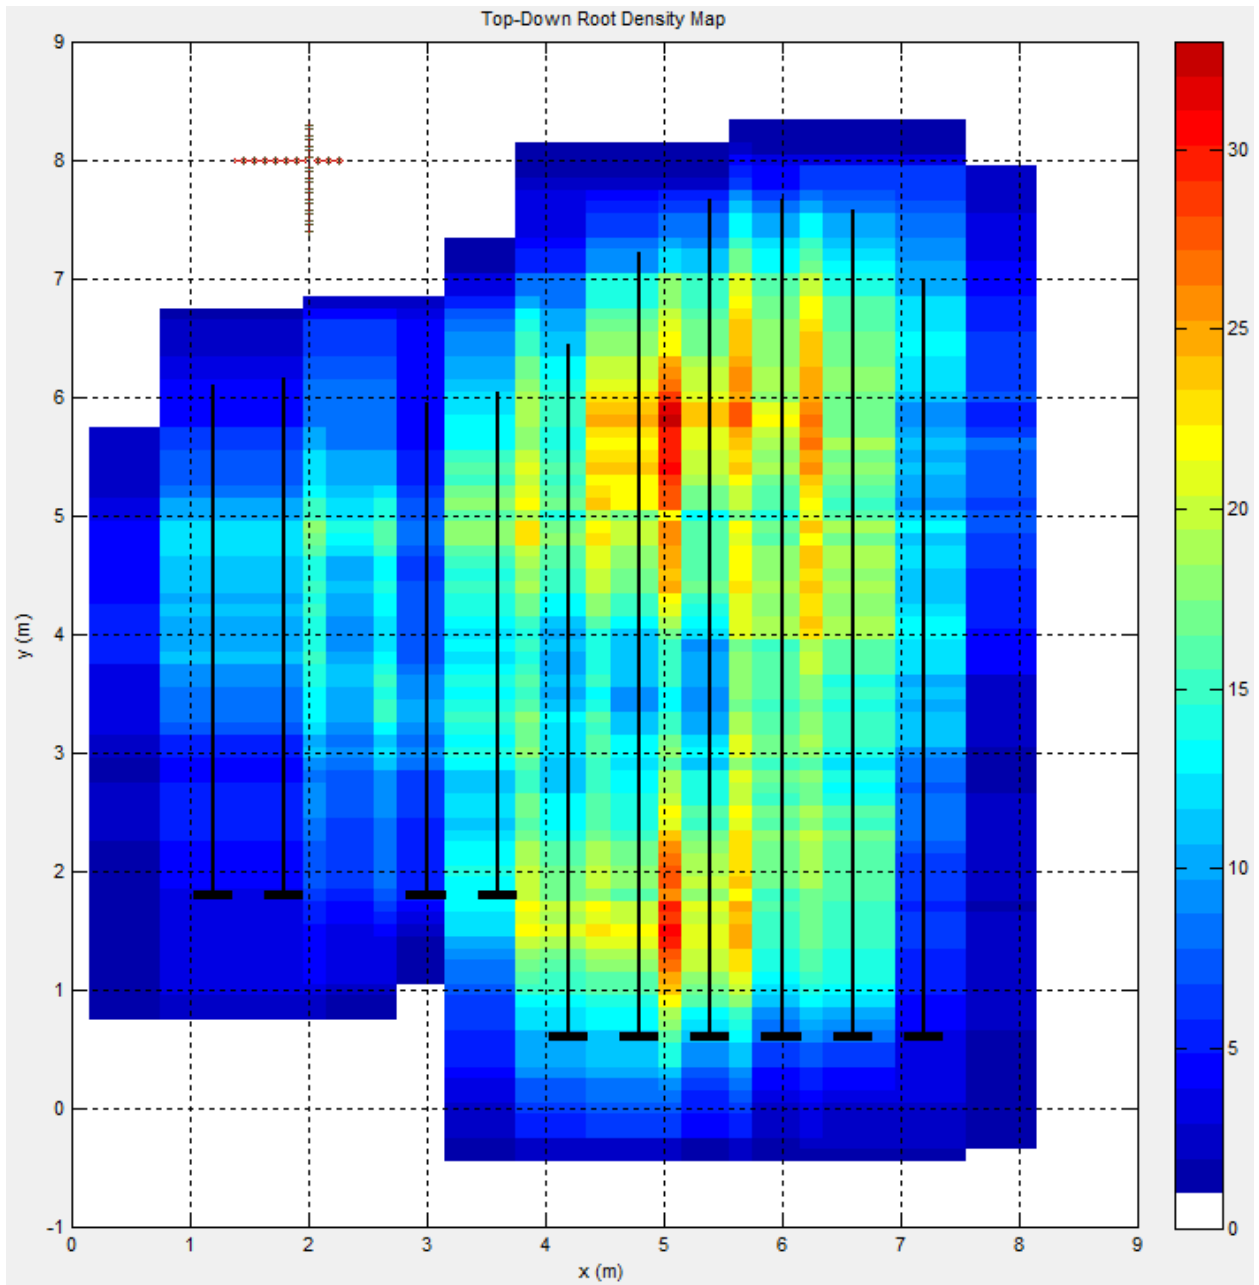
Figure 19. Top-down root density map at 0-60 cm depth of Group 3.

Root density maps have been produced for Group 3, and for each depth range. The color scale indicator on the right-hand side of the graph illustrates the concentration or number of roots within the given area.

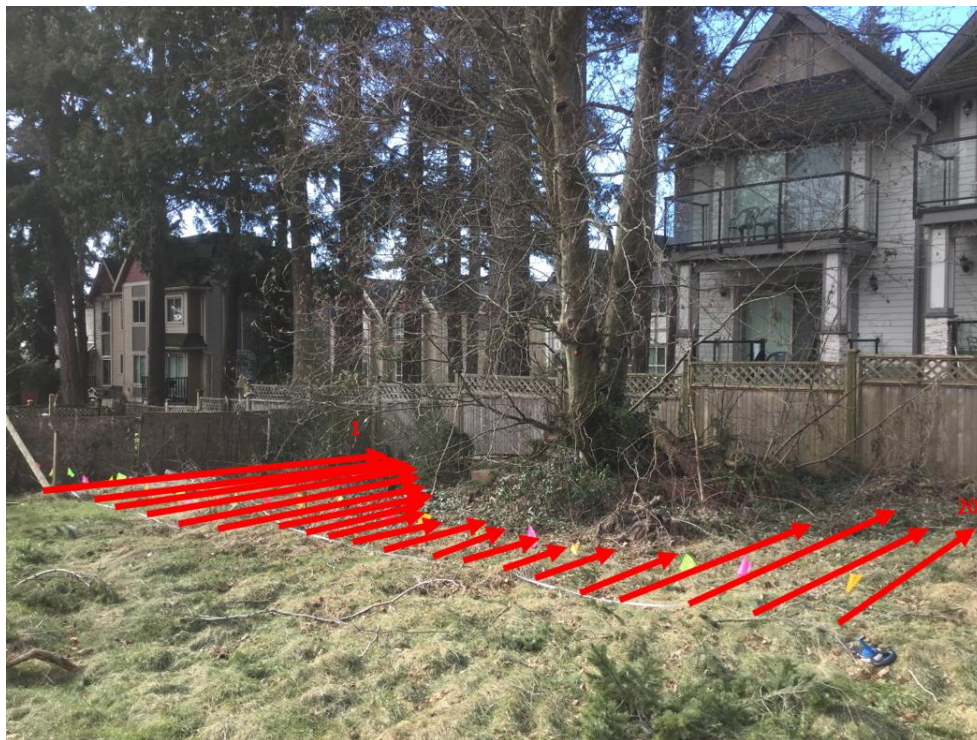
Figure 23. Location of Measurements 4.1 to 4.20.

- Measurement 4.17 – 4.7 m in length, 3.0 m from centre of tree #376 at nearest point
- Measurement 4.18 – 5.9 m in length, 3.6 m from centre of tree #376 at nearest point

- Measurement 4.19 – 3.9 m in length, 4.2 m from centre of tree #376 at nearest point
- Measurement 4.20 – 4.1 m in length, 4.8 m from centre of tree #376 at nearest point
