From: [Krista Baronian](#)
To: [Neethu Syam](#); [Anne Berry](#)
Cc: [Parb Rehal](#)
Subject: RE: 1441 Vidal Street - Items to be addressed prior to scheduling Public Hearing
Date: July 5, 2023 10:43:35 AM
Attachments: [image001.jpg](#)
[image002.jpg](#)
[image003.png](#)

RESIDENTIAL DEVELOPMENT
 1441-1465 VIDAL STREET & 14937 THRIFT AVENUE, WHITE ROCK, B.C.
EROSION & SEDIMENT CONTROL PLAN

RESIDENTIAL DEVELOPMENT
1441-1465 VIDAL STREET & 14937 THRIFT AVENUE, WHITE ROCK, B.C.
EROSION & SEDIMENT CONTROL DETAILS (1 OF 2)

RESIDENTIAL DEVELOPMENT
1441-1465 VIDAL STREET & 14937 THRIFT AVENUE, WHITE ROCK, B.C.
EROSION & SEDIMENT CONTROL DETAILS (2 OF 2)

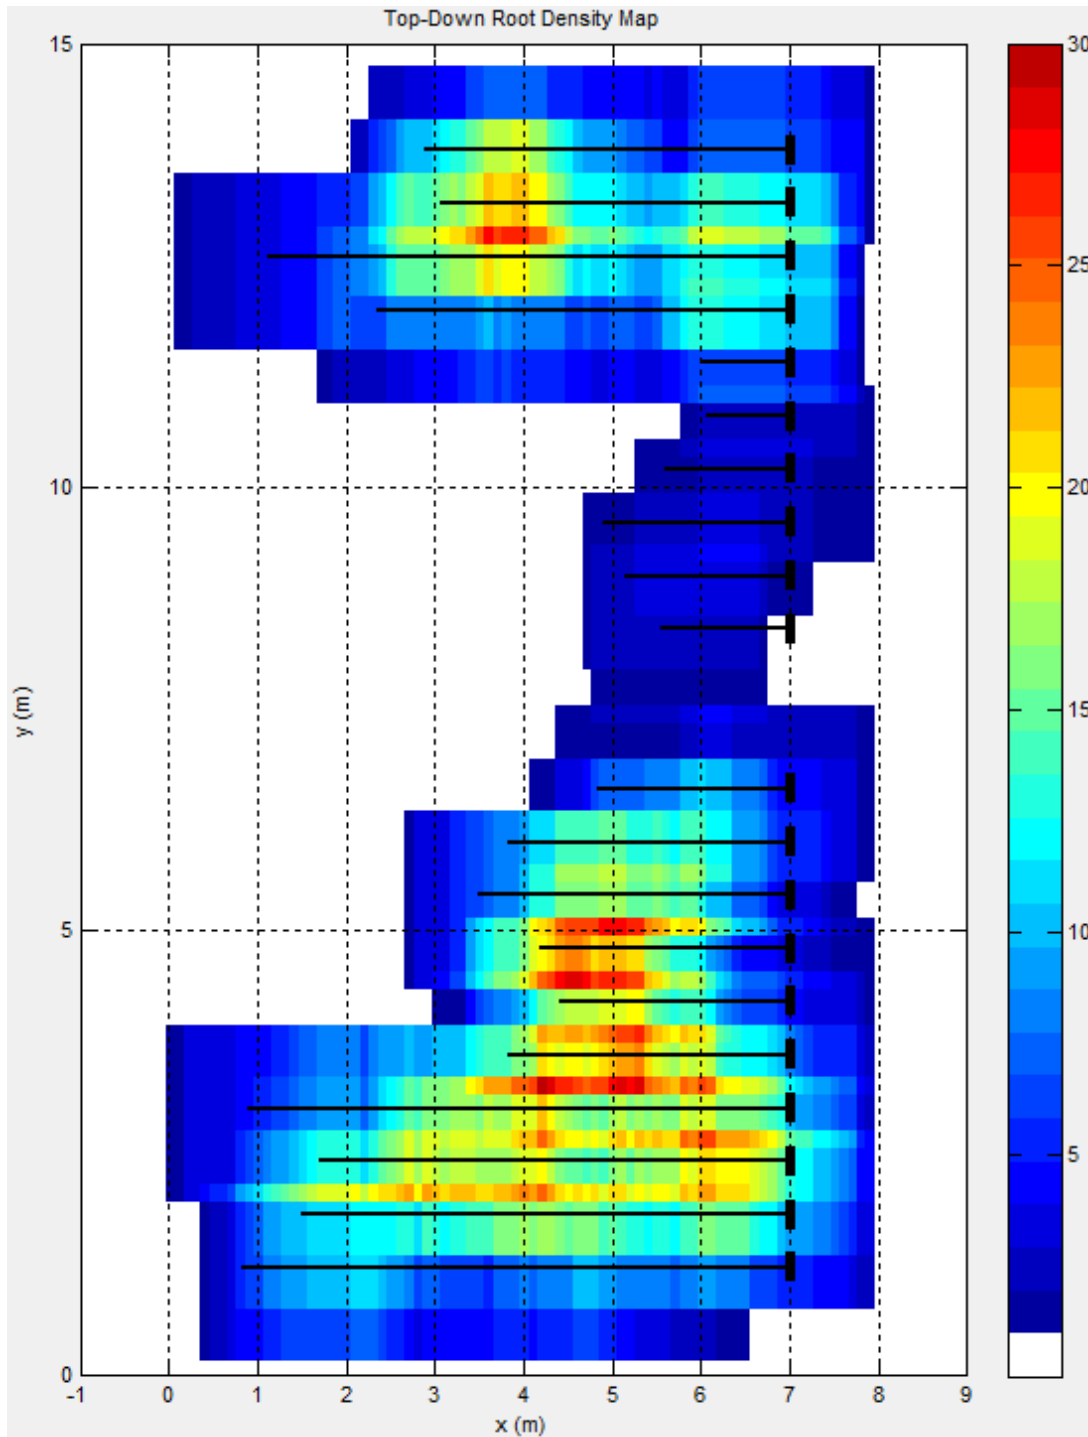
Figure 24. Top-down root density map at 0-60 cm depth of Group 4.

Root density maps have been produced for Group 4, and for each depth range. The color scale indicator on the right-hand side of the graph illustrates the concentration or number of roots within the given area.

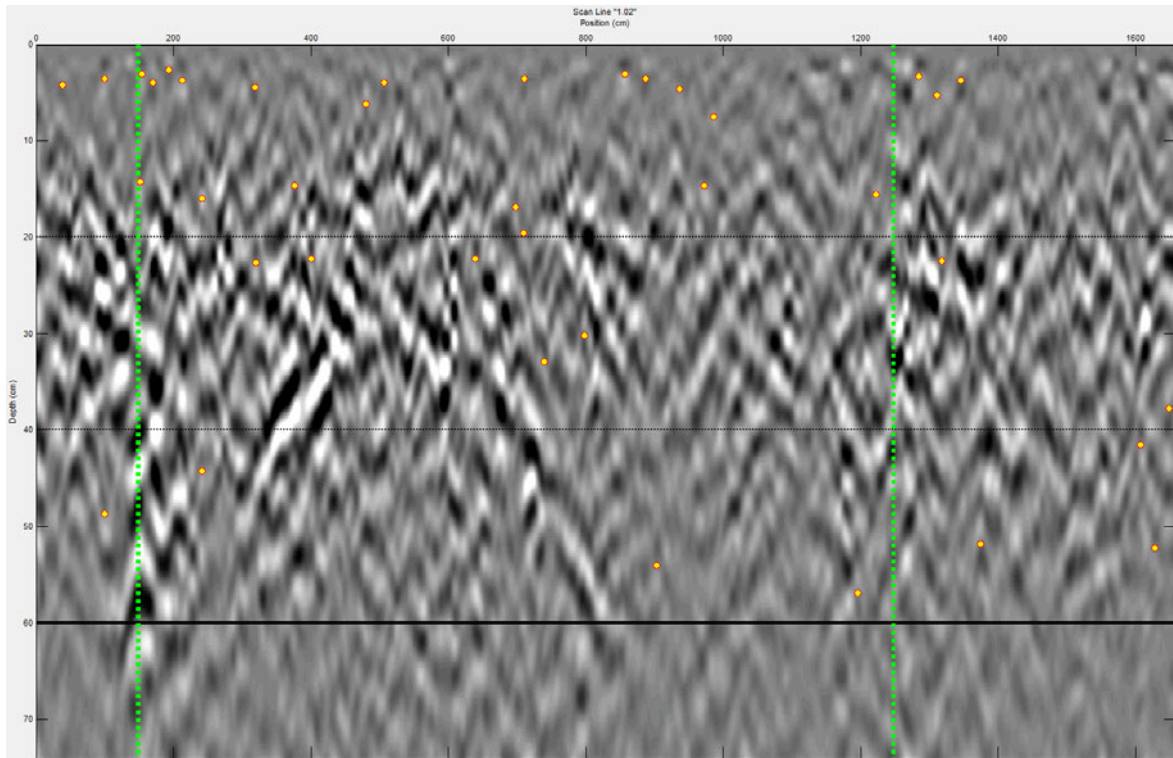
Measurement 1.2 - 16.6 m in length, 11.4 m from centre of tree OS2 at nearest point

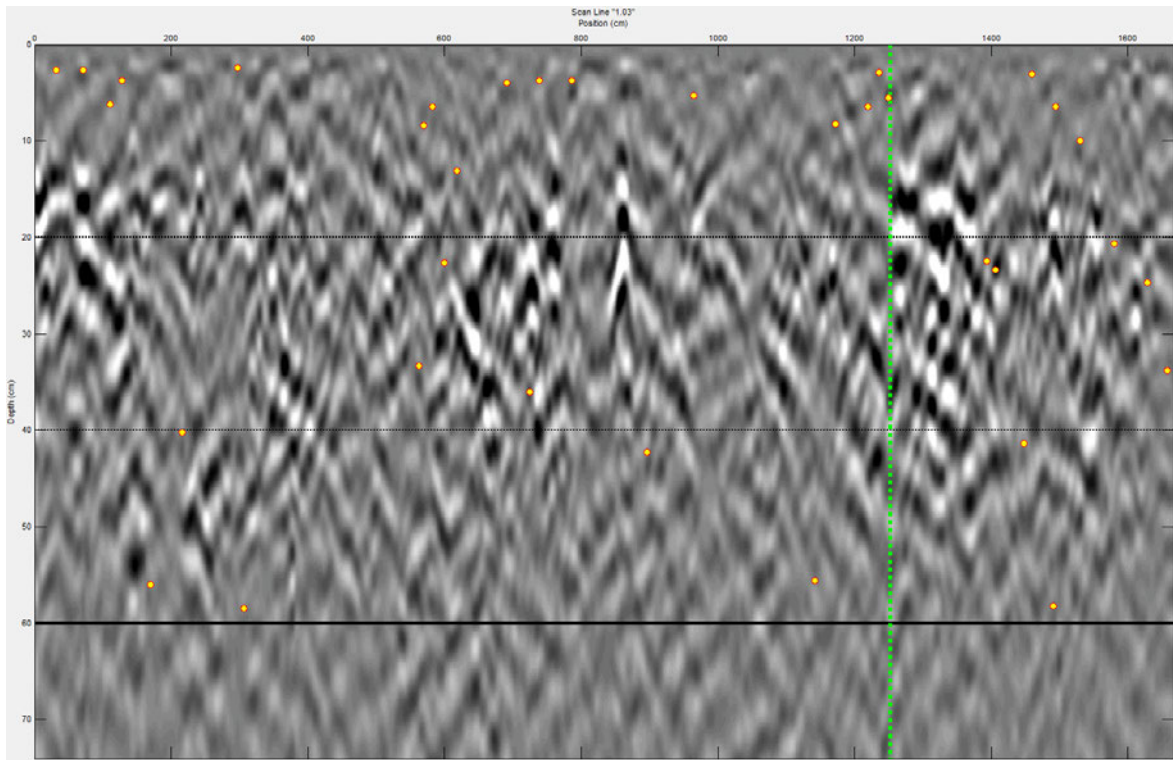
Measurement 1.3 - 16.7 m in length, 10.8 m from centre of tree OS2 at nearest point

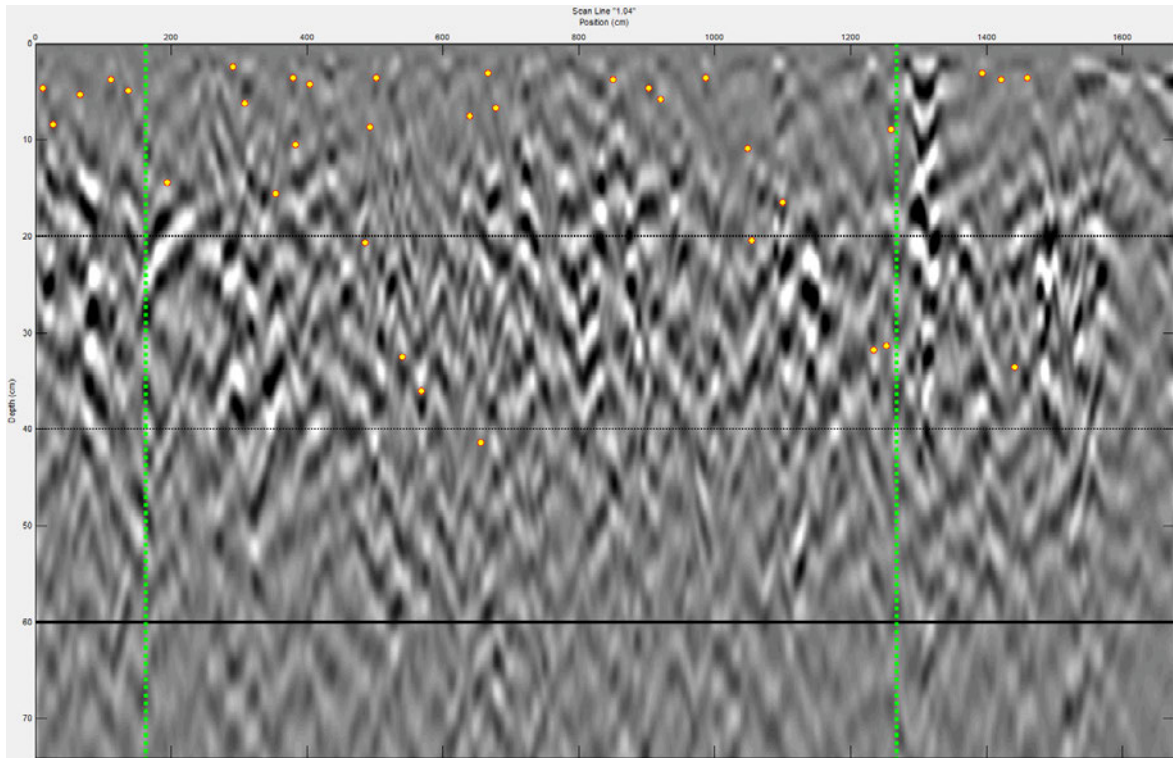
Measurement 1.4 - 16.8 m in length, 10.2 m from centre of tree OS2 at nearest point

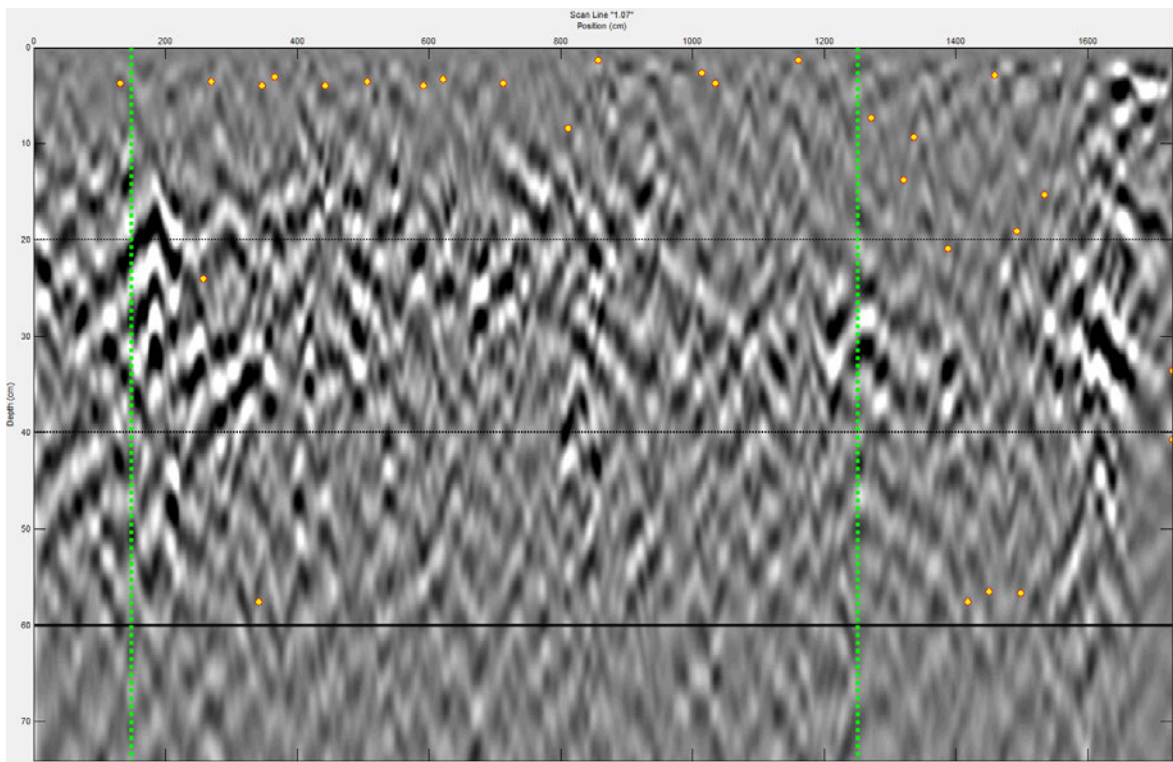
Measurement 1.7 - 17.3 m in length, 8.4 m from centre of tree OS2 at nearest point

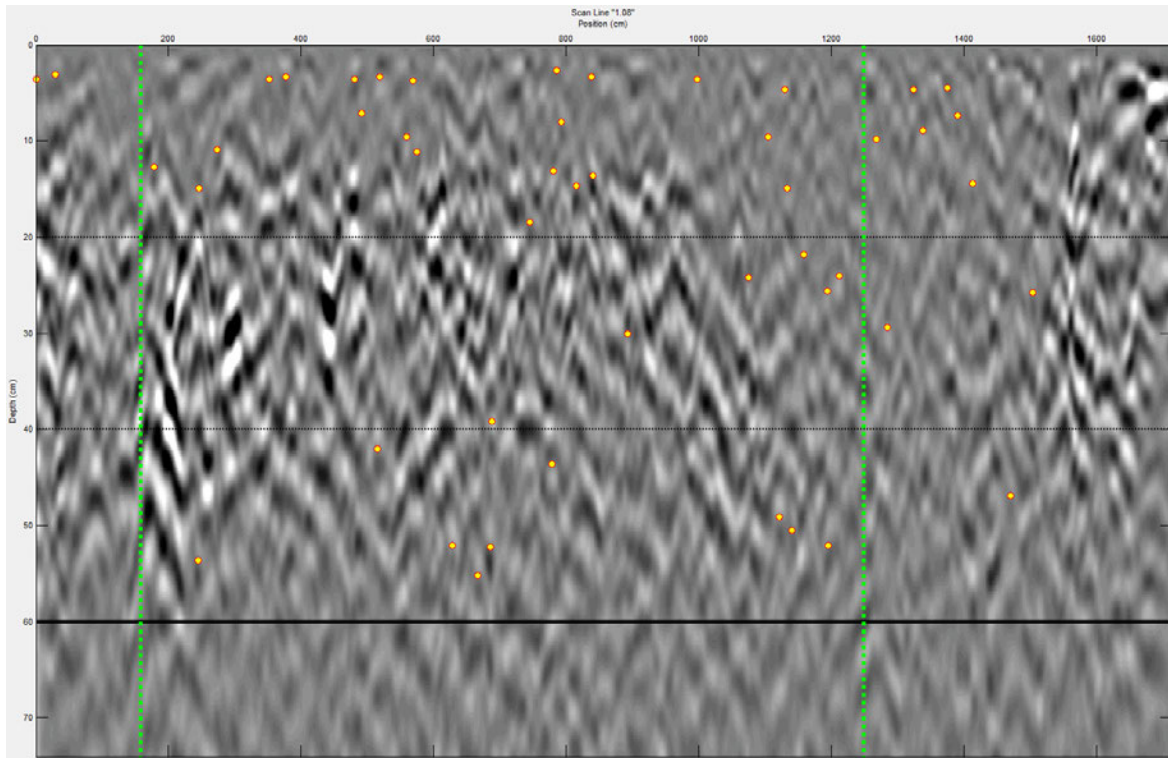
Measurement 1.8 - 17.1 m in length, 7.8 m from centre of tree OS2 at nearest point

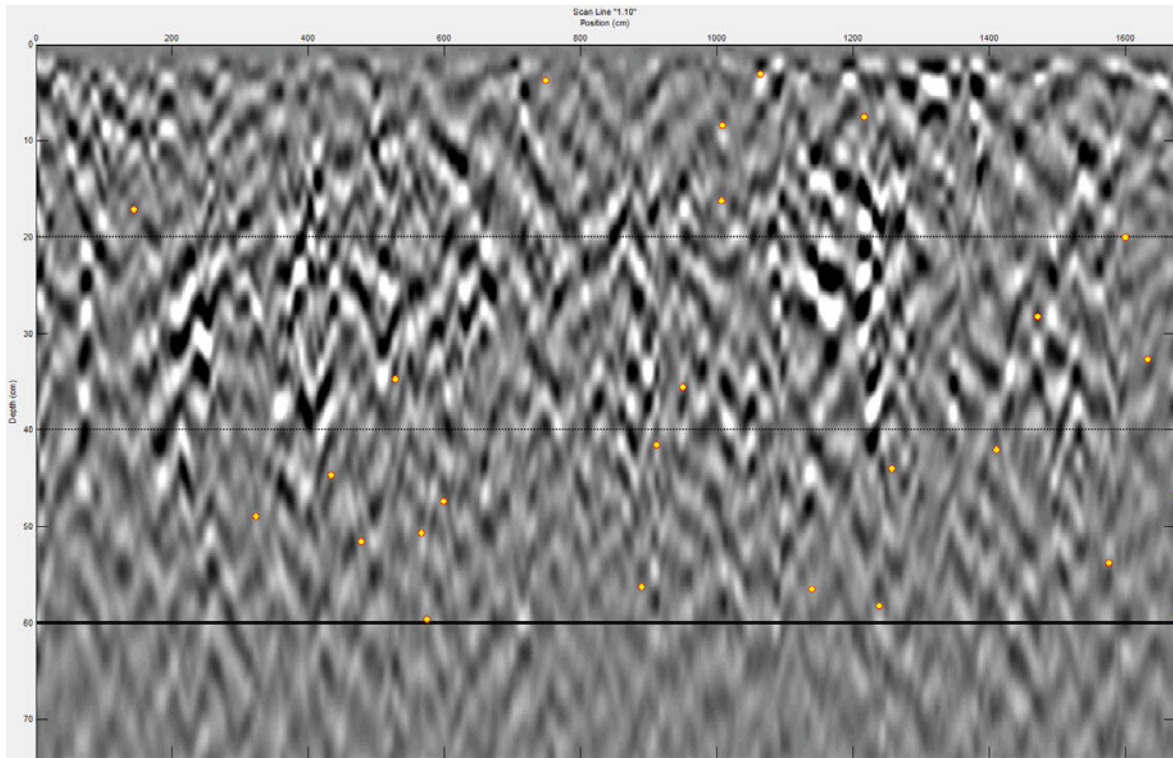
Measurement 1.10 - 16.7 m in length, 6.0 m from centre of tree OS2 at nearest point

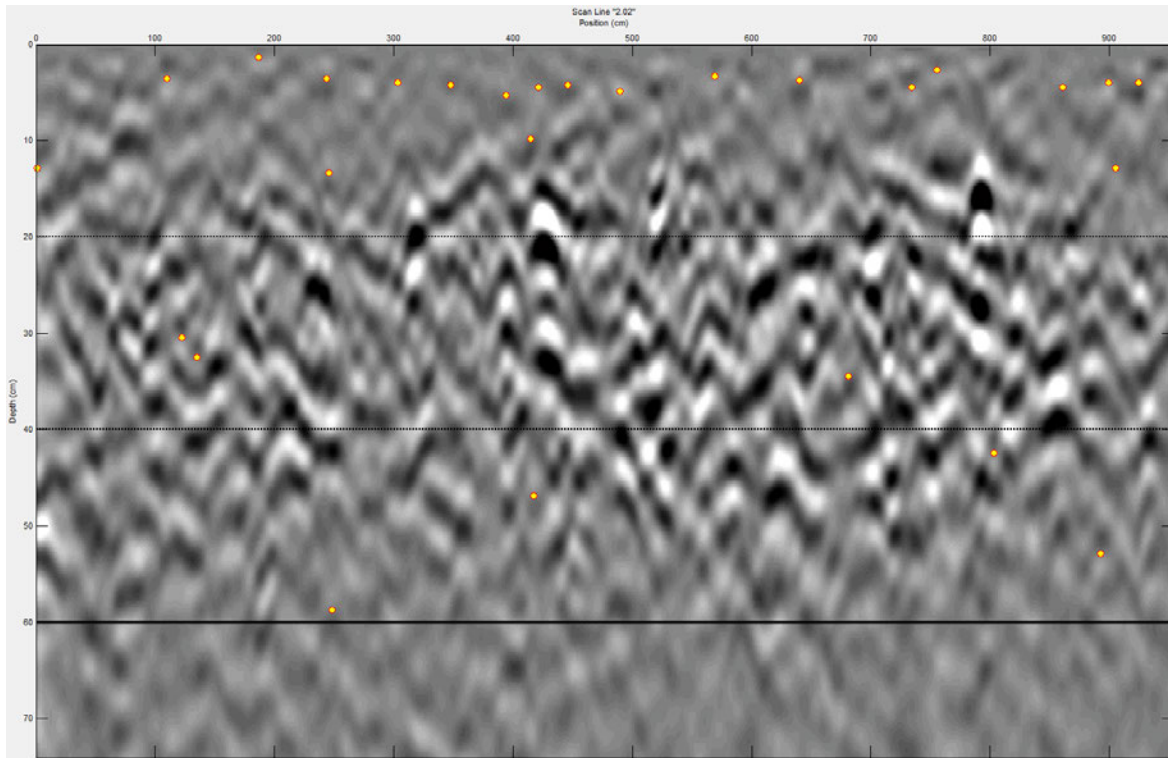
Measurement 2.2 - 9.5m in length, 7.7 m from centre of tree OS5 at nearest point

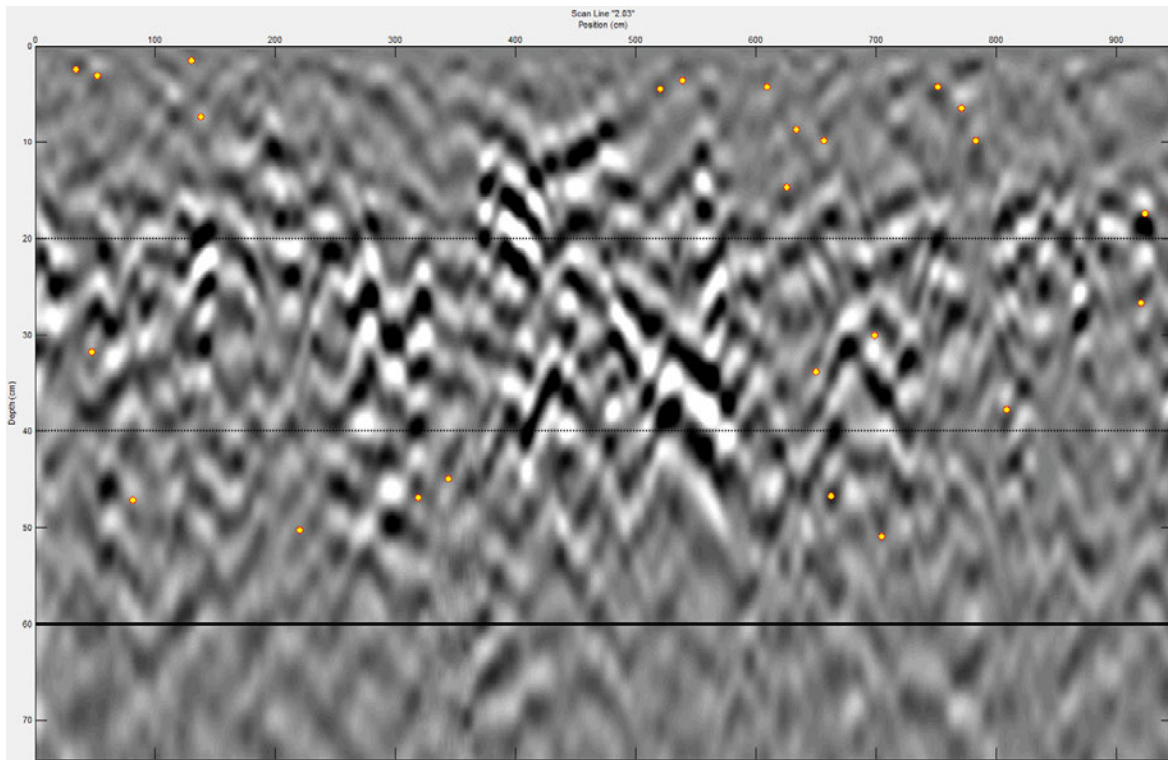
Measurement 2.3 - 9.5 m in length, 7.1 m from centre of tree OS5 at nearest point

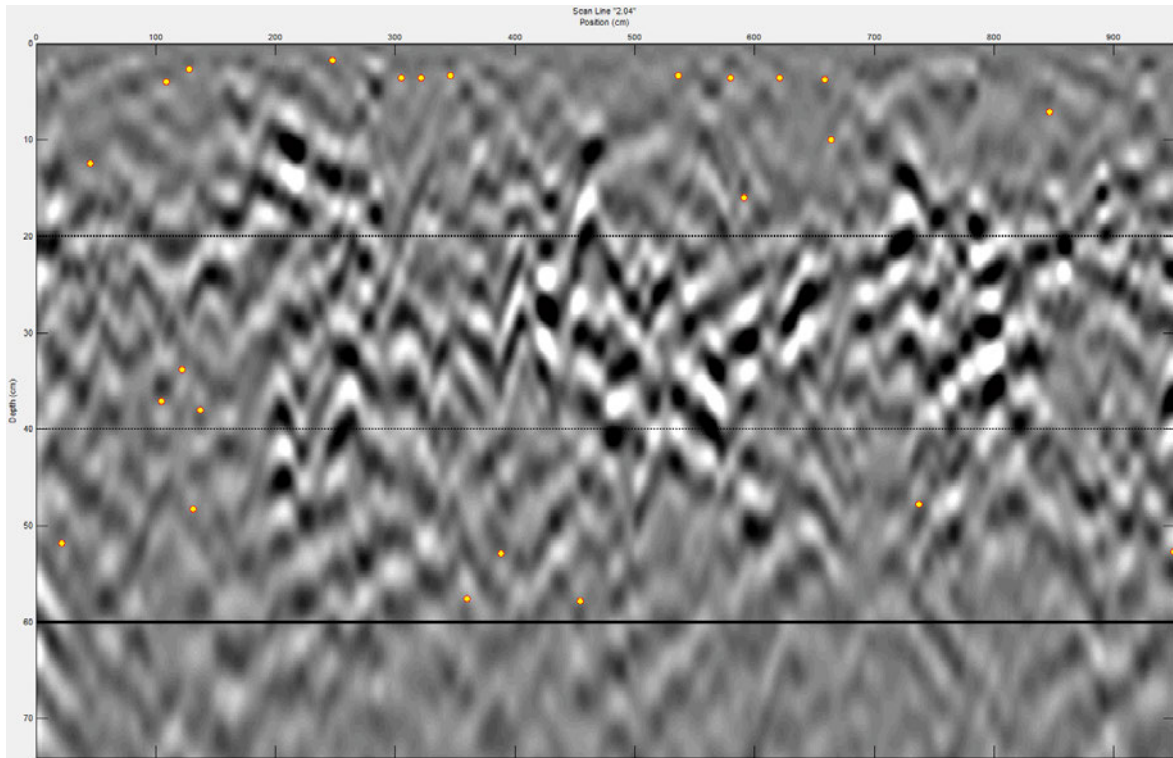
Measurement 2.4 – 9.5 m in length, 6.5 m from centre of tree OS5 at nearest point

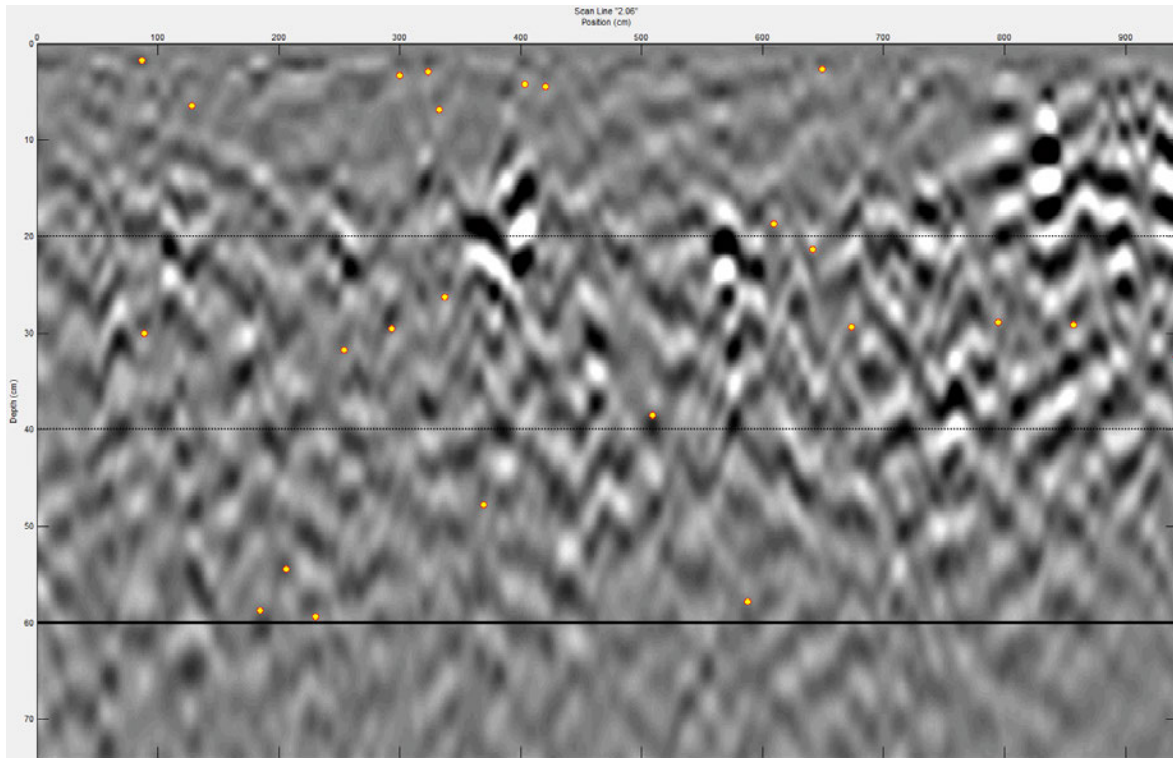
Measurement 2.6 – 9.4 m in length, 5.3 m from centre of tree OS5 at nearest point

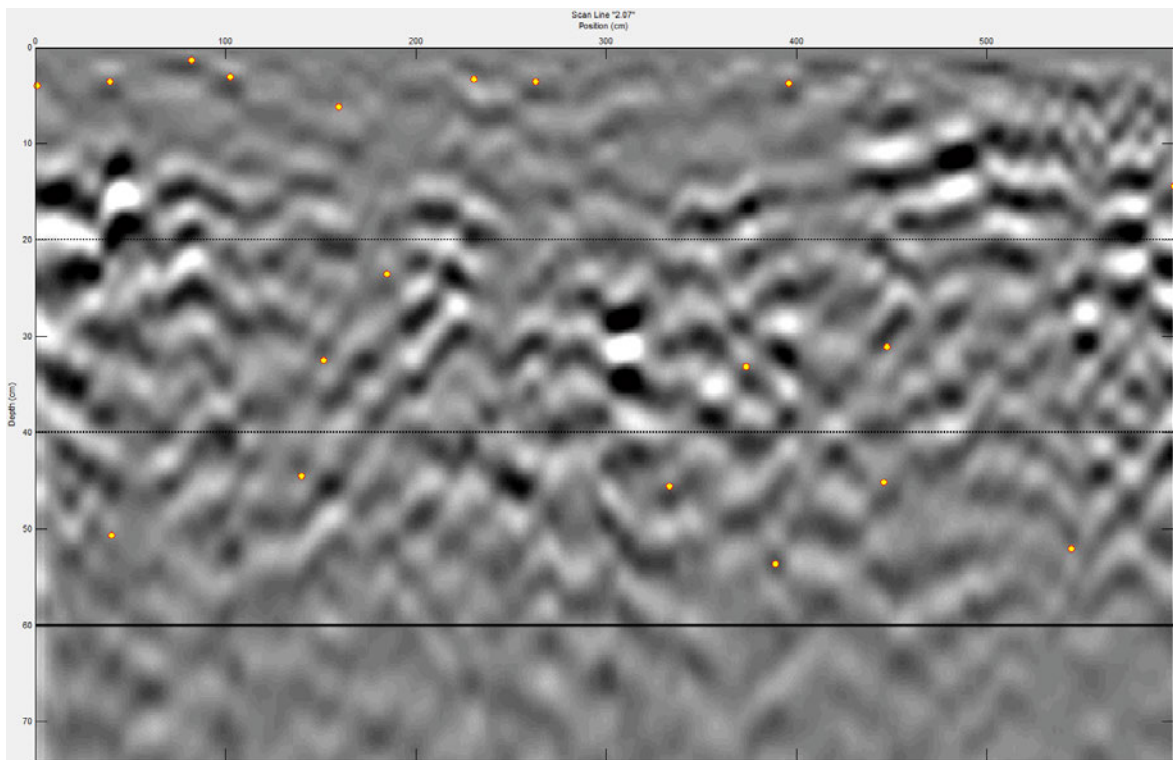
Measurement 2.7 – 6.0 m in length, 4.7 m from centre of tree OS5 at nearest point

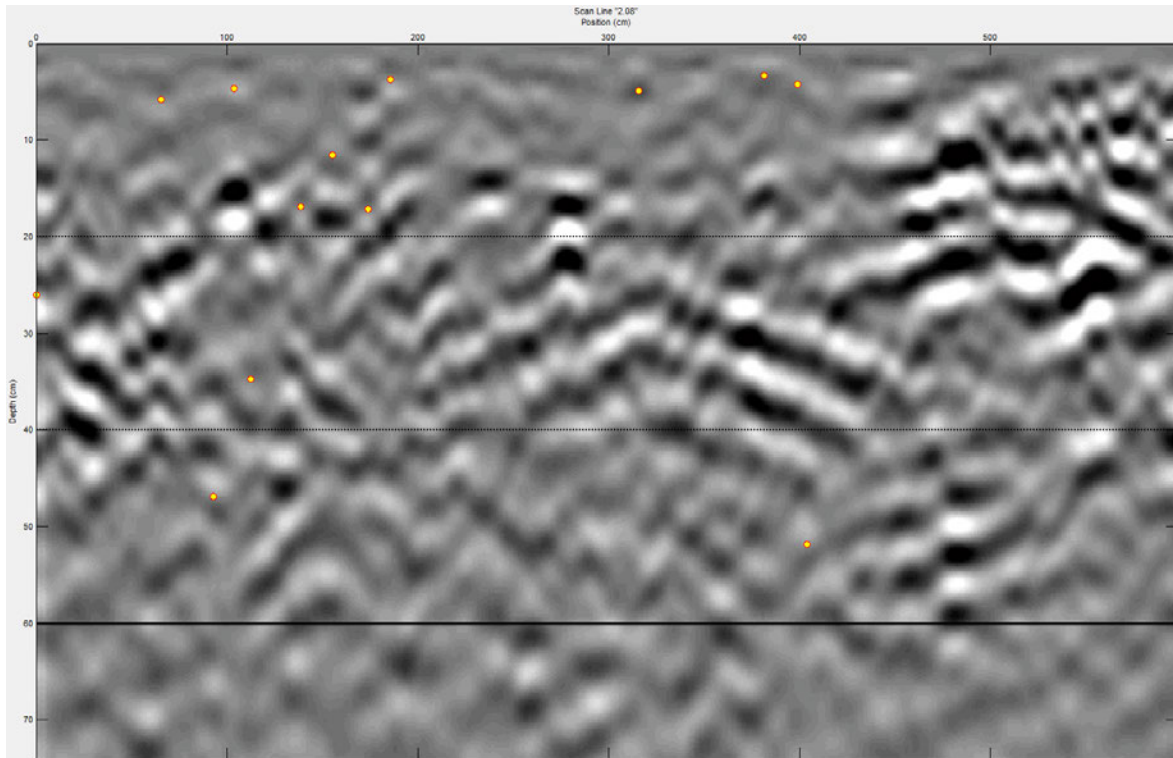
Measurement 2.8 – 6.0 m in length, 4.1 m from centre of tree OS5 at nearest point

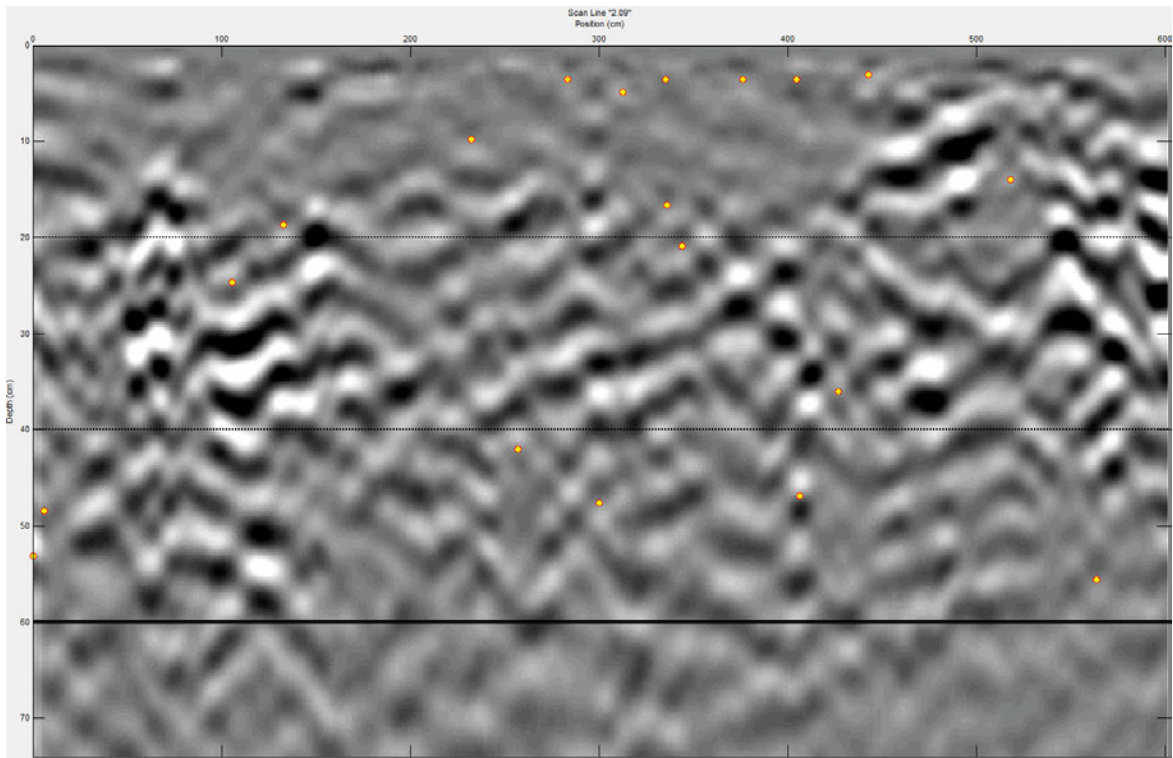
Measurement 2.9 – 6.0 m in length, 3.5 m from centre of tree OS5 at nearest point

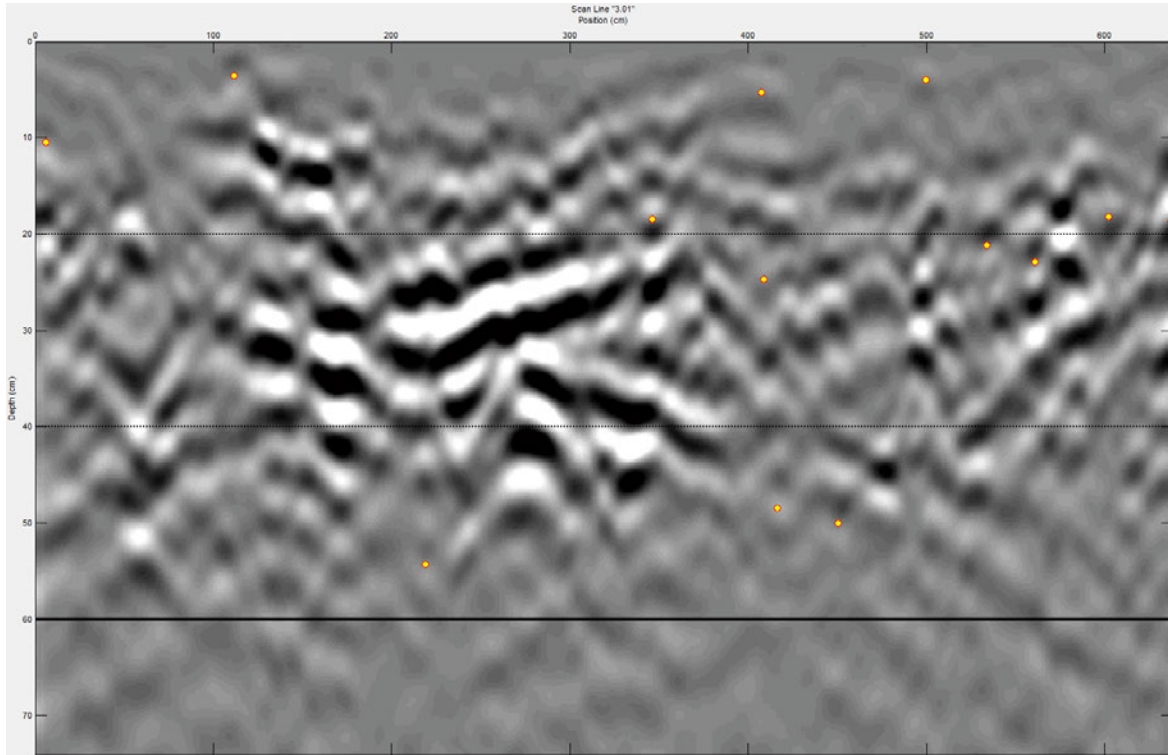
Measurement 3.1 – 9.5 m in length, 12.1 m from centre of tree OS6 at nearest point

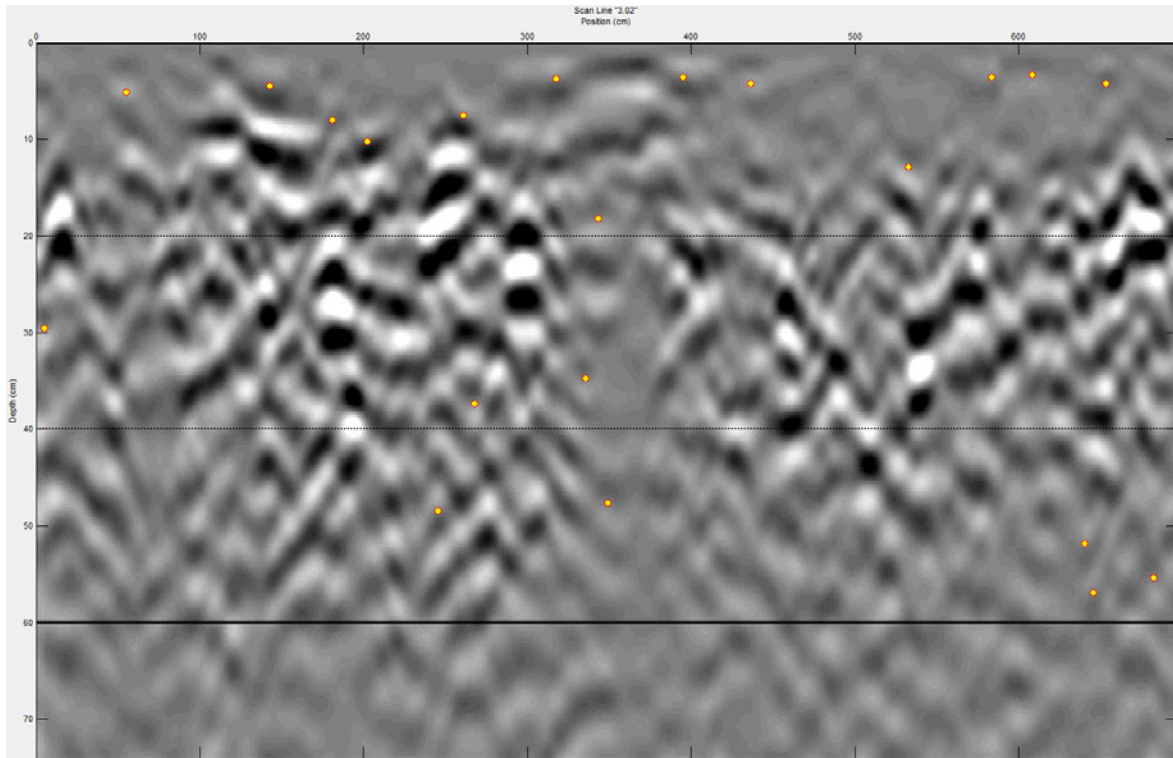
Measurement 3.2 – 9.5 m in length, 11.5 m from centre of tree OS6 at nearest point

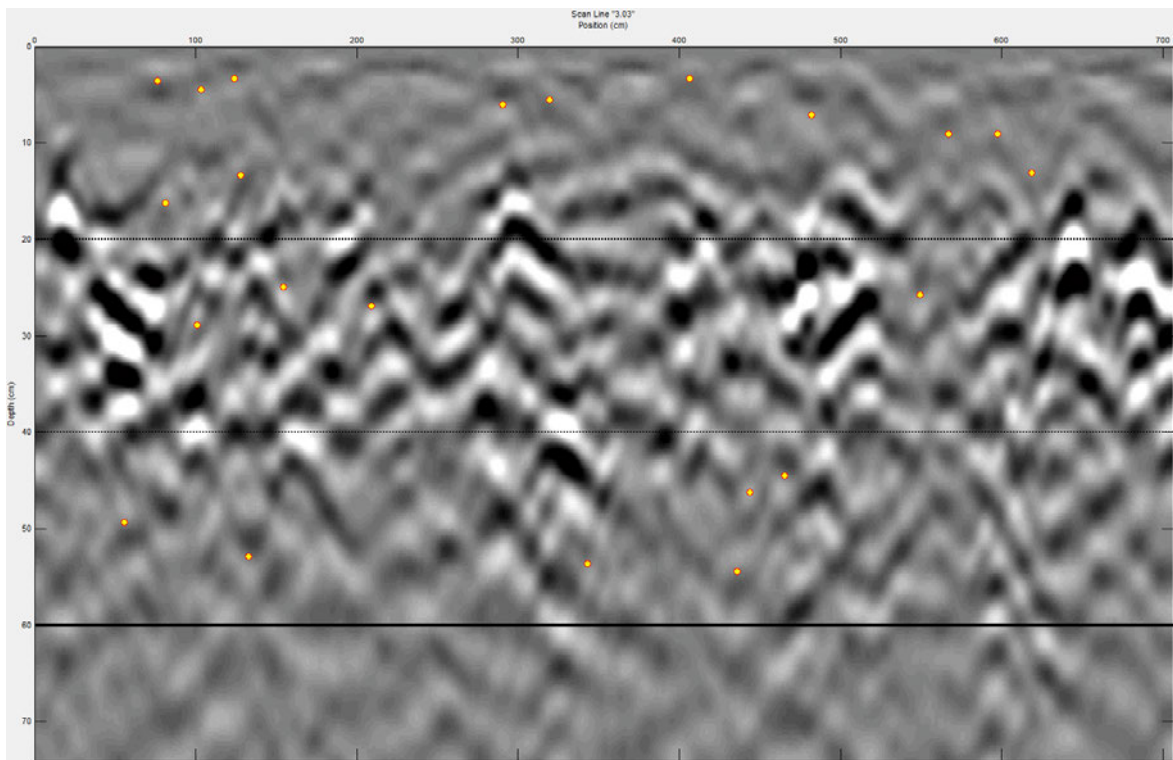
Measurement 3.3 – 9.5 m in length, 10.9 m from centre of tree OS6 at nearest point

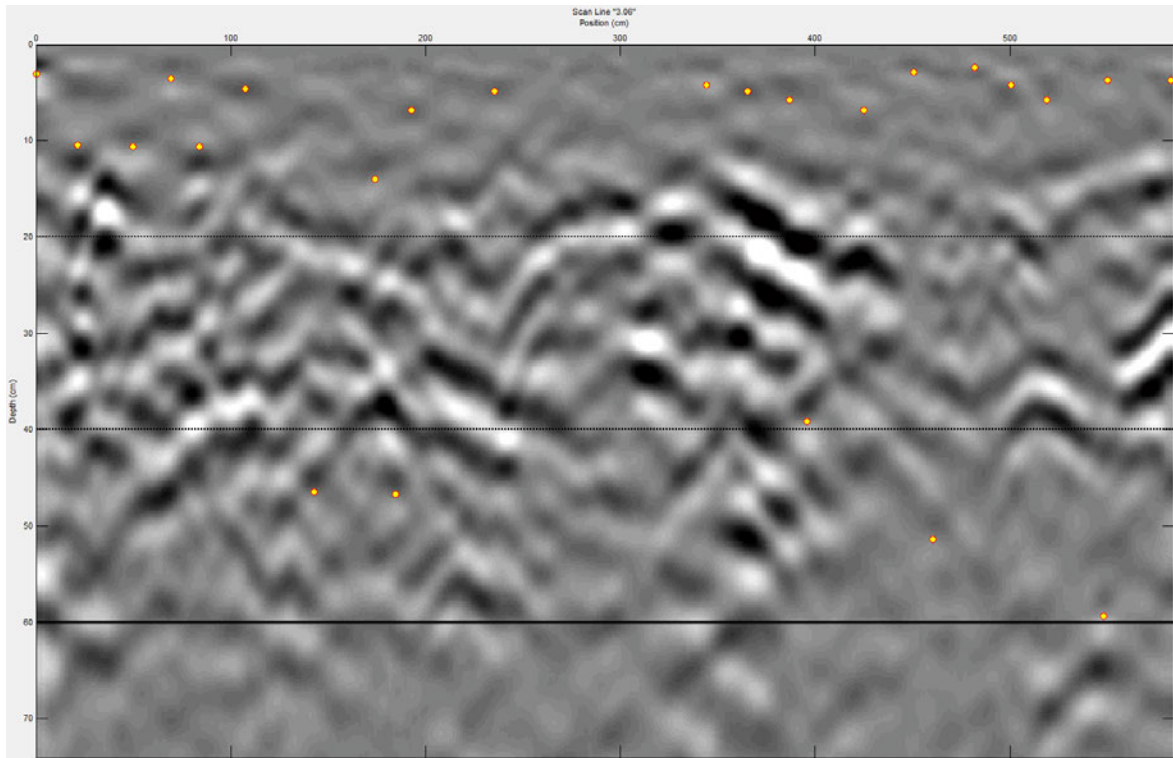
Measurement 3.6 – 9.5 m in length, 9.1 m from centre of tree OS6 at nearest point

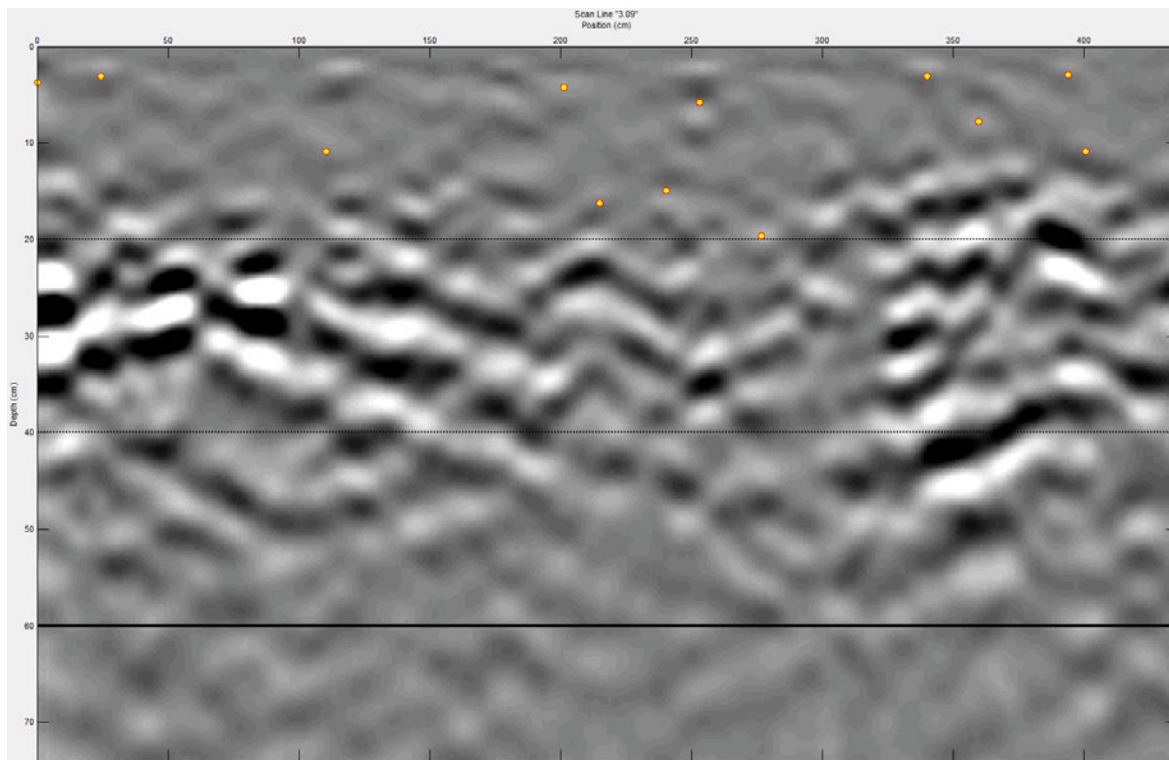
Measurement 3.9 - 9.5 m in length, 6.7 m from centre of tree OS6 at nearest point

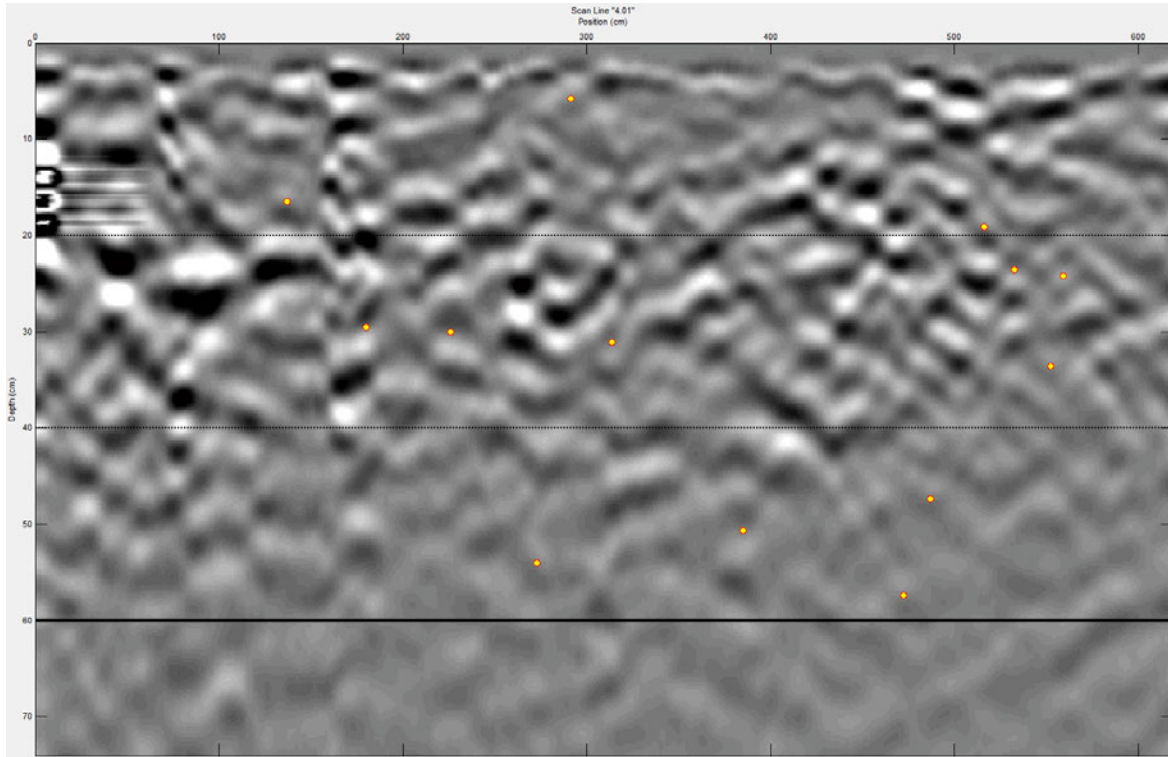
Measurement 4.1 – 6.2 m in length, 7.8 m from centre of tree #376 at nearest point

GPR assessment for tree OS8 was partially blocked by tree #376 and shrubs. About 25% of the CRZ of tree OS8 will be impacted by the proposed retaining wall / landscape feature. Tree OS8 can be reasonably retained with no cut at Property Line, and designing a point-footing retaining wall with suspended beams. Arborist oversight is recommended for the excavation at Property Line for the installation of the proposed retaining wall / landscape feature. It shall be determined by the project arborist where a tree protection barrier is installed for tree OS8. Root pruning for tree OS8 may be required to mitigate damage caused by the excavation process for point footings to create conditions for damaged roots to compartmentalize and restore typical root functions. Pruning of structural roots should be avoided. Use of a pneumatic air excavation is recommended to expose tree roots for root pruning.

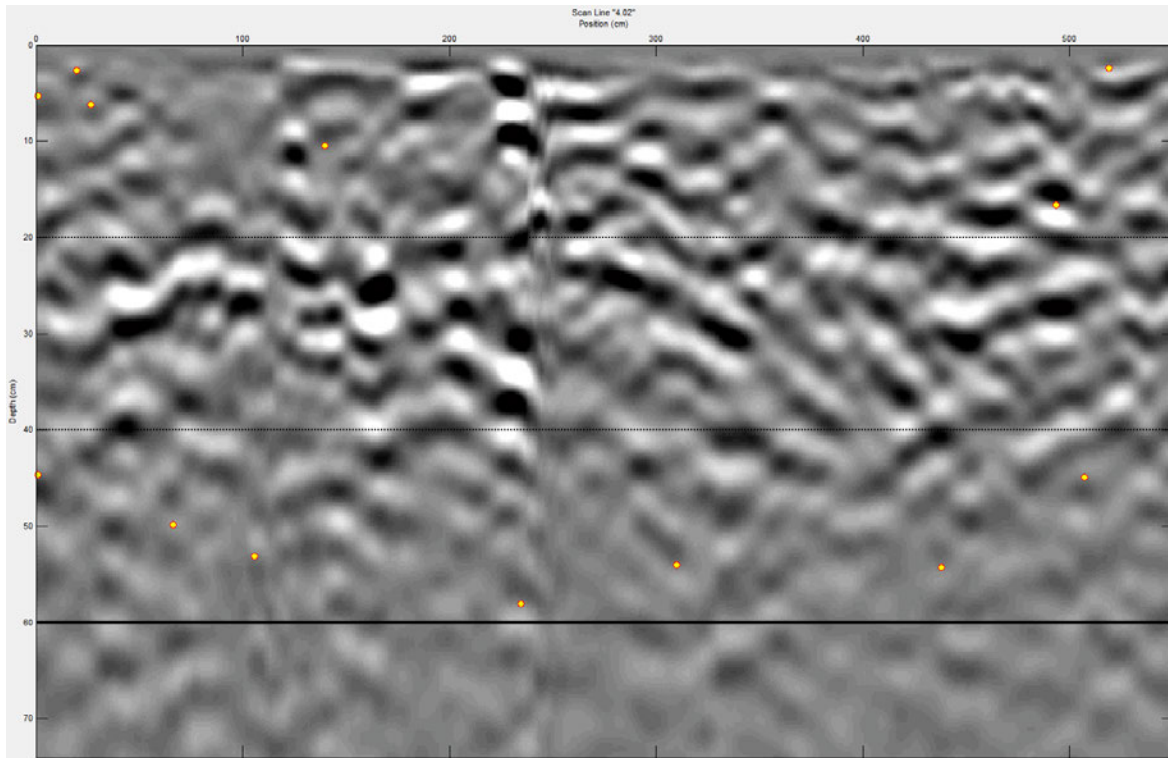
Measurement 4.2 - 5.5 m in length, 7.2 m from centre of tree #376 at nearest point

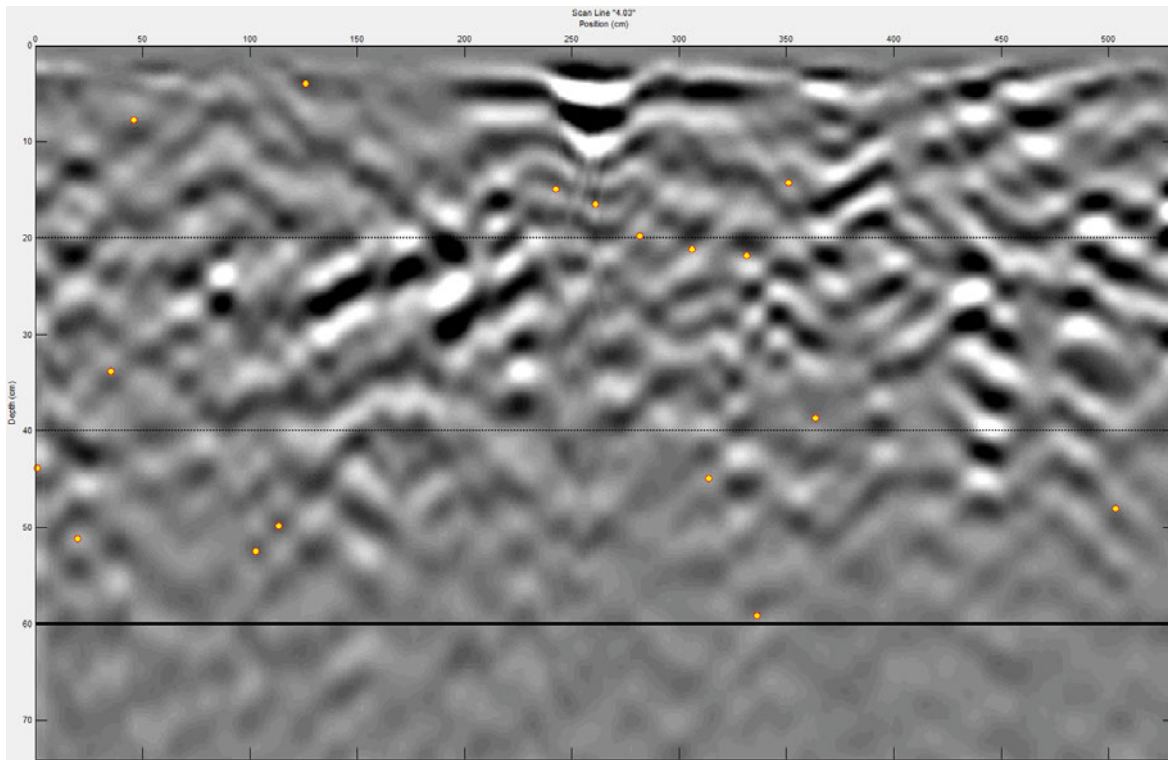
Measurement 4.3 - 5.3 m in length, 6.6 m from centre of tree #376 at nearest point

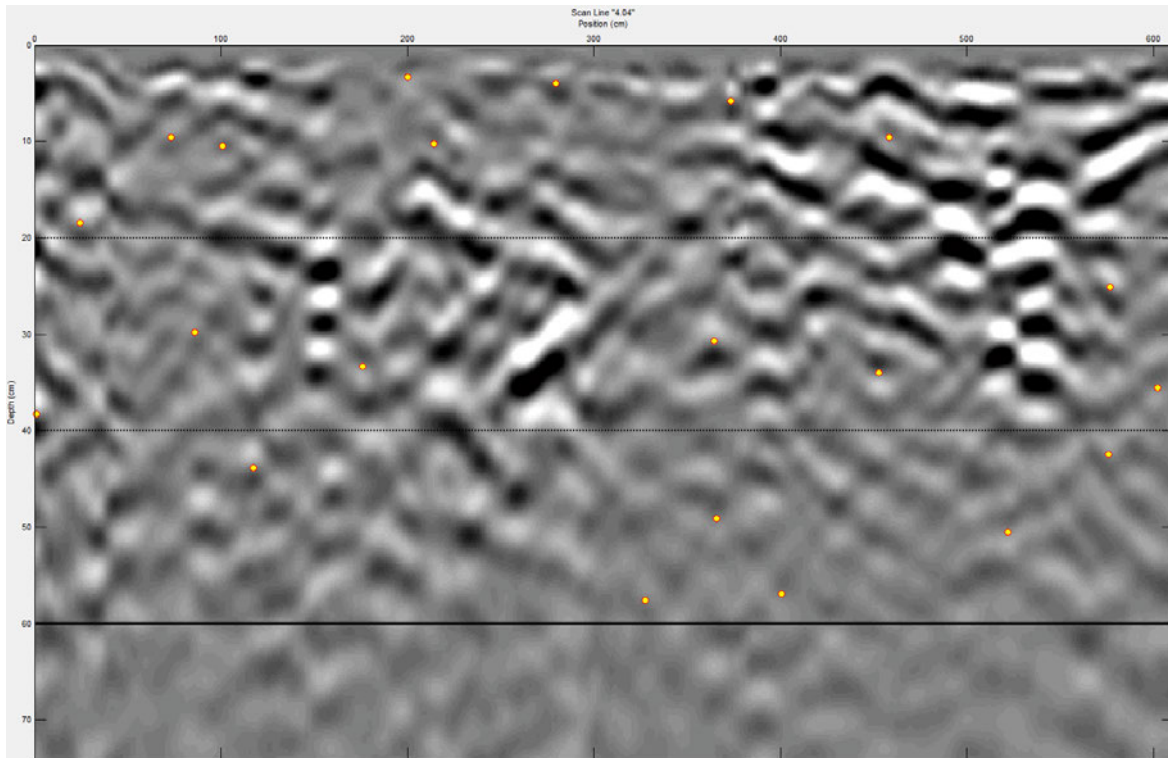
Measurement 4.4 - 6.1 m in length, 6.0 m from centre of tree #376 at nearest point

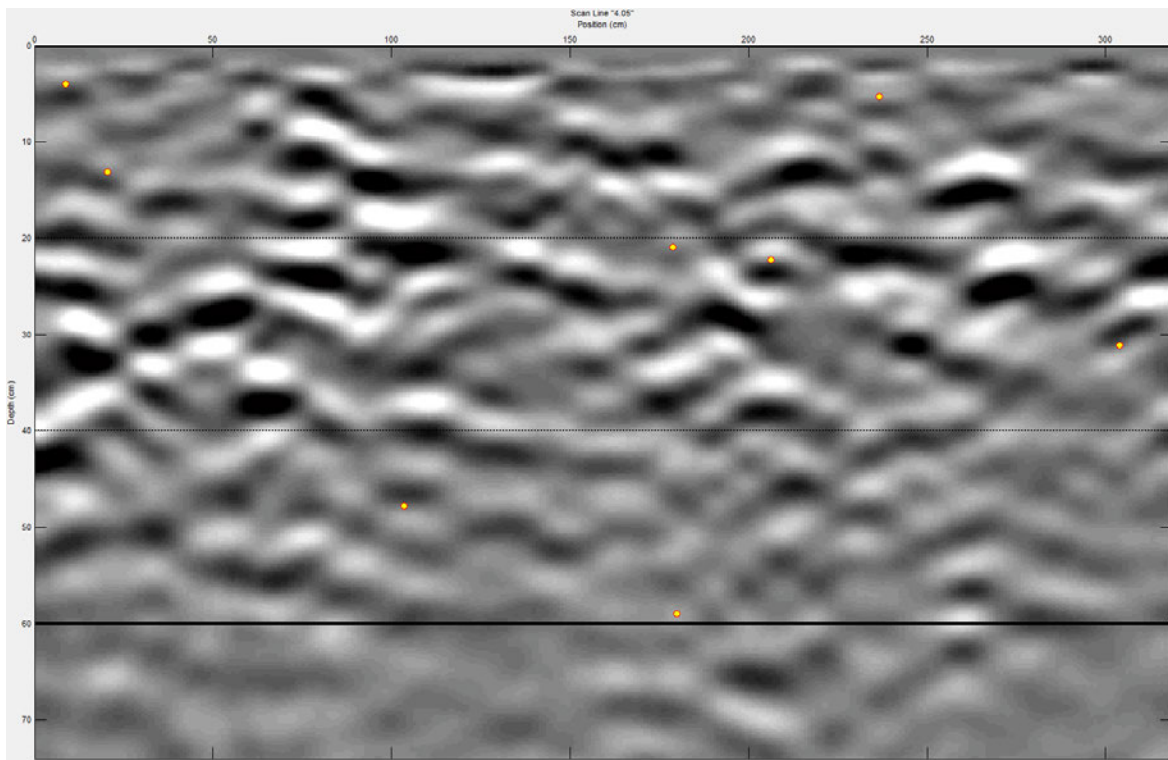
Measurement 4.5 - 3.2 m in length, 5.4 m from centre of tree #376 at nearest point
