From: [Krista Baronian](#)
To: [Neethu Syam](#); [Anne Berry](#)
Cc: [Parb Rehal](#)
Subject: RE: 1441 Vidal Street - Items to be addressed prior to scheduling Public Hearing
Date: July 5, 2023 10:43:35 AM
Attachments: [image001.jpg](#)
[image002.jpg](#)
[image003.png](#)

RESIDENTIAL DEVELOPMENT
 1441-1465 VIDAL STREET & 14937 THRIFT AVENUE, WHITE ROCK, B.C.
EROSION & SEDIMENT CONTROL PLAN

RESIDENTIAL DEVELOPMENT
1441-1465 VIDAL STREET & 14937 THRIFT AVENUE, WHITE ROCK, B.C.
EROSION & SEDIMENT CONTROL DETAILS (1 OF 2)

RESIDENTIAL DEVELOPMENT
1441-1465 VIDAL STREET & 14937 THRIFT AVENUE, WHITE ROCK, B.C.
EROSION & SEDIMENT CONTROL DETAILS (2 OF 2)

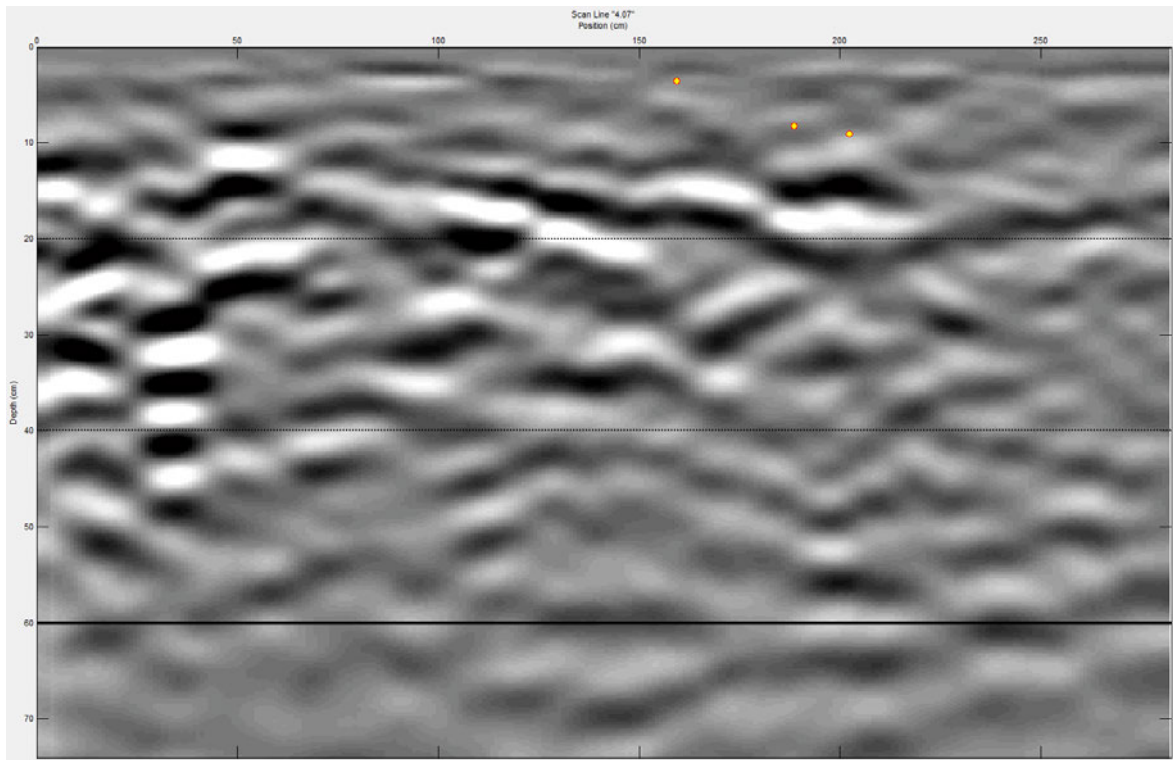
Measurement 4.7 - 2.8 m in length, 4.2 m from centre of tree #376 at nearest point

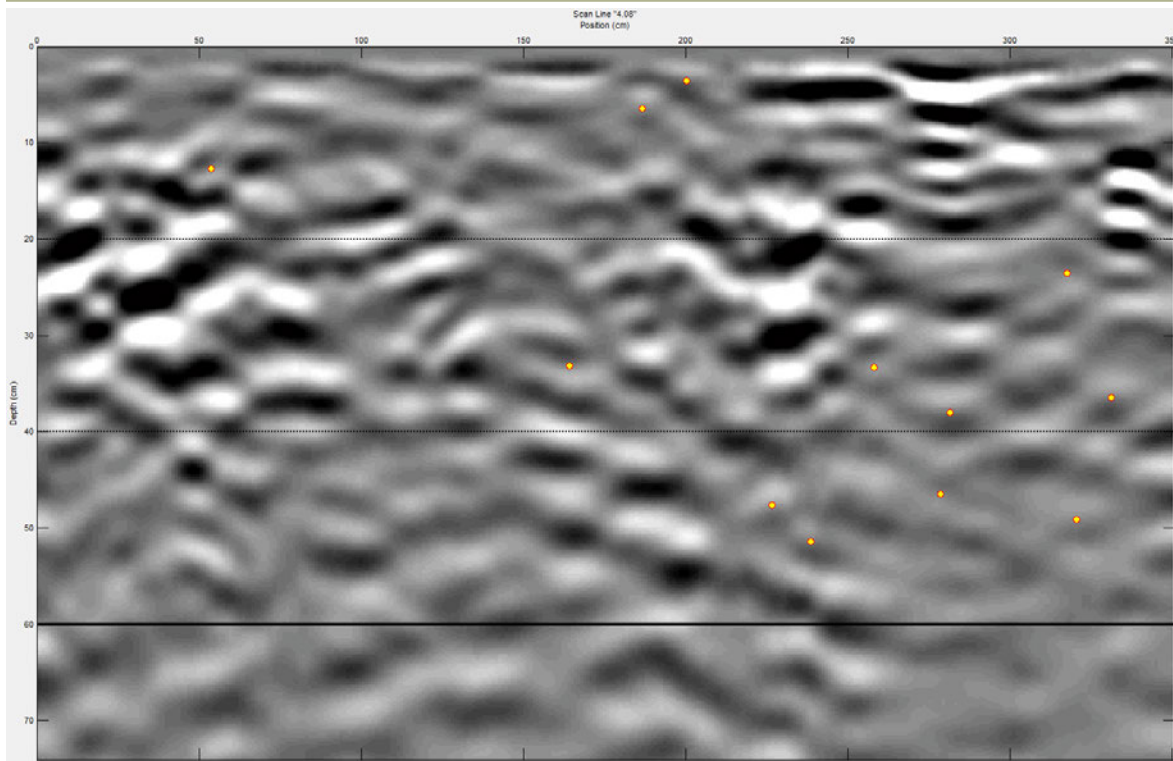
Measurement 4.8 - 3.5 m in length, 3.6 m from centre of tree #376 at nearest point

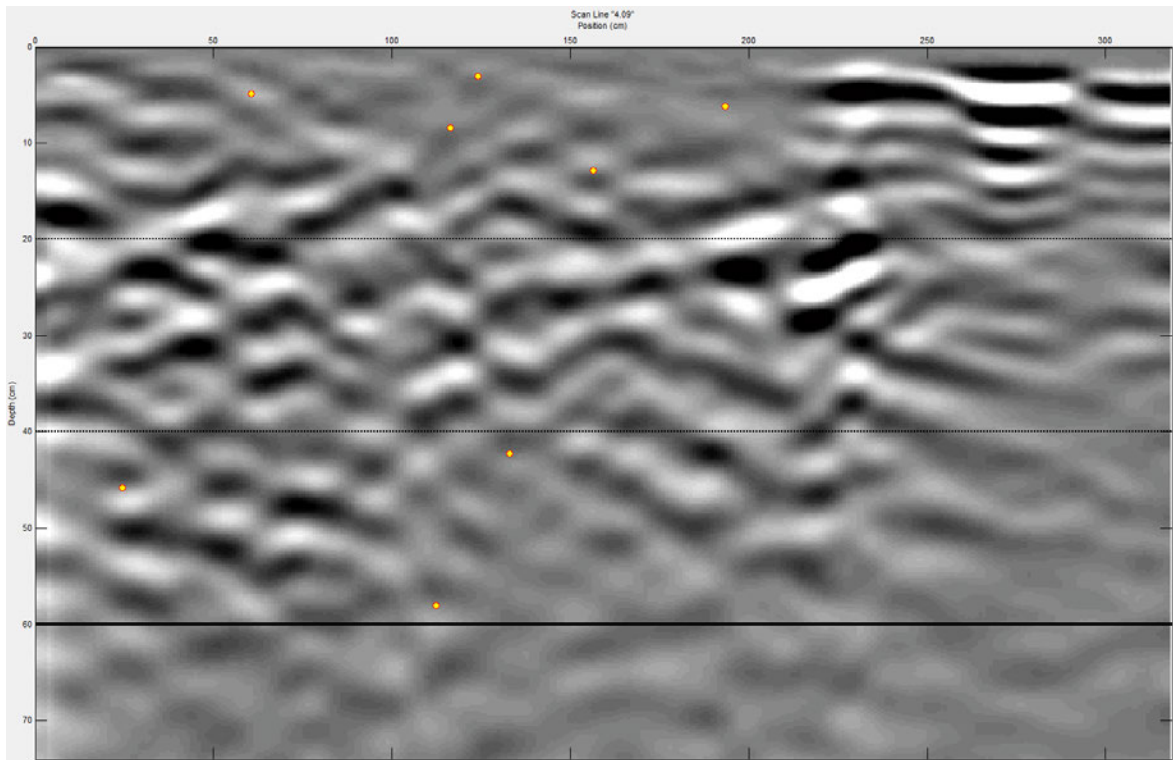
Measurement 4.9 - 3.2 m in length, 3.0 m from centre of tree #376 at nearest point

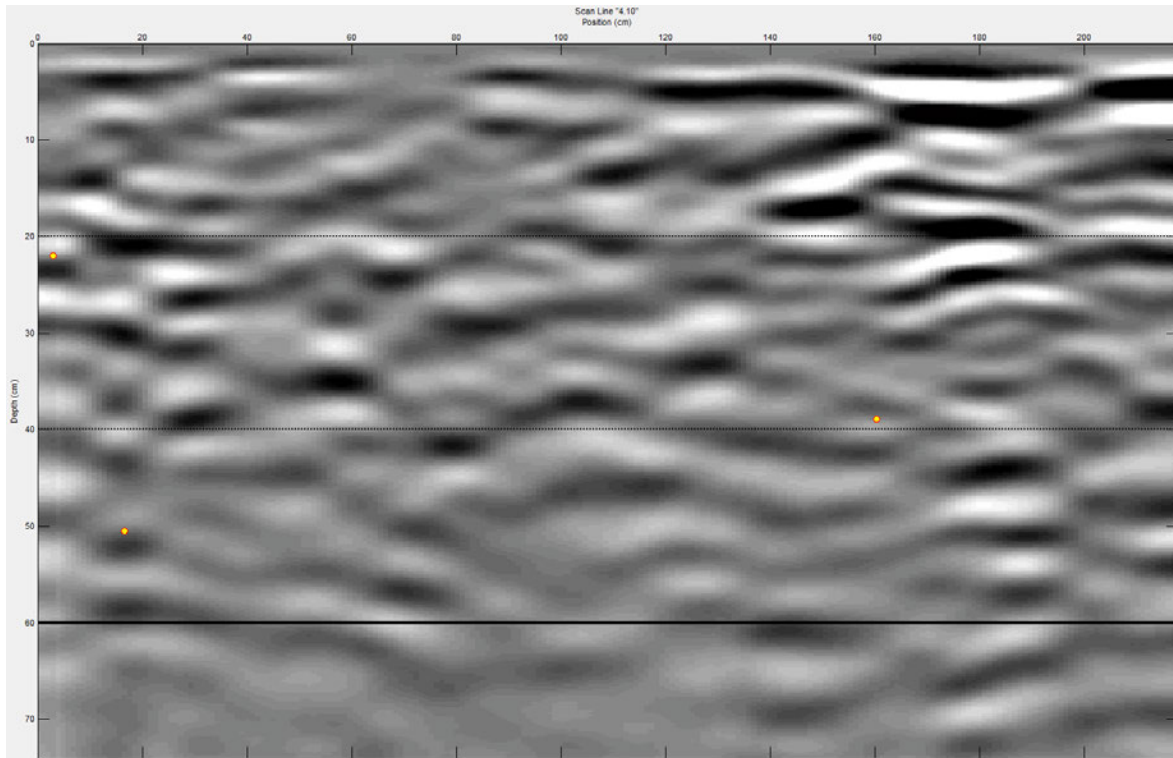
Measurement 4.10 - 2.2 m in length, 2.4 m from centre of tree #376 at nearest point

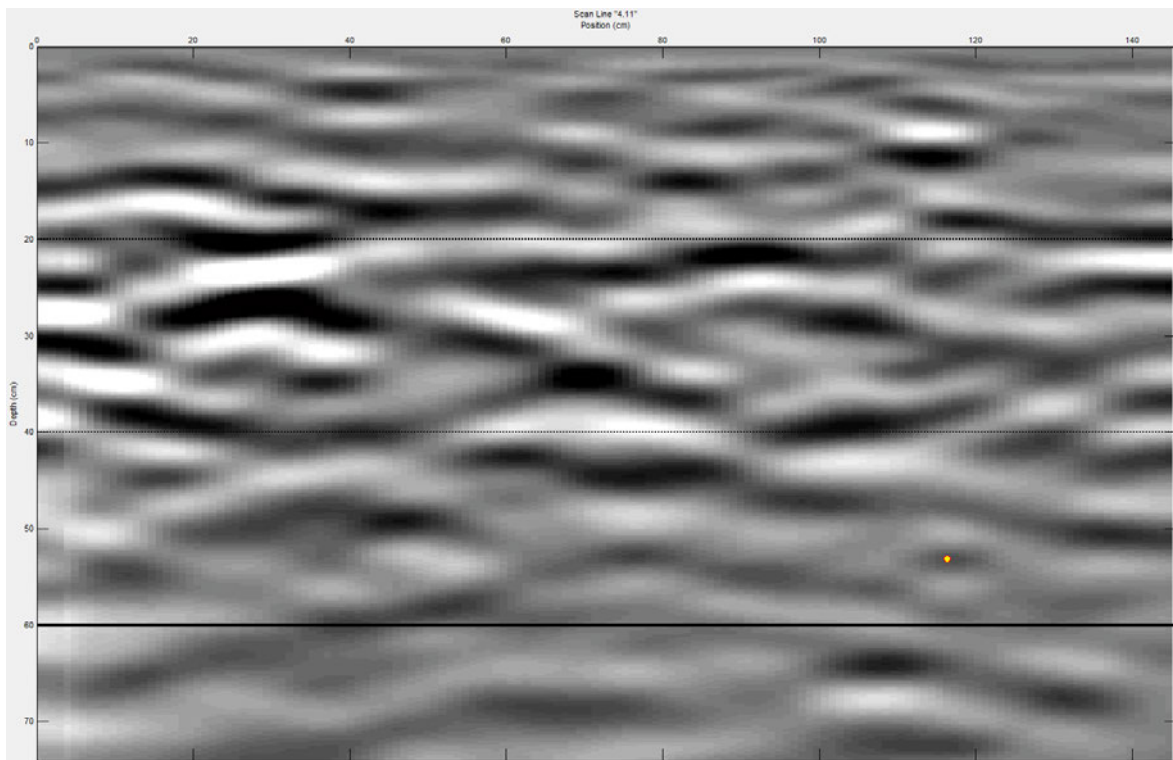
Measurement 4.11 - 1.5 m in length, 0.6 m from centre of tree #376 at nearest point

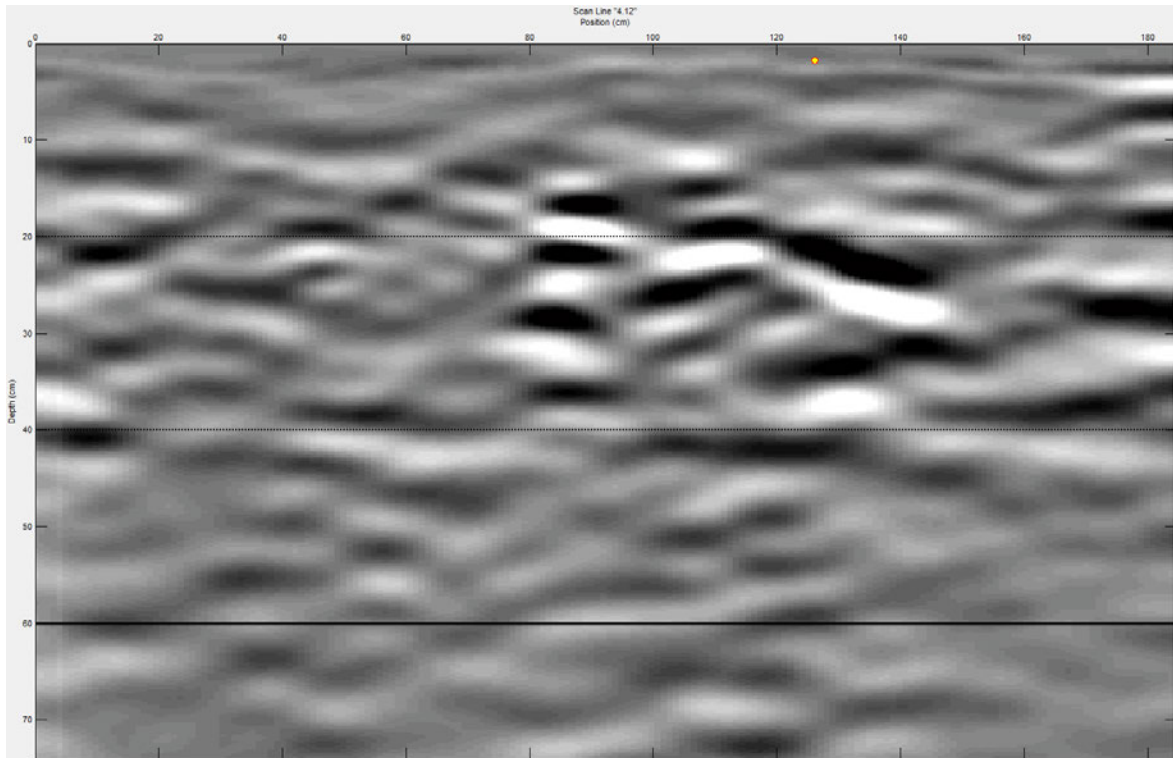
Measurement 4.12 - 1.8 m in length, 0.0 m from centre of tree #376 at nearest point

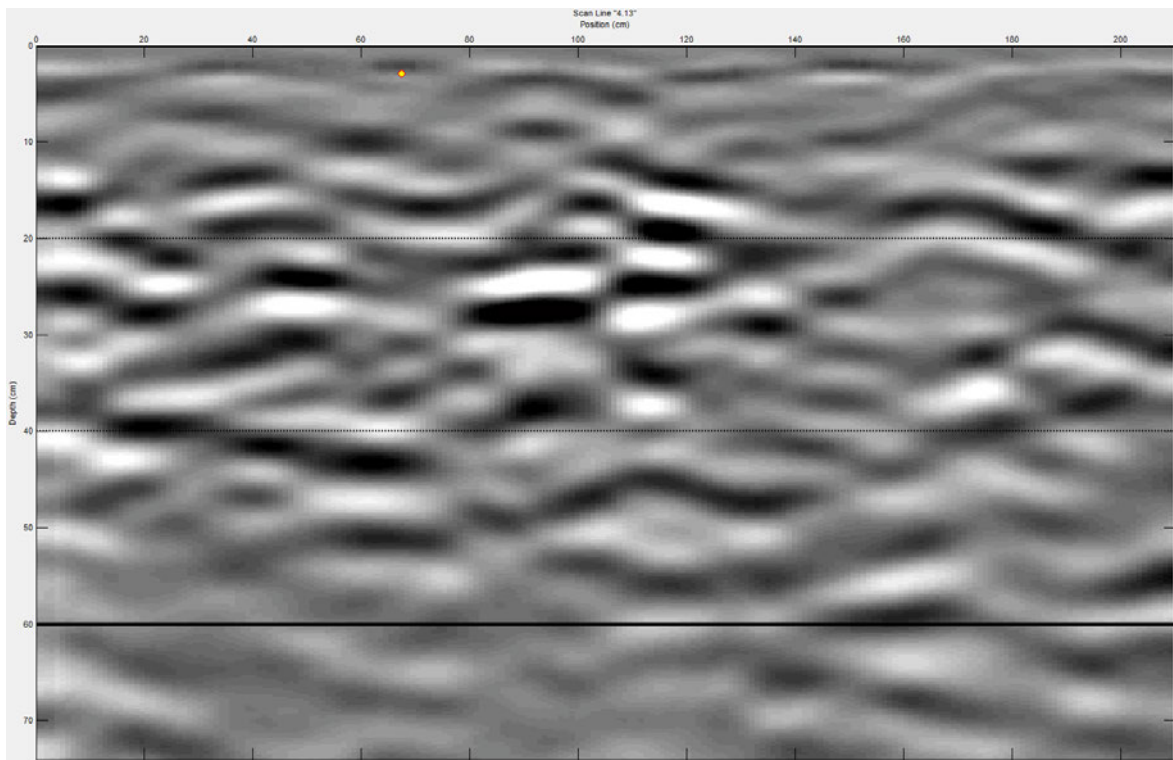
Measurement 4.13 - 2.1 m in length, 0.6 m from centre of tree #376 at nearest point

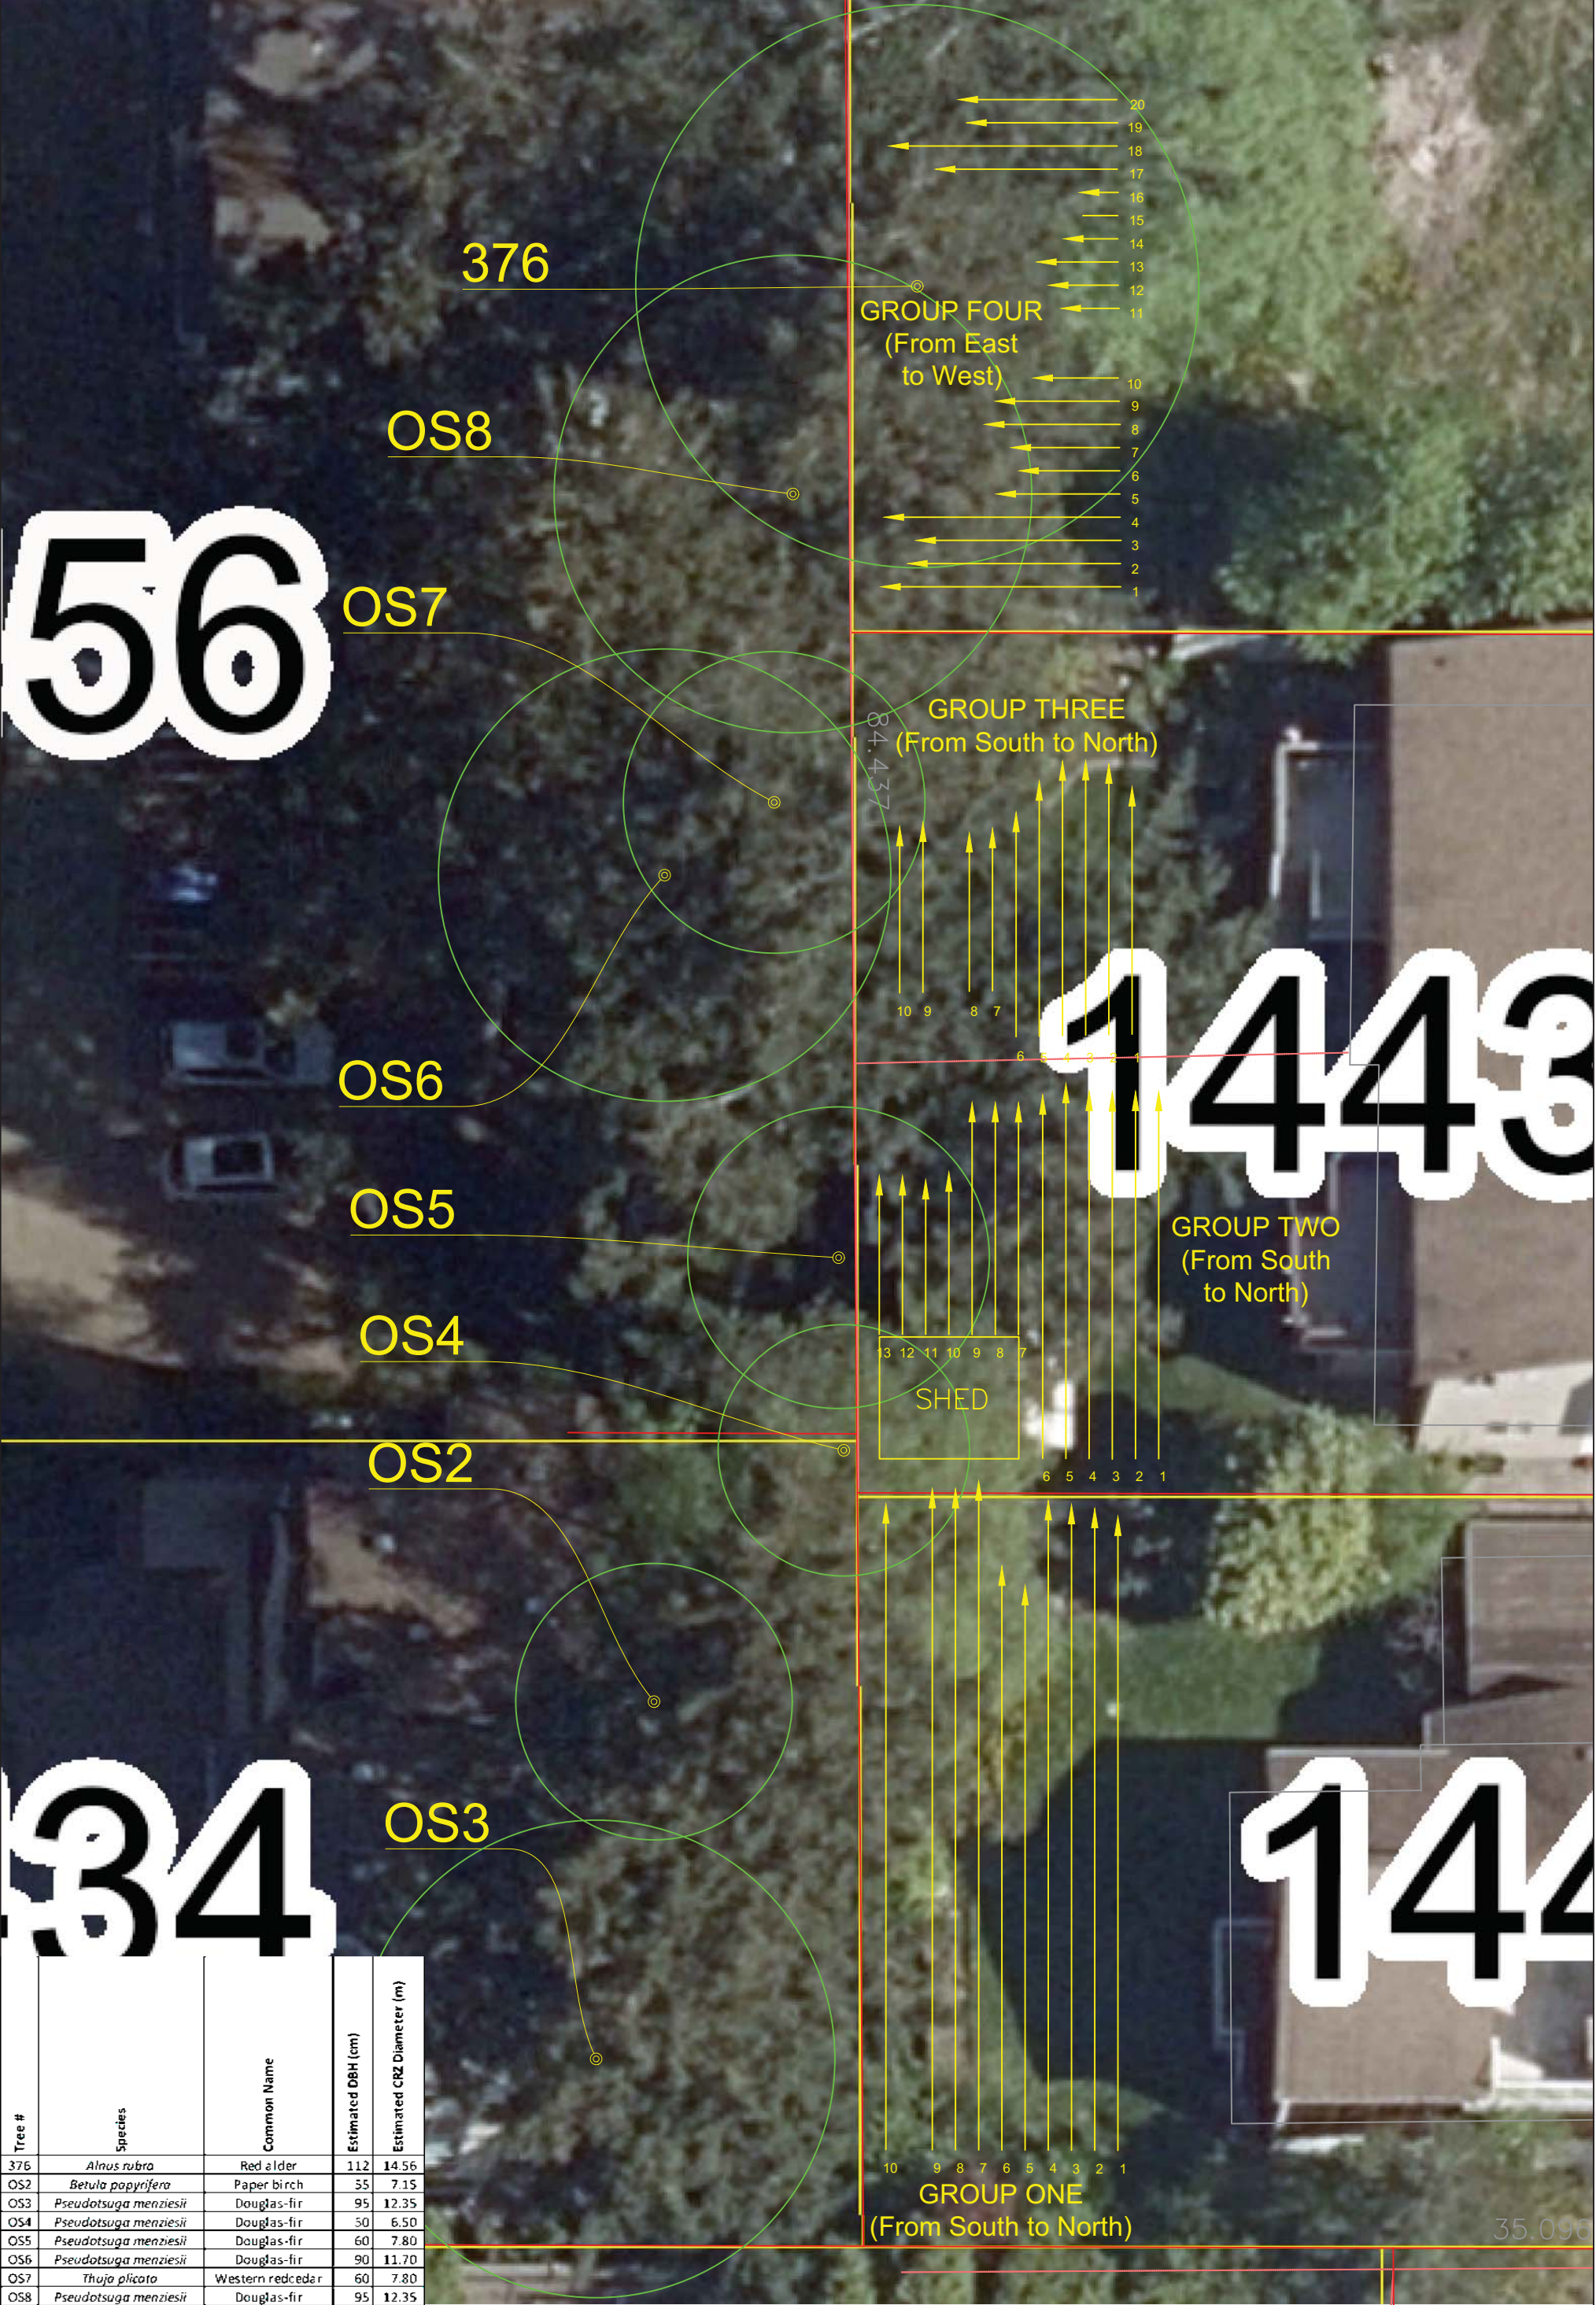
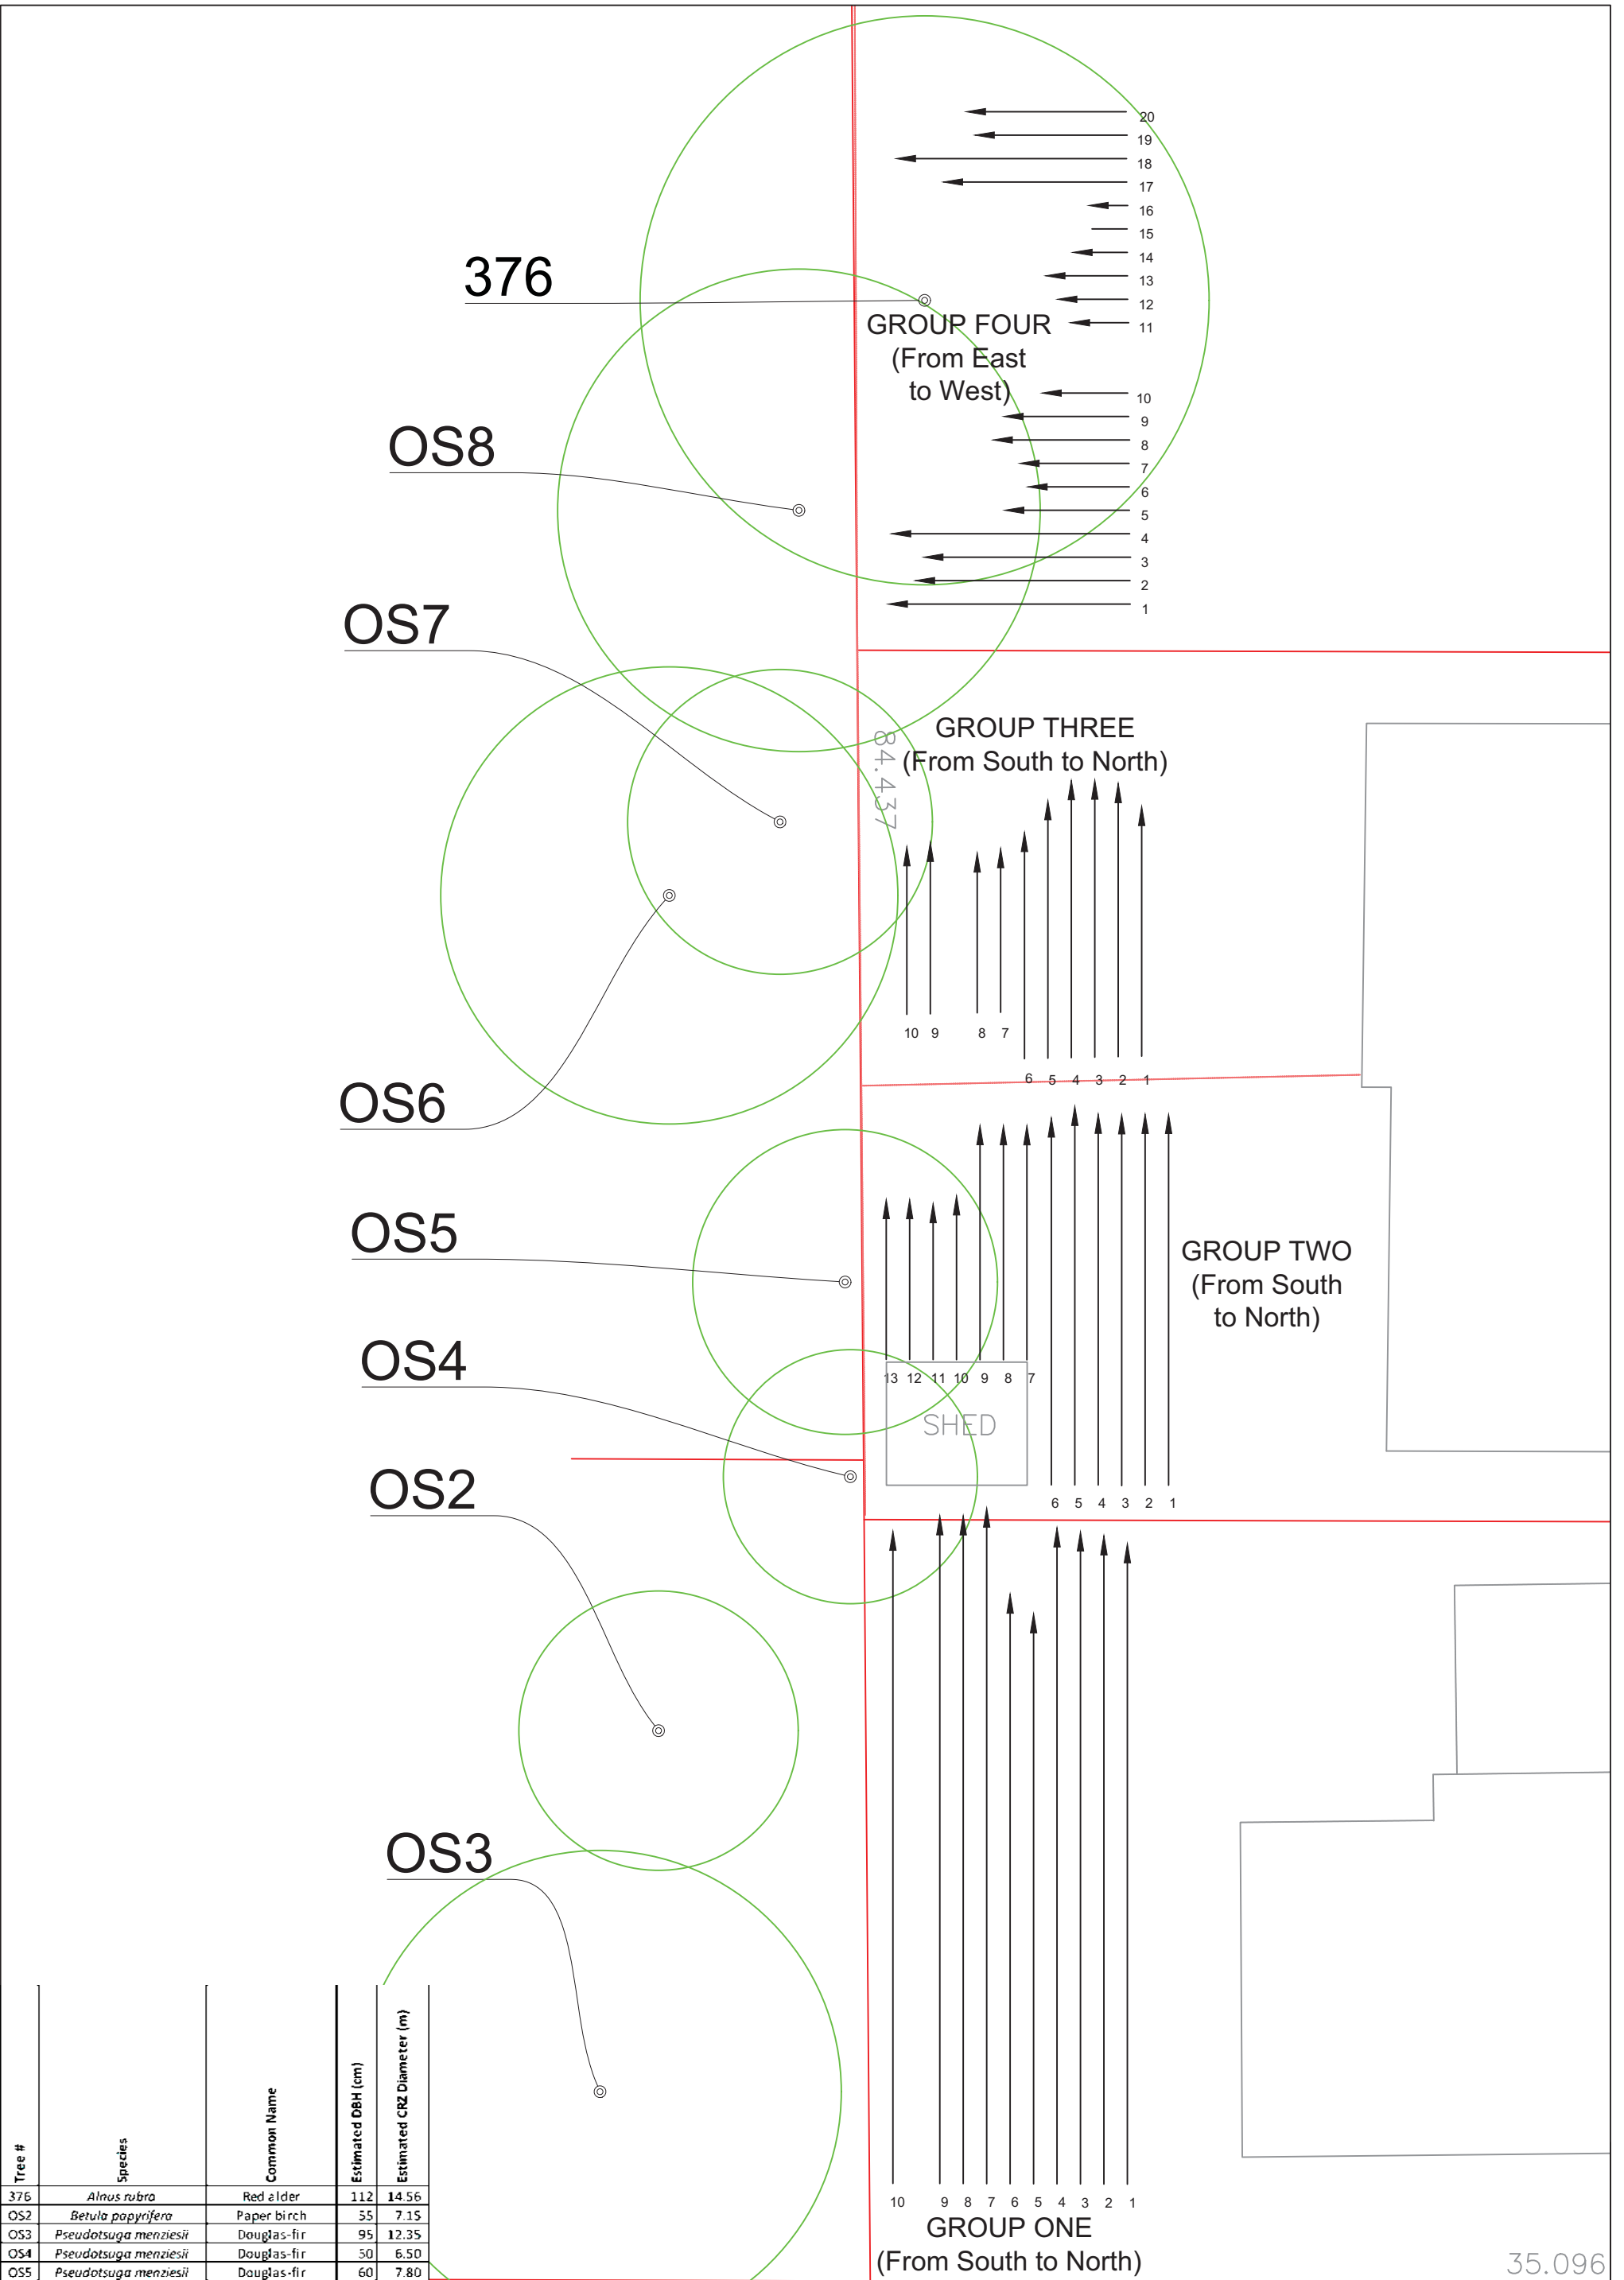
Drawing No.	Sheet Title	Project No.	Project Address	LEGEND
1 of 8	Aerial Site Map	van der Zalm Associates Inc. 20181211	1441, 1443-45, 1465 Vidal St, White Rock	Tree No.
	Revision No.	N/A	Arborist Report for a Tree Root Mapping	Client Name
	<p>All Units in Meters</p>		BC Plant Health Care Inc. 18465 53 rd Avenue, Surrey, BC. P: 604-575-8727 F: 604-576-2972 E: info@bcplanthealthcare.com 24 Hour Emergency Pager: 604-607-1616	Philip Kin Cho ISA Certified Arborist #HK-1086A ISA Tree Risk Assessment Qualification Forester in Training #5727 BSSc, MSc, MSFM
Page 57 of 65	Production Date: March 18 th , 2019			376 Tree No. Critical Root Zone Ground Penetrating Radar No.

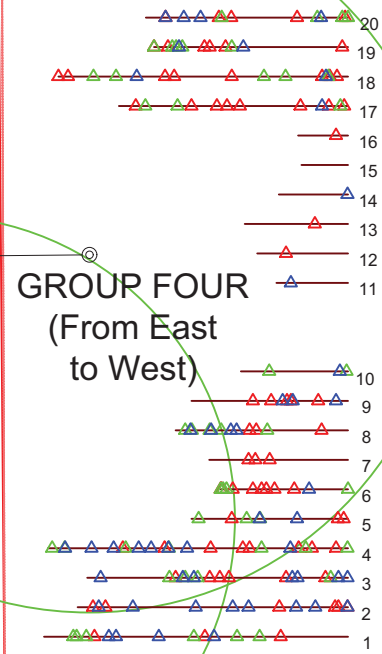
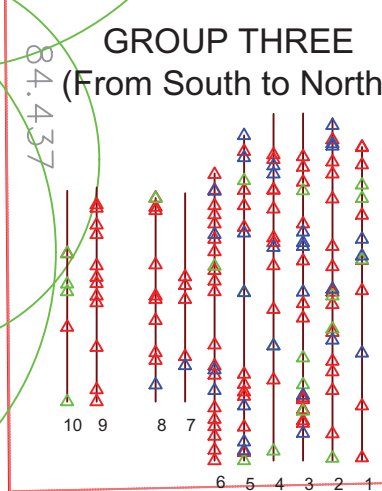
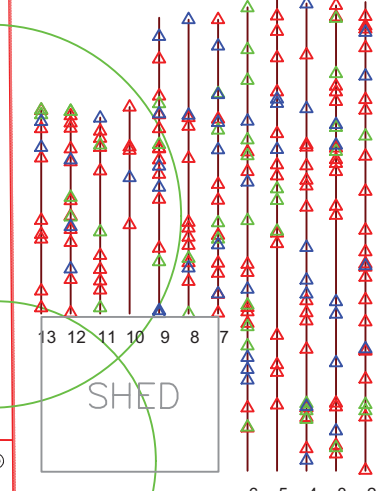
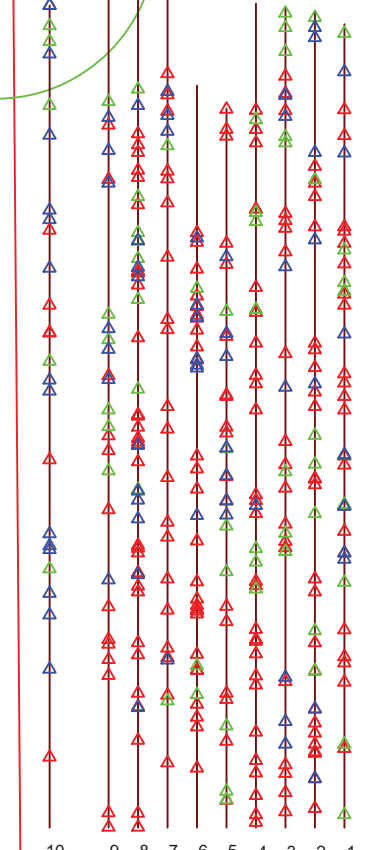
Drawing No. 2 of 8	Sheet Title Site Map		Project No. van der Zalm Associates Inc. 20181211	Project Address 1441, 1443-45, 1465 Vidal St, White Rock, BC V3Z 3T6	LEGEND Tree No. Critical Root Zone Ground Penetrating Radar No.	
	Revision No.	N/A	Project Title Arborist Report for a Tree Root Mapping	Client Name Austin Peterson		
	 All Units in Meters		BC Plant Health Care Inc. 18465 53 rd Avenue, Surrey, BC. P: 604-575-8727 F: 604-576-2972 E: info@bcplanthealthcare.com 24 Hour Emergency Pager: 604-607-1616	Philip Kin Cho ISA Certified Arborist #HK-1086A ISA Tree Risk Assessment Qualification Forester in Training #5727 BSSc, MSc, MSFM		
Page 58 of 65	Production Date:	March 18 th , 2019

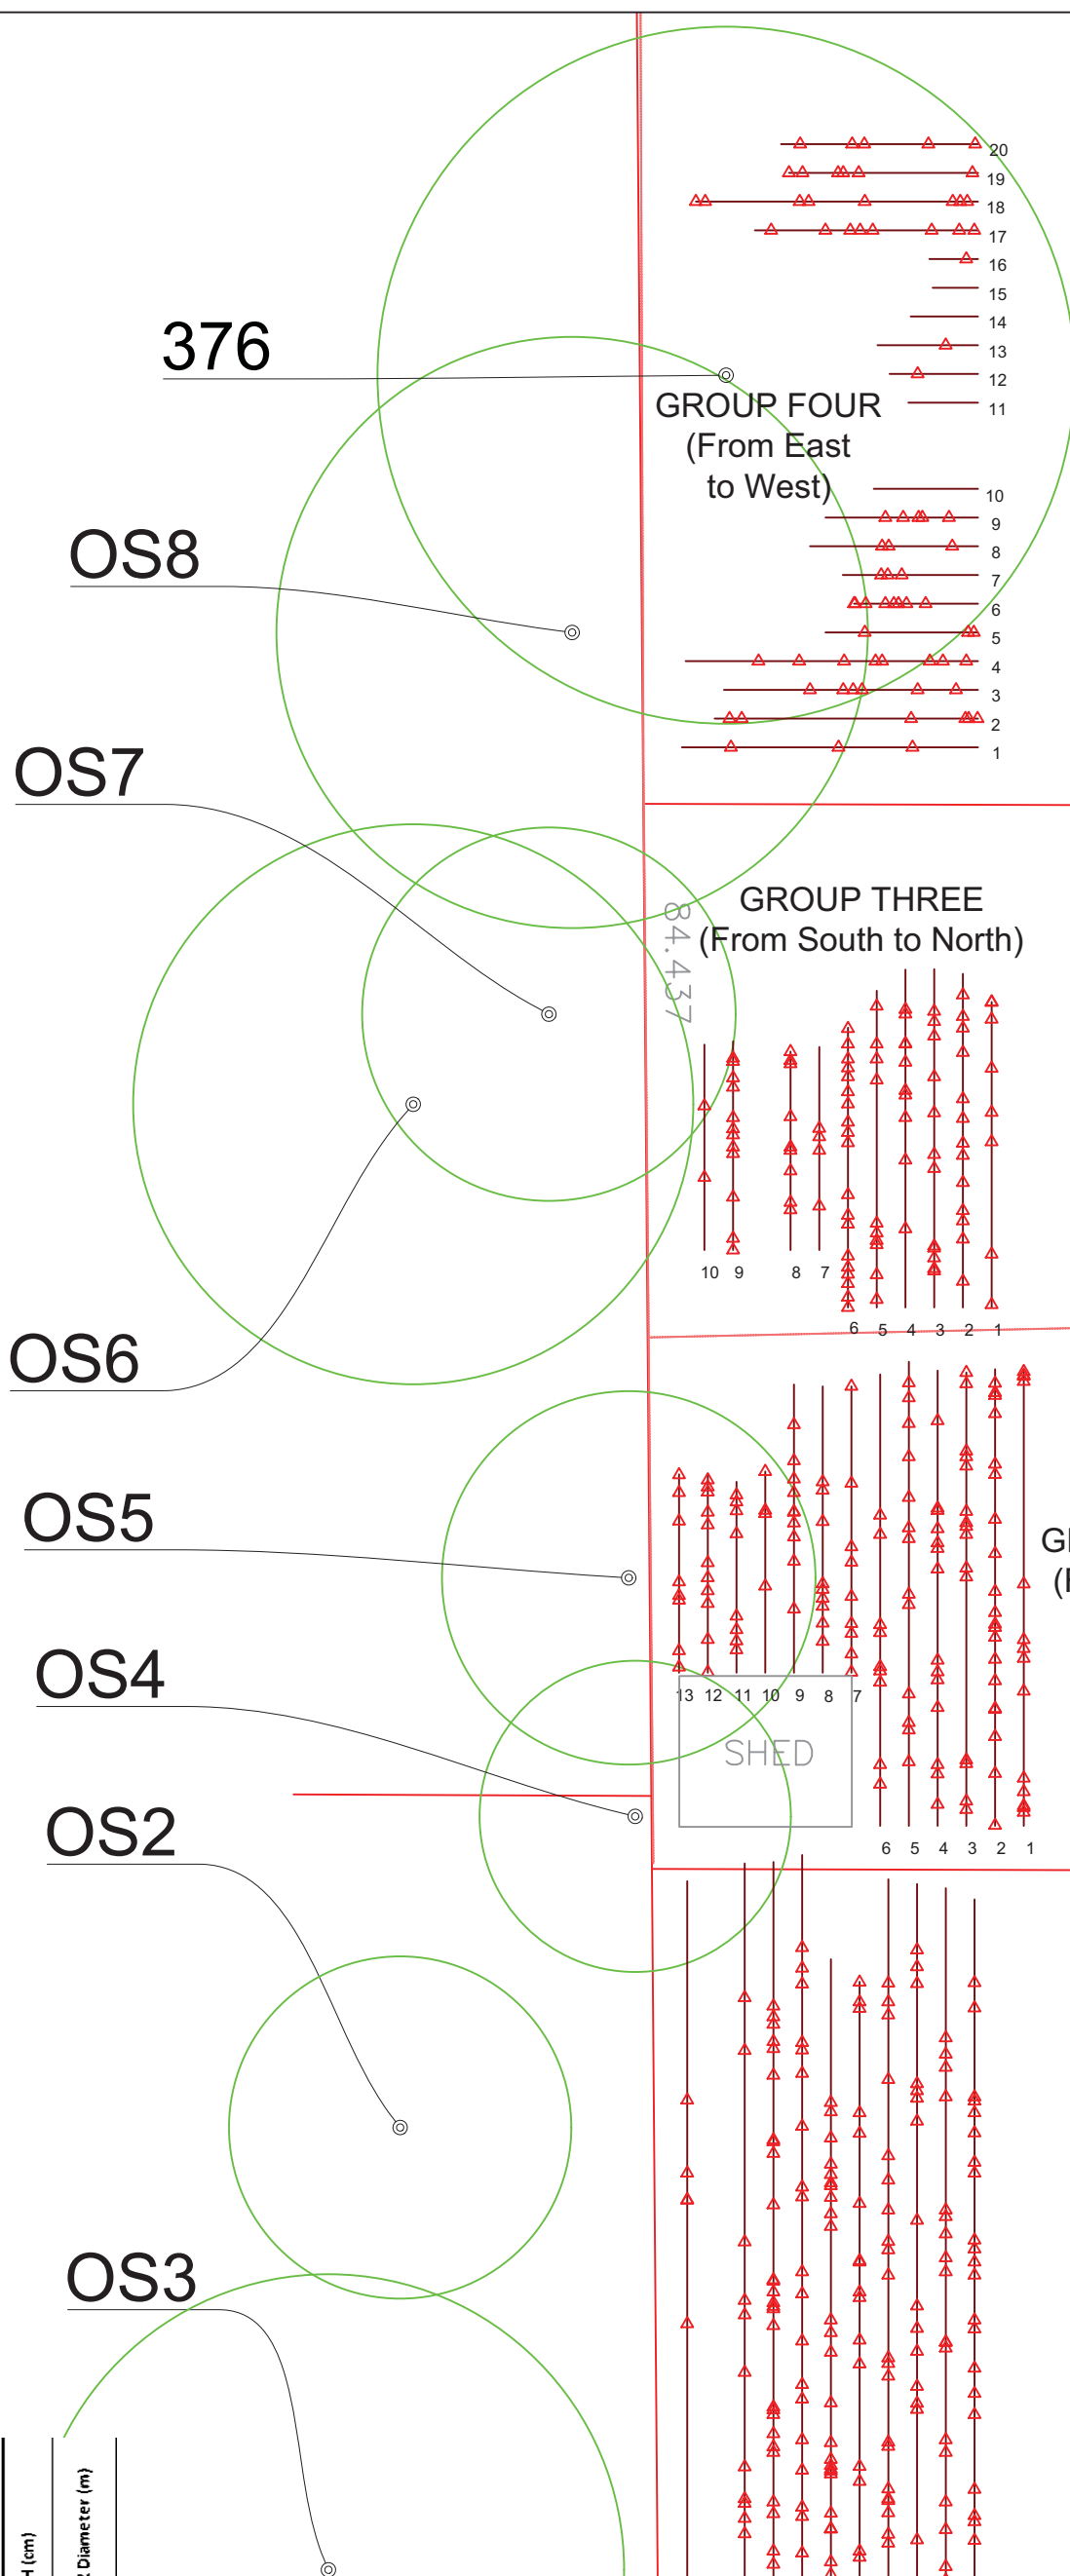
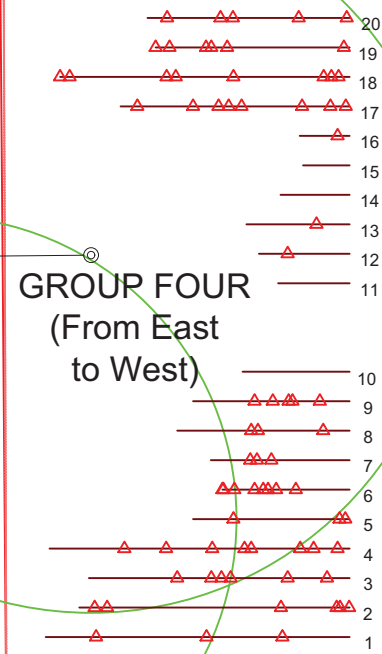
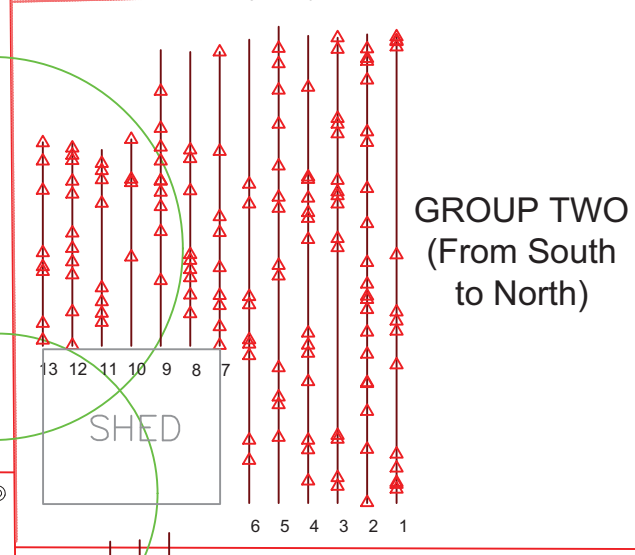
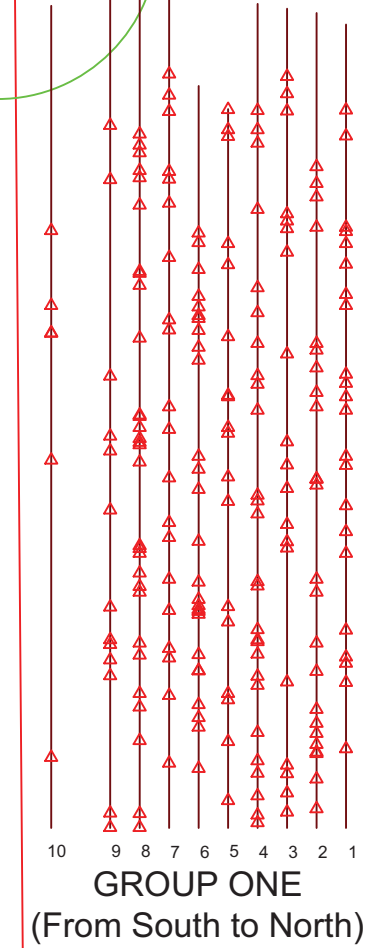
3 of 8	Drawing No.		Sheet Title	
			Root Detection Map at 0-60 cm	
	Revision No.	N/A

LEGEND	
	Tree No.
	Critical Root Zone
	Ground Penetrating Radar No.
	Root Detection at 0-20 cm
	Root Detection at 20-40 cm
	Root Detection at 40-60 cm

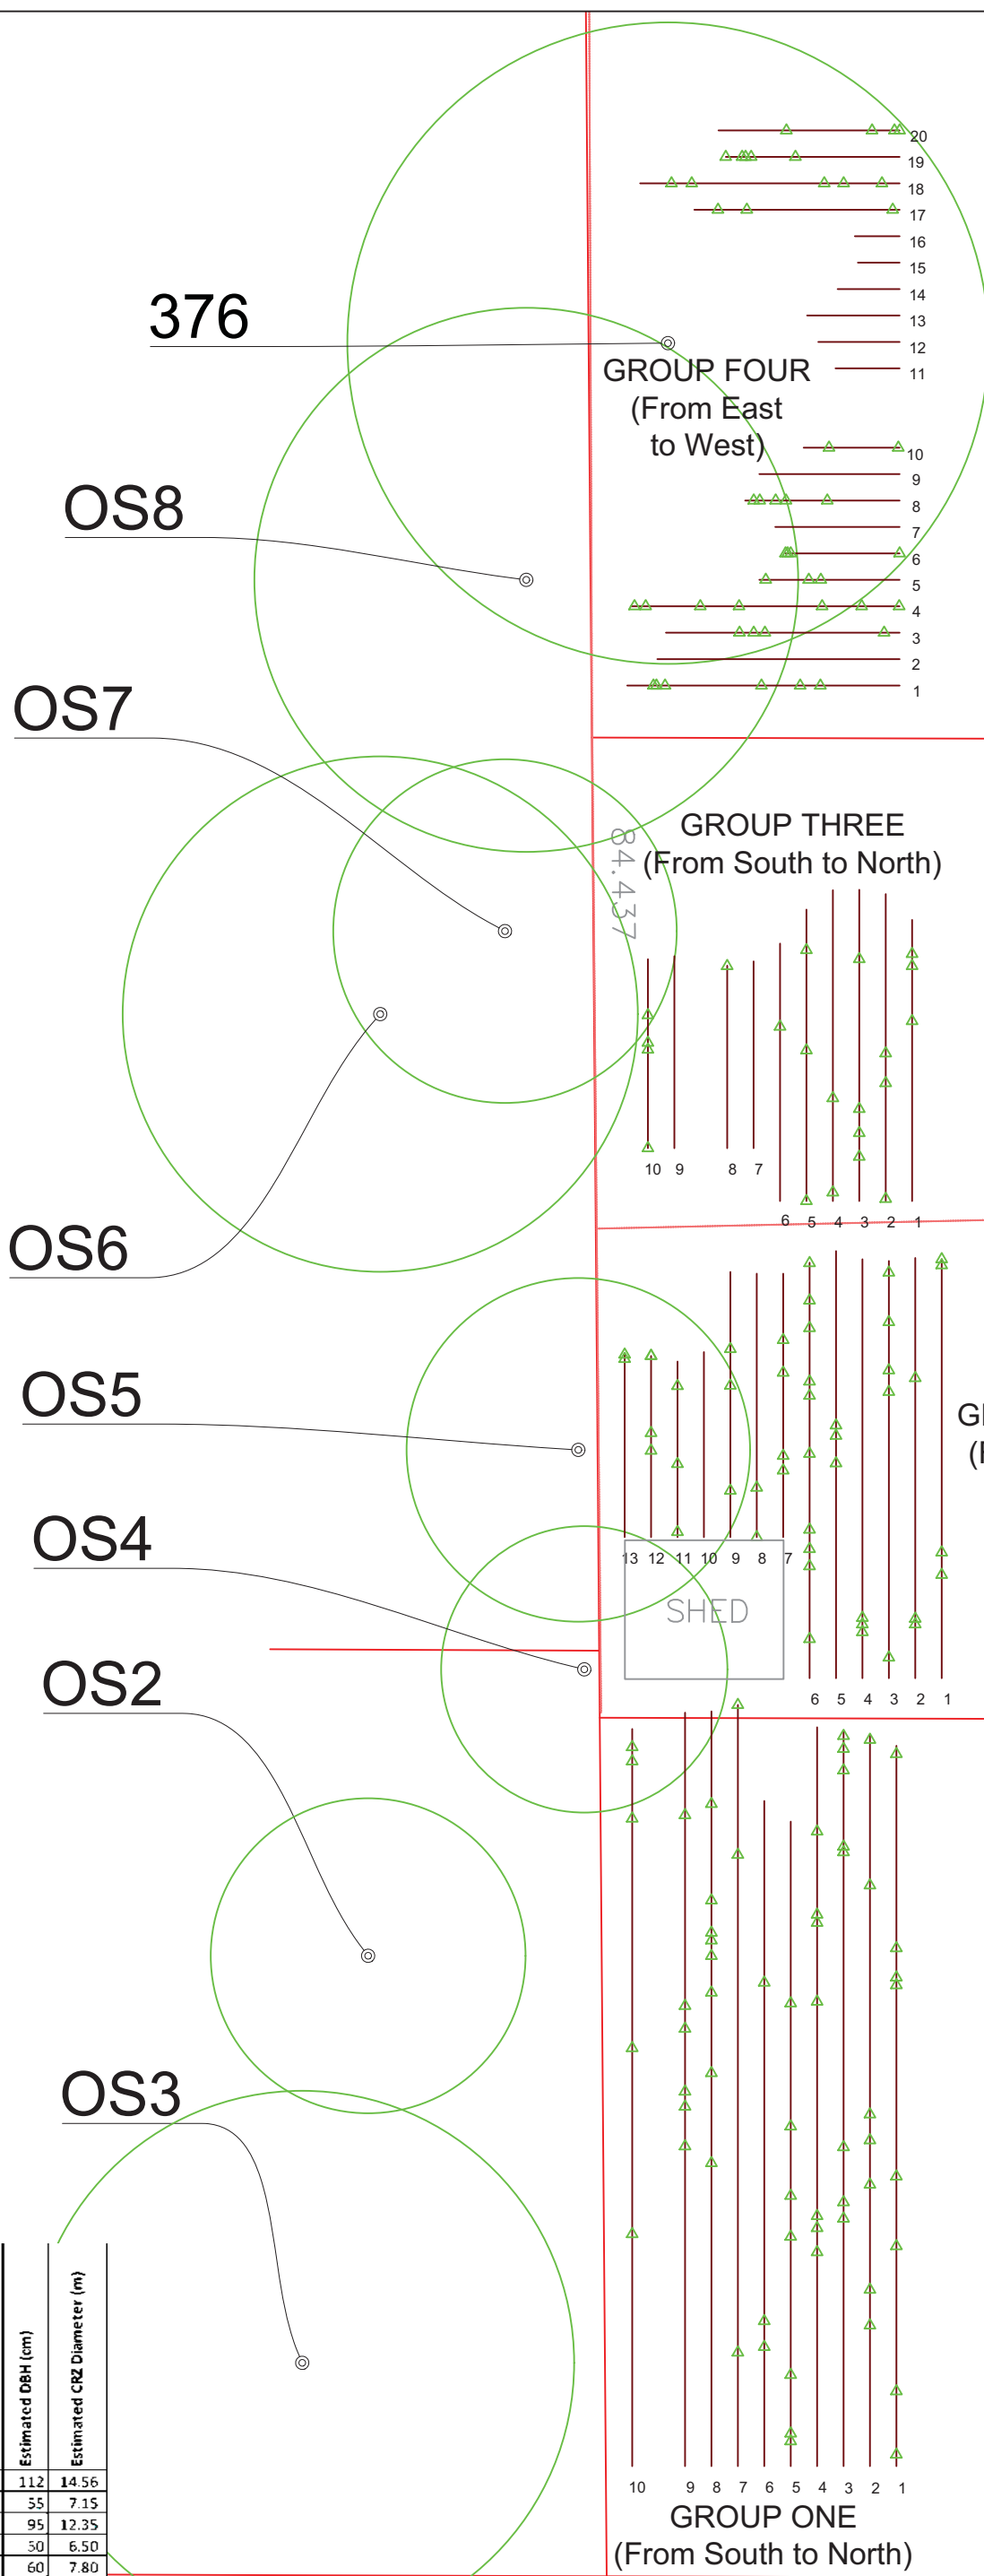
Drawing No.	Sheet Title	Project No.	Project Address	LEGEND	
4 of 8	Root Detection Map at 0-20 cm	van der Zalm Associates Inc. 20181211	1441, 1443-45, 1465 Vidal St, White Rock	Tree No.	
	Revision No. N/A	Arborist Report for a Tree Root Mapping	Client Name Austin Peterson	Critical Root Zone	
	<p>All Units in Meters</p>		BC Plant Health Care Inc. 18465 53 rd Avenue, Surrey, BC. P: 604-575-8727 F: 604-576-2972 E: info@bcplanthealthcare.com 24 Hour Emergency Pager: 604-607-1616	Philip Kin Cho ISA Certified Arborist #HK-1086A ISA Tree Risk Assessment Qualification Forester in Training #5727 BSSc, MSc, MSFM	Ground Penetrating Radar No.
Page 60 of 65	Production Date: March 18 th , 2019				Root Detection at 0-20 cm

With reference to the top-down root density map at 0-20 cm depth of Group 1 (Figure 10), and measurements 1.6 to 1.8 (Attachment A), there are roots in the 0-20 cm depth range, and are likely to be comprised of feeder roots. Furthermore, trees OS2 and OS3 are about 6 m and 8 m from the proposed development respectively, and their CRZs do not enter the subject lot. The proposed development is unlikely to have a major impact to the CRZ of trees OS2 and OS3.
