From: [Krista Baronian](#)
To: [Neethu Syam](#); [Anne Berry](#)
Cc: [Parb Rehal](#)
Subject: RE: 1441 Vidal Street - Items to be addressed prior to scheduling Public Hearing
Date: July 5, 2023 10:43:35 AM
Attachments: [image001.jpg](#)
[image002.jpg](#)
[image003.png](#)

RESIDENTIAL DEVELOPMENT
 1441-1465 VIDAL STREET & 14937 THRIFT AVENUE, WHITE ROCK, B.C.
EROSION & SEDIMENT CONTROL PLAN

RESIDENTIAL DEVELOPMENT
1441-1465 VIDAL STREET & 14937 THRIFT AVENUE, WHITE ROCK, B.C.
EROSION & SEDIMENT CONTROL DETAILS (1 OF 2)

RESIDENTIAL DEVELOPMENT
1441-1465 VIDAL STREET & 14937 THRIFT AVENUE, WHITE ROCK, B.C.
EROSION & SEDIMENT CONTROL DETAILS (2 OF 2)

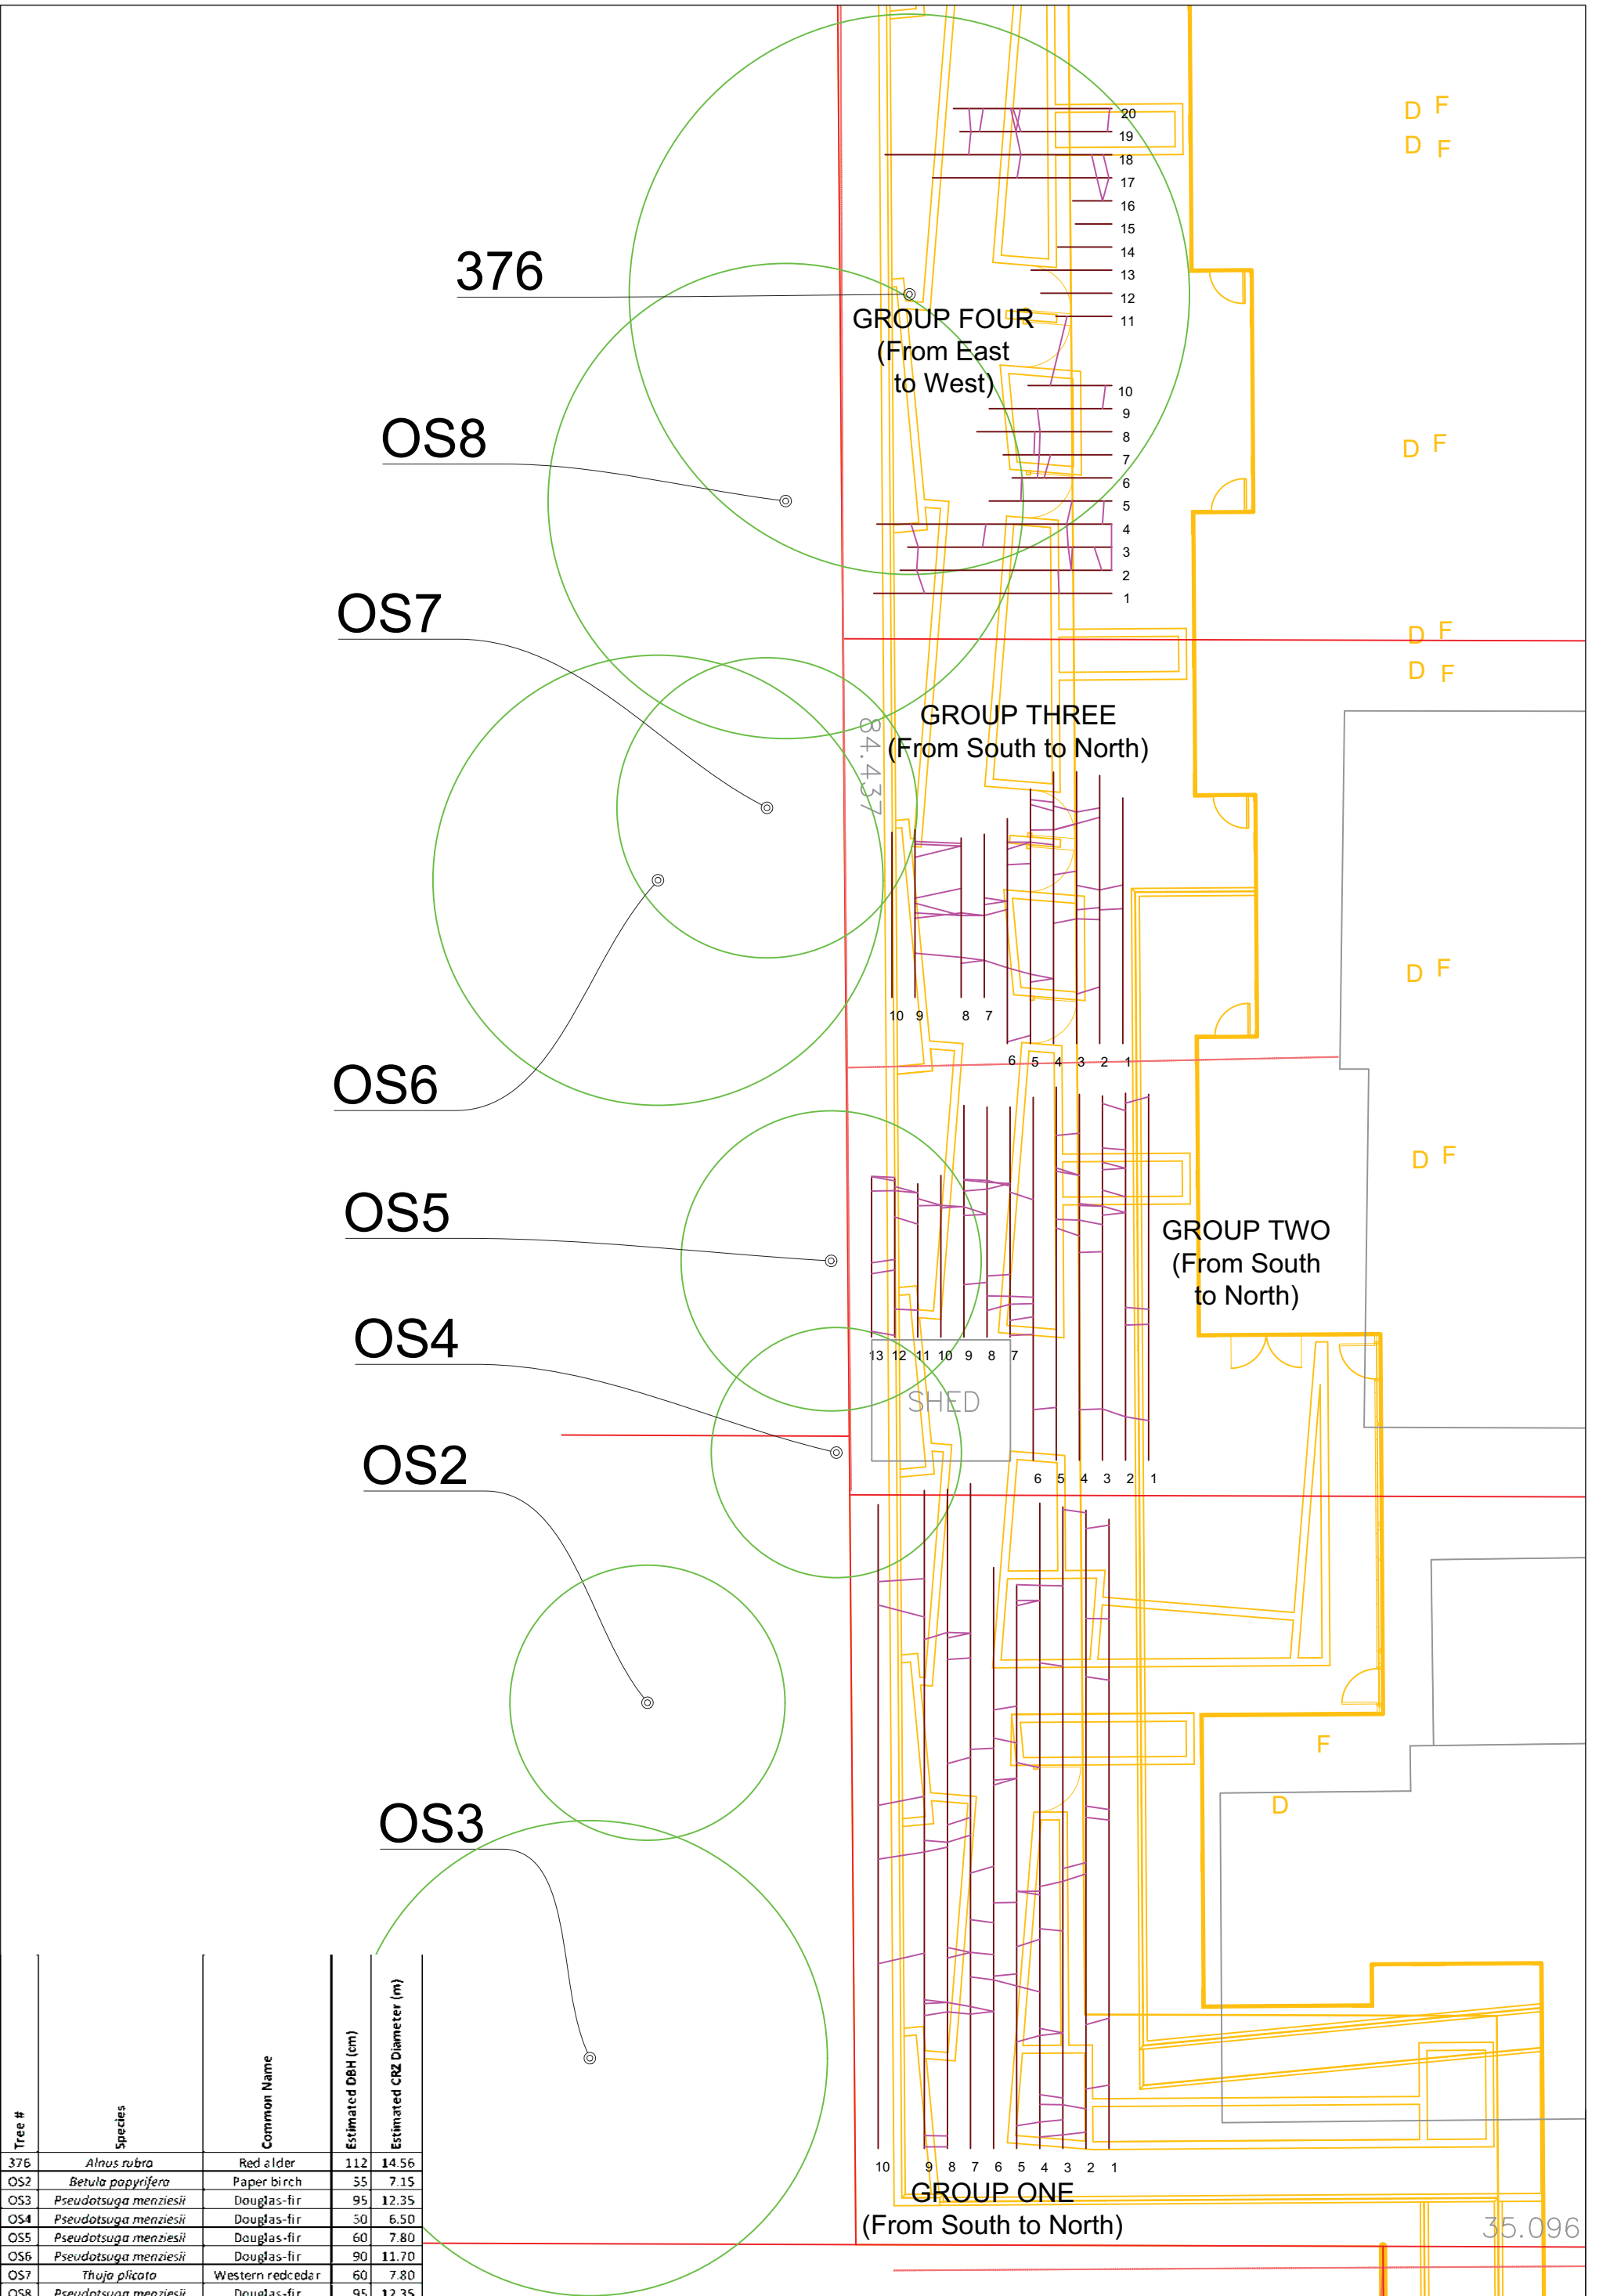
Drawing No. 5 of 8	Sheet Title Root Detection Map at 20-40 cm		Project No. van der Zalm Associates Inc. 20181211	Project Address 1441, 1443-45, 1465 Vidal St, White Rock	LEGEND <ul style="list-style-type: none"> Tree No. Critical Root Zone Ground Penetrating Radar No. Root Detection at 20-40 cm 	
	Revision No.	N/A	Project Title Arborist Report for a Tree Root Mapping	Client Name Austin Peterson		
	<p>All Units in Meters</p>		BC Plant Health Care Inc. 18465 53 rd Avenue, Surrey, BC. P: 604-575-8727 F: 604-576-2972 E: info@bcplanthealthcare.com 24 Hour Emergency Pager: 604-607-1616	Philip Kin Cho ISA Certified Arborist #HK-1086A ISA Tree Risk Assessment Qualification Forester in Training #5727 BSSc, MSc, MSFM		
Page 61 of 65	Production Date:	March 18 th , 2019

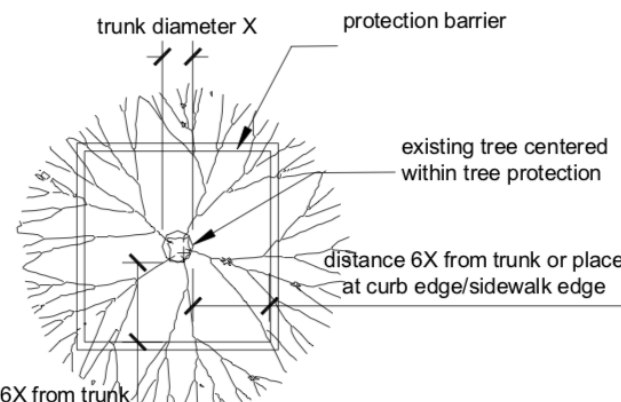
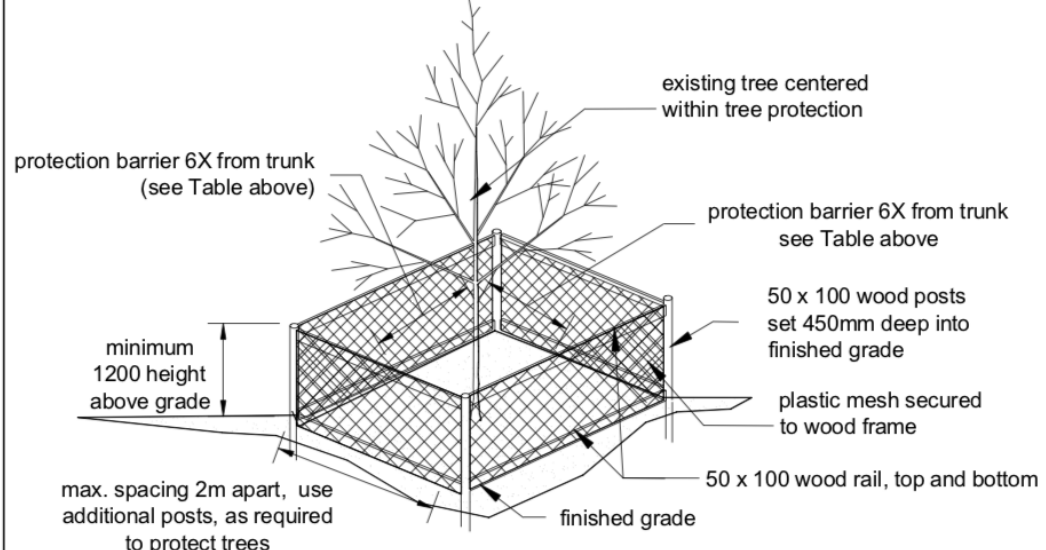
Specifications for Tree Protection Barriers

TRUNK DIAMETER (CM)	MINIMUM PROTECTION DISTANCE (M FROM TRUNK)
X	6X
20	1.2
25	1.5
30	1.8
35	2.1
40	2.4
45	2.7
50	3.0
55	3.3
60	3.6
75	4.5
90	5.0
100	6.0

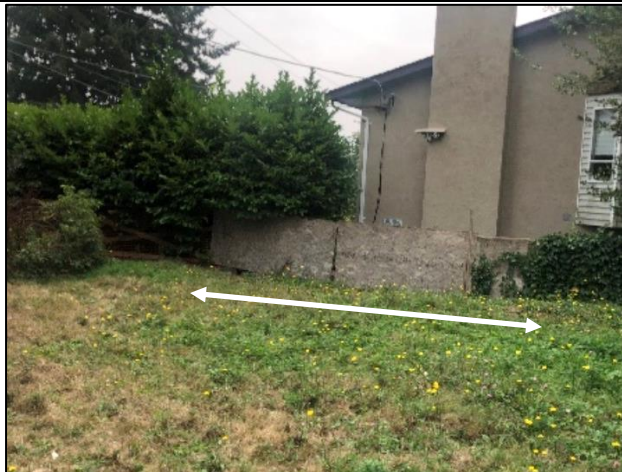
Fig. 15 – North property line of 1441 Vidal St, east corner.

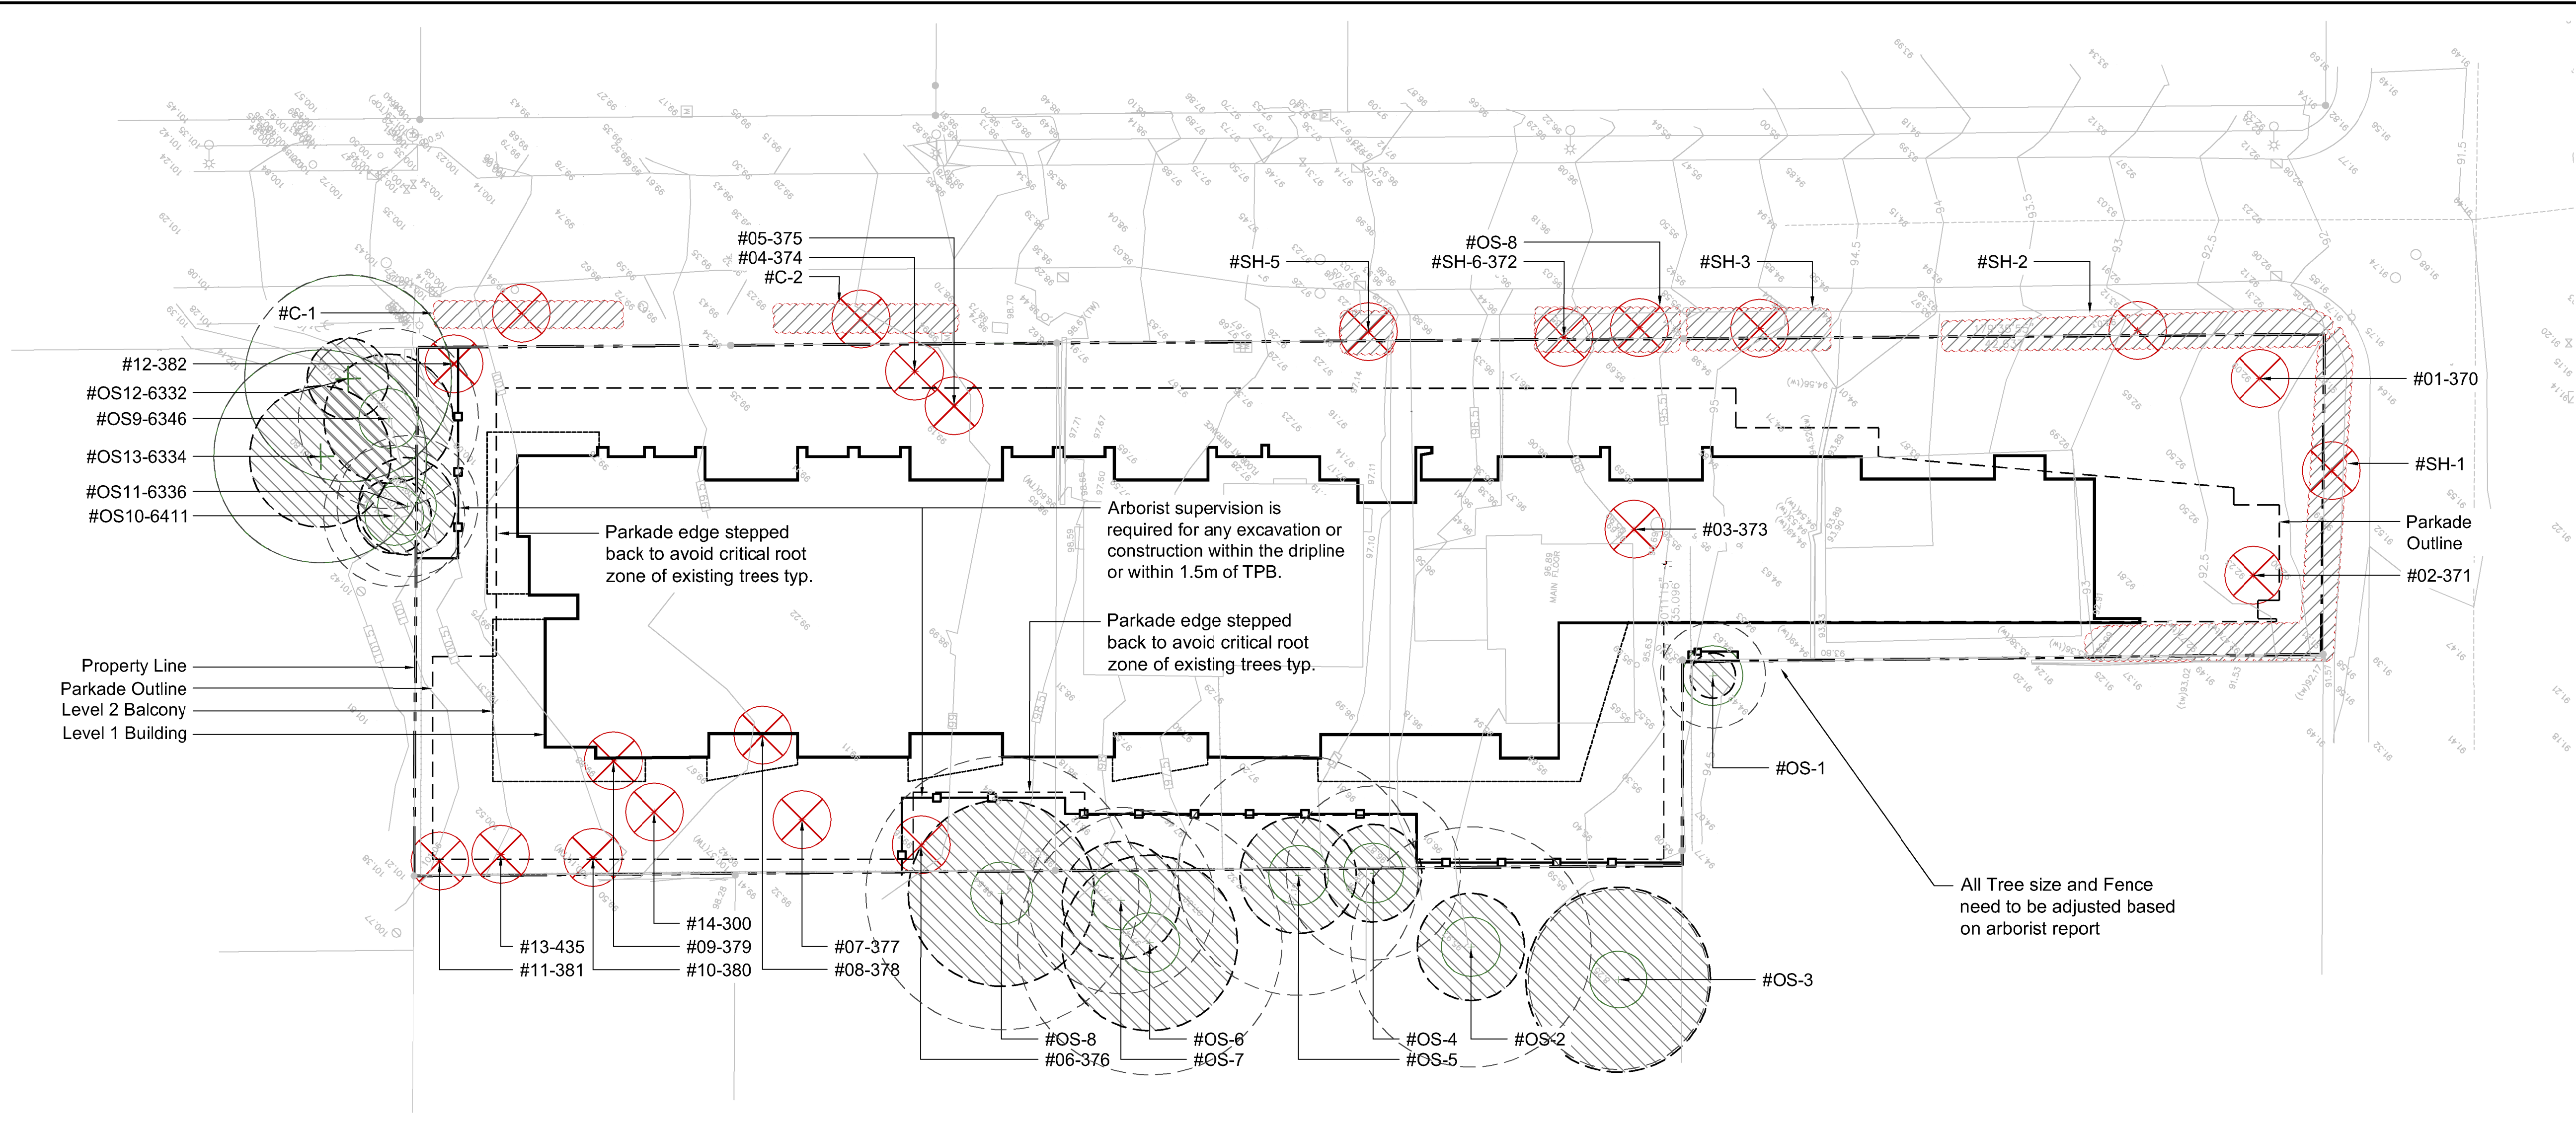
1 TREE PROTECTION AND REMOVAL PLAN
 Scale 1:250

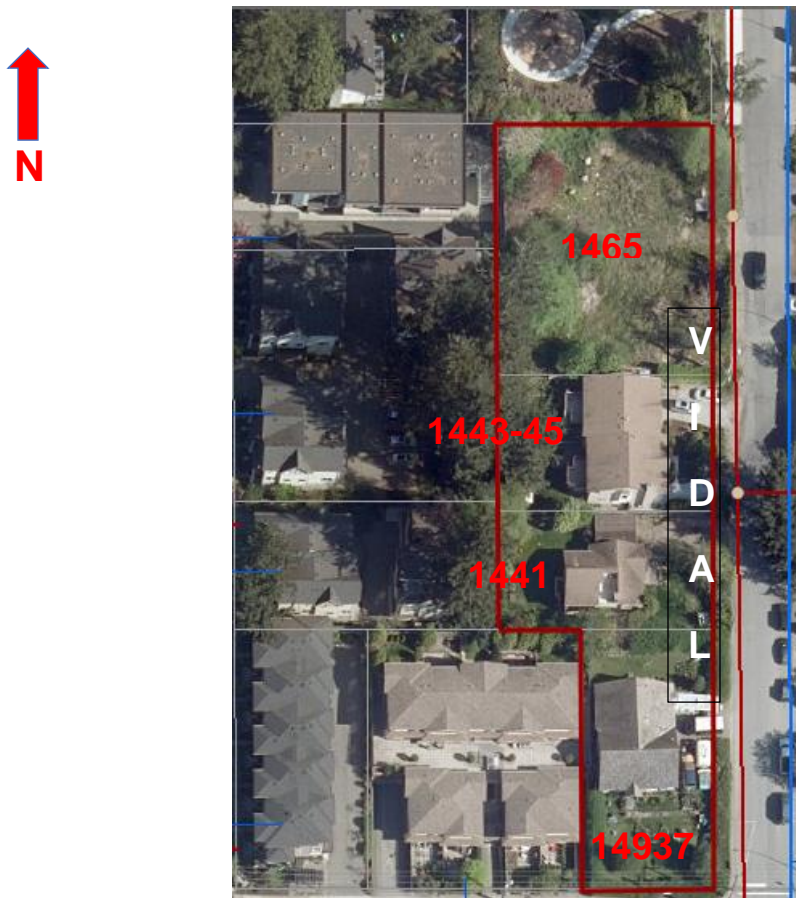
Fig. 1 – Aerial view of property (WROMS)

The site consists of four residential lots, three of which have existing houses.. The southernmost lot is a single-family residential home that fronts onto Thrift Avenue. It is joined via the north property line to the first three lots proceeding up the west side of Vidal Street. From Thrift Avenue, Vidal Street inclines north. To the west lay an assortment of low-rise multifamily residences and to the north is a newer high-rise development.

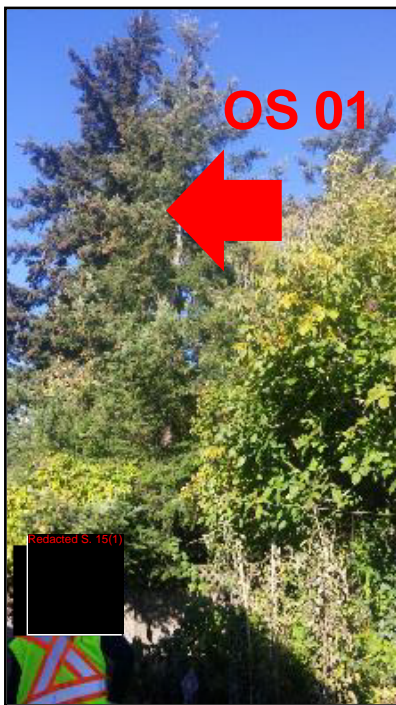
Fig. 3 – Off-site Douglas-fir tree

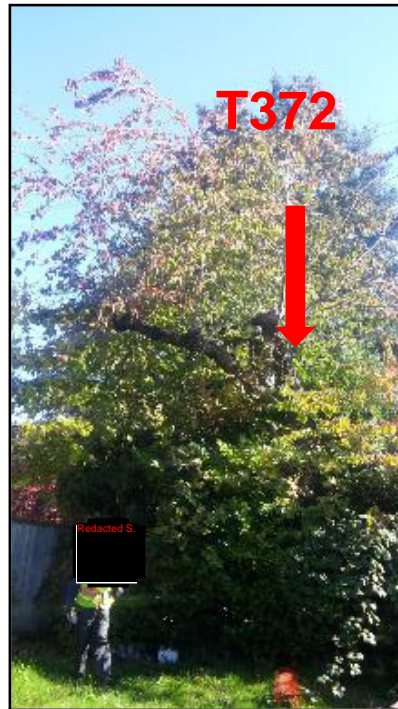
Fig. 4 – Tree 03 growing within S4

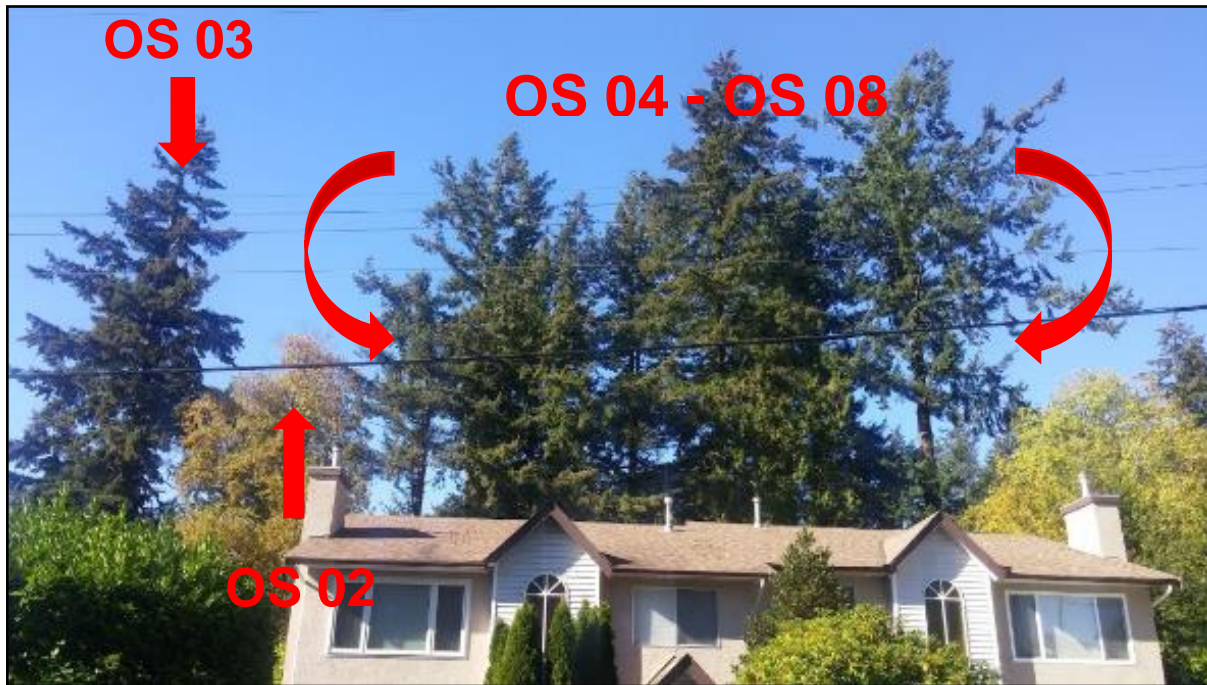
Fig. 6 – Stand of off-site conifers located directly west of 1441/1443-45/1465 Vidal Street.

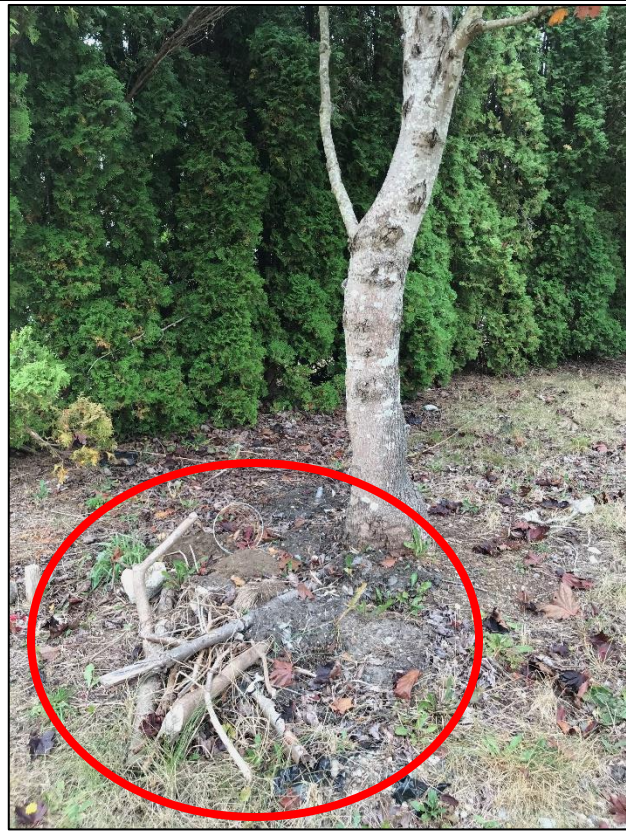
Fig. 14 – Pruning of tree branches along east property line, 1465, 1443-45.

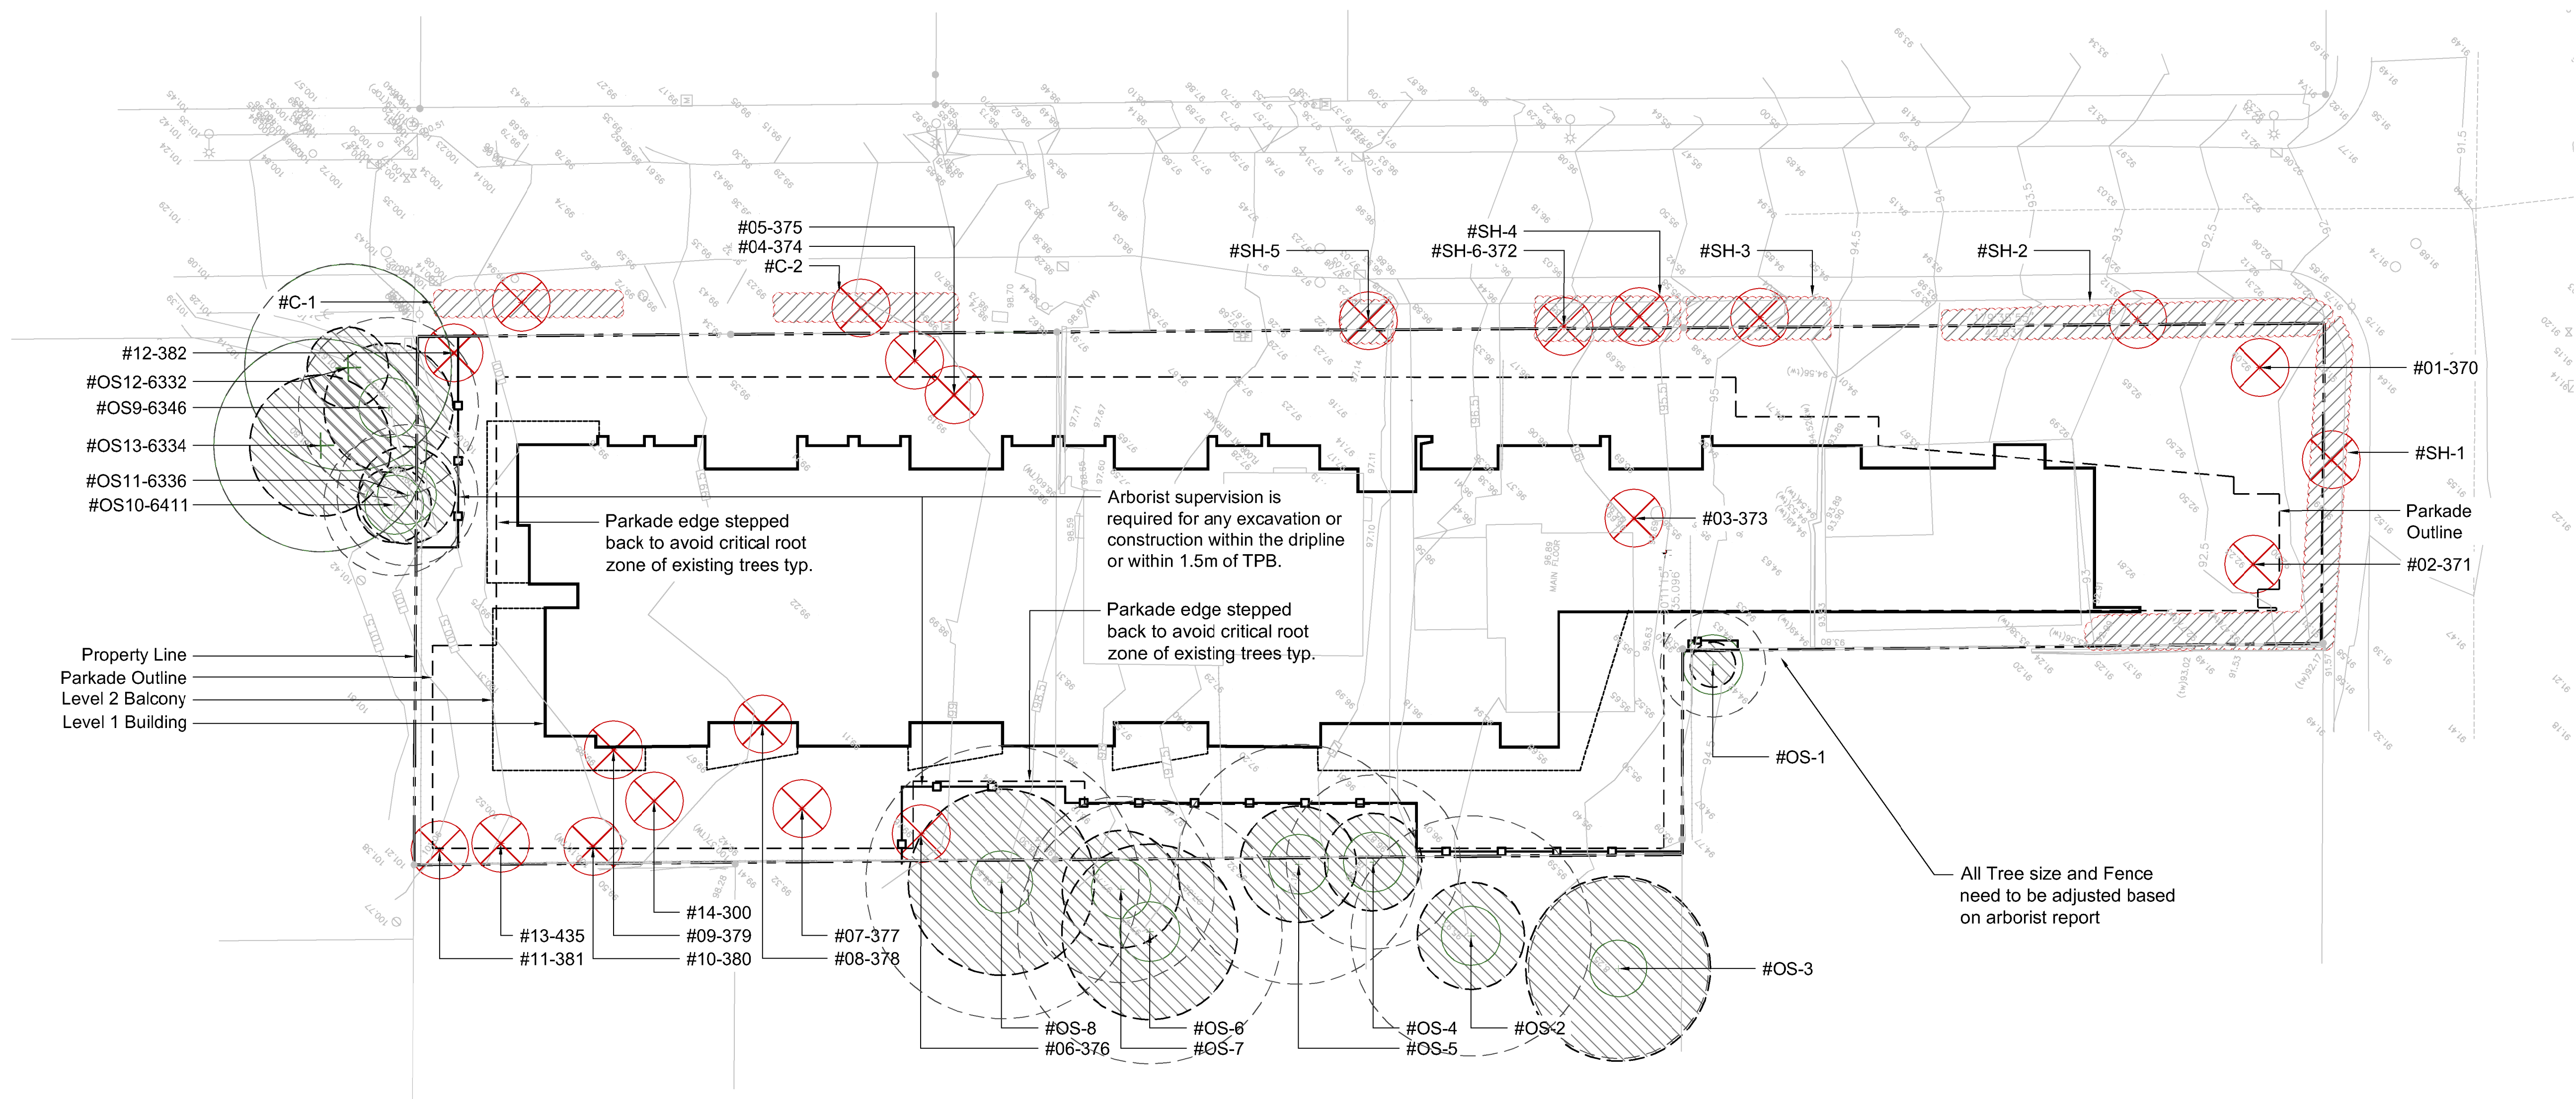
1 TREE PROTECTION AND REMOVAL PLAN
 Scale 1:250

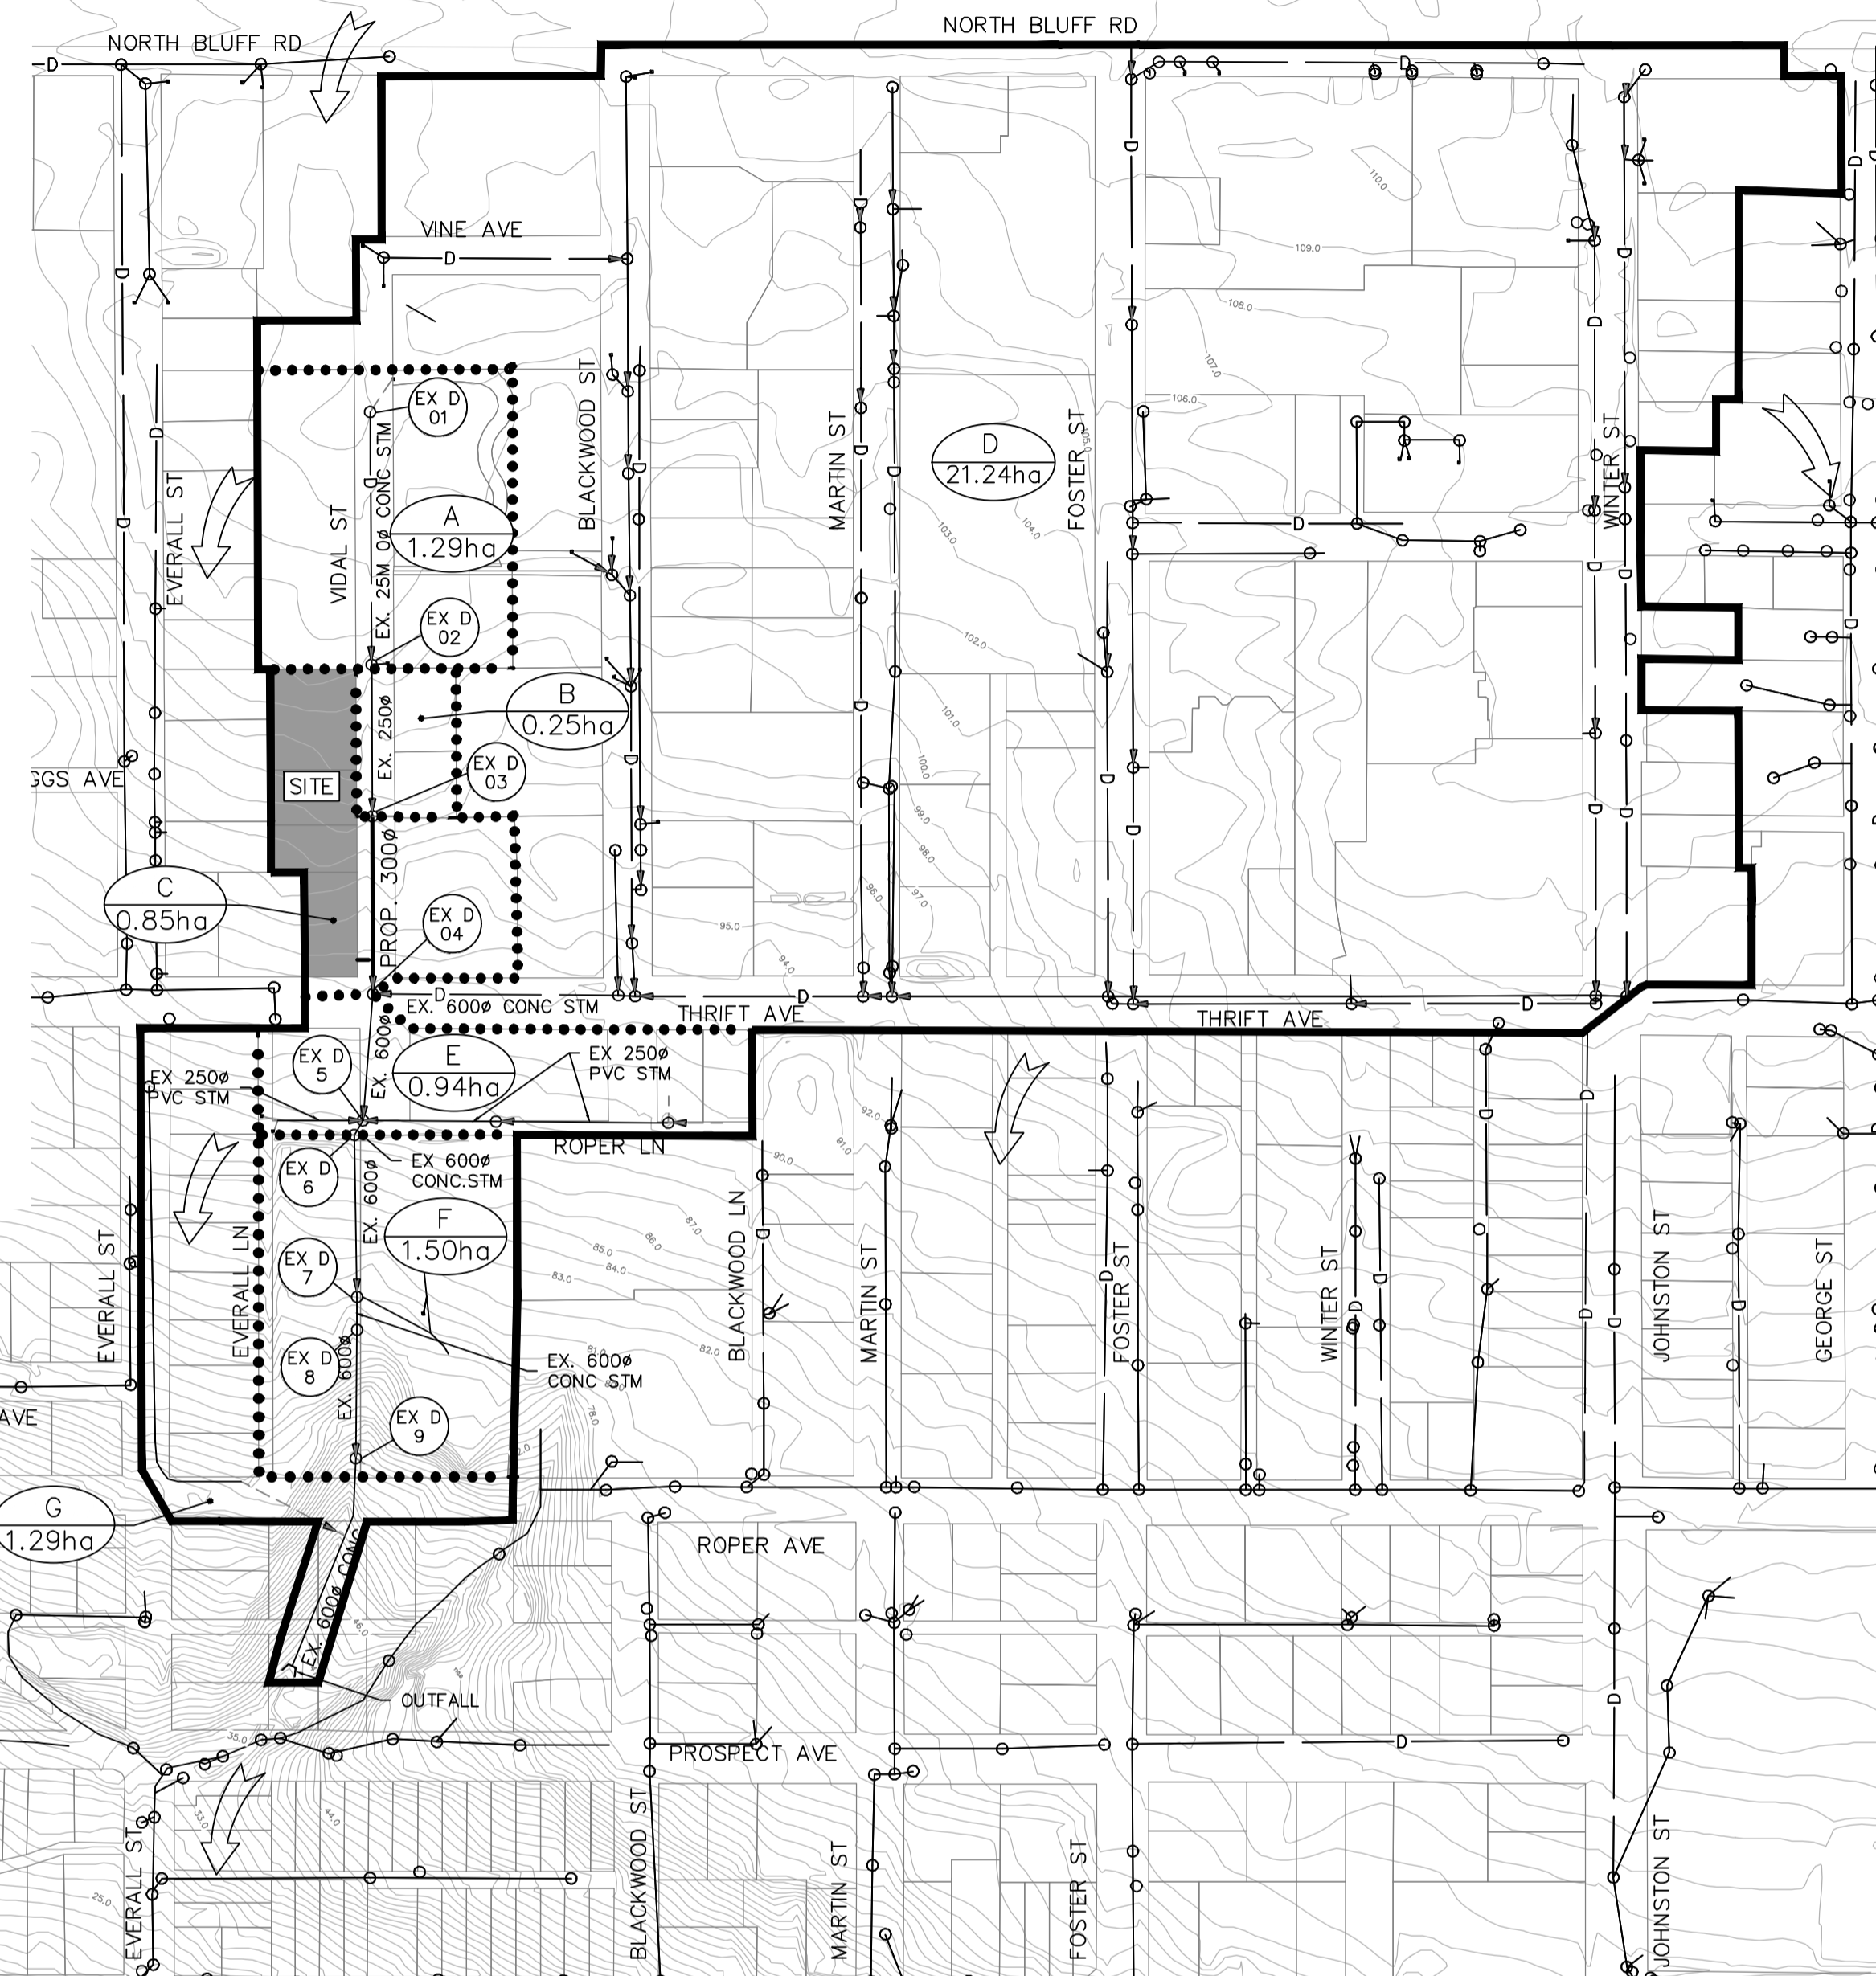
STORMWATER MANAGEMENT PLAN
SCALE : 1:2500

Storage requirements per Modified Rational Method						
Project Vidal Street Development, White Rock						
White Rock STP Rain Gauge						
ARE A	Hectares	A=	0.39			
DESIGN RETURN PERIOD	Years		5			
CONTROL TO 50% OF THE 2-YEAR POST-DEVELOPMENT RATE						
RUNOFF COEFFICIENT		R=	0.6			
TIME OF CONCENTRATION	Minutes	Tc=	15			
RAINFALL INTENSITY	mm/hour	I=	23.64			
2-yr RELEASE RATE	cms	Q _{2yr} =	0.015			
50% 2yr-RELEASE RATE	cms	Q _{2yr/50%} =	0.008			
5-YEAR POST DEVELOPMENT CONDITIONS						
RUNOFF COEFFICIENT			0.85			
EFFECTIVE AREA	Hectares	AR=	0.33			
Time (min)	Intensity (mm/hr)	Post Q (cms)	Storm Volume (cu.m)	Release Q (cms)	Release Volume (cu.m)	Storage Volume (cu.m)
5	63.39	0.06	17.43	0.008	2.40	15.03
10	43.93	0.04	24.16	0.008	4.80	19.36
15	35.45	0.03	29.25	0.008	7.20	22.05
20	30.44	0.03	33.48	0.008	9.60	23.88
30	24.57	0.02	40.54	0.008	14.40	26.14
40	21.10	0.02	46.42	0.008	19.20	27.22
50	18.75	0.02	51.56	0.008	24.00	27.56

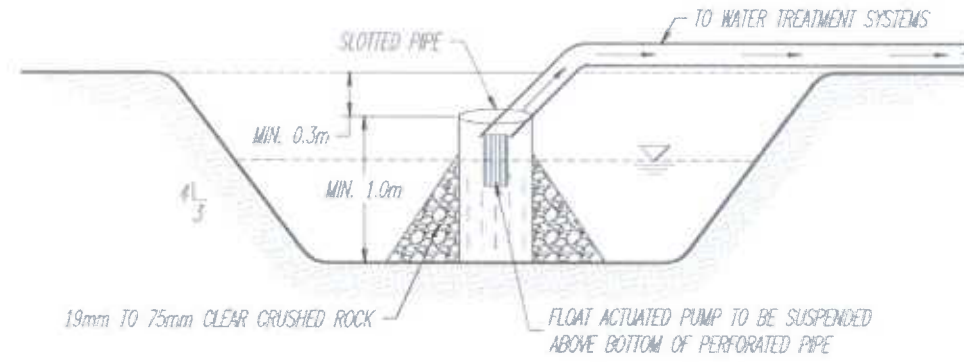
TYPICAL CROSS SECTION

SUMP WITH SEDIMENT TRAP DETAIL - BMP C240

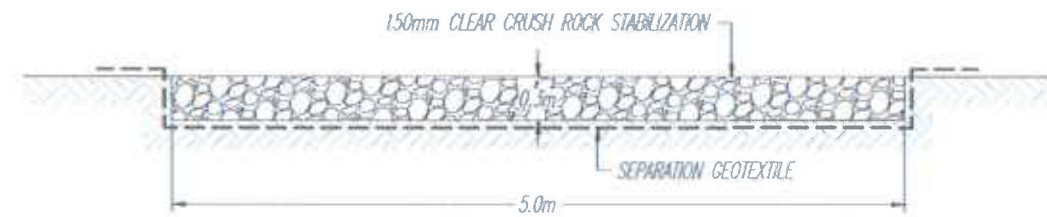
GEOTEXTILE SEPARATION SPECS

GRAB TENSILE STRENGTH (ASTM D4751)	200psi MIN.
GRAB TENSILE ELONGATION (ASTM D4632)	30% MAX.
MULLEN BURST STRENGTH (ASTM D3786 - 80A)	400psi MIN.
AVERAGE OPENING SIZE (ASTM D4751)	20 - 45 (U.S. STANDARD SIZE)

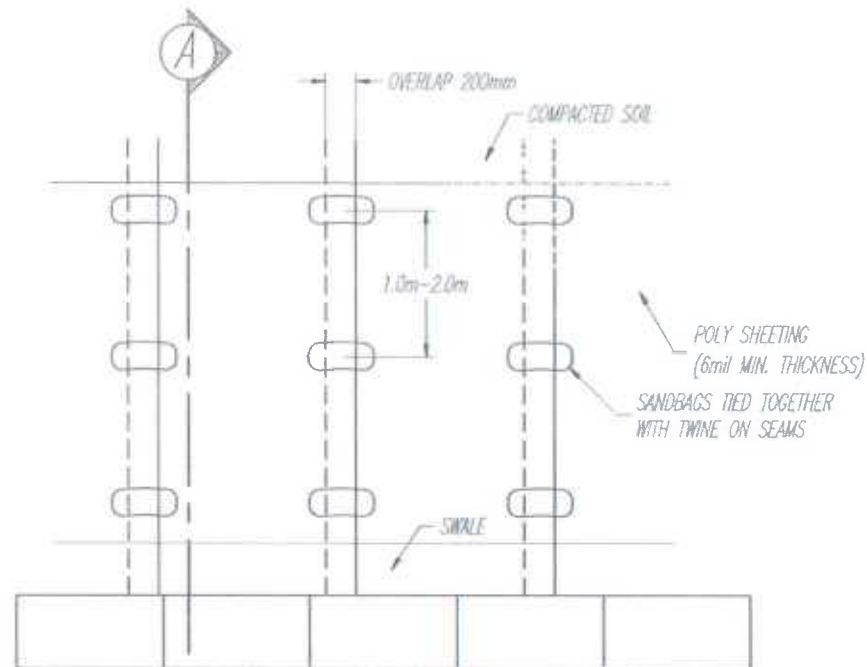
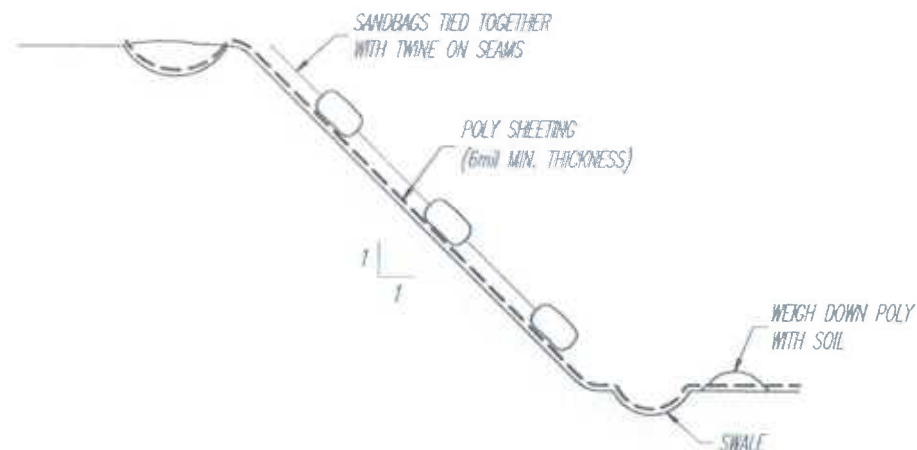
SLOPE PLAN VIEW

SLOPE SECTION A

PLASTIC COVERING - BMP C123

1. POLYETHYLENE SHEETING WITH A MINIMUM THICKNESS OF 6mil TO BE USED.
2. SHEETING TO BE PLACED PARALLEL TO THE SLOPE WITH A MINIMUM 200mm OVERLAP BETWEEN SHEETS.
3. TRENCH TO BE EXCAVATED AT THE HEAD OF THE SLOPE TO ALLOW SHEETING TO BE SECURED UNDER COMPACTED SOIL.
4. TRENCH TO BE EXCAVATED AT THE TOE OF THE SLOPE, TO A DEPTH OF 300mm, WHICH WILL ACT AS A SWALE.
5. BURLAP OR GEOTEXTILE BAGS FILLED WITH SAND TO BE PLACED AT 1.0m TO 2.0m INTERVALS ALONG SEAMS. BAGS TO BE TIED TOGETHER WITH TWINE TO HOLD IN PLACE.
6. REGULAR INSPECTION OF THE SHEETING IS REQUIRED. TORN SHEETS MUST BE REPLACED AND OPEN SEAMS MUST BE SEALED.

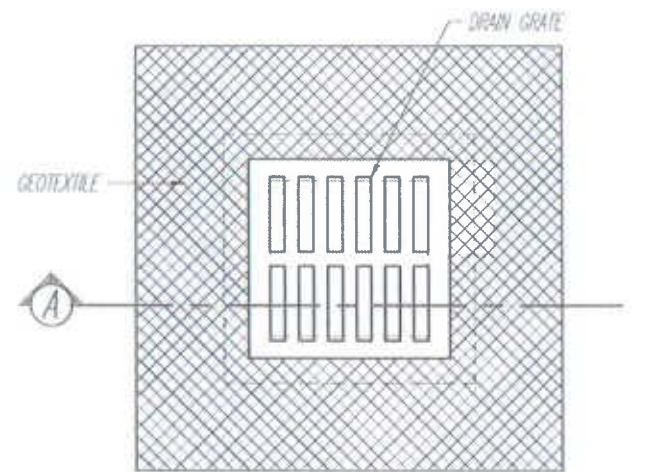
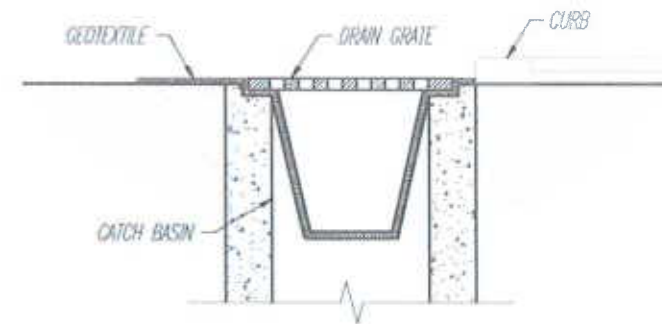
PLAN VIEW

SECTION A

CATCH BASIN SEDIMENT SACK DETAIL - BMP C220

- STORE SPARE CATCH BASIN PROTECTION ONSITE AT ALL TIMES.
- INSPECT CATCH BASIN PROTECTION WEEKLY, AND DAILY DURING STORM EVENTS. CLEAN OR REPLACE WHEN 1/3 FULL, CLOGGED, OR SIGNS OF WEAR OCCUR.
- CATCH BASIN PROTECTION TO BE USED ON ALL CATCH BASINS WITHIN 150m OF SITE EXIT ALONG HAUL ROUTE.

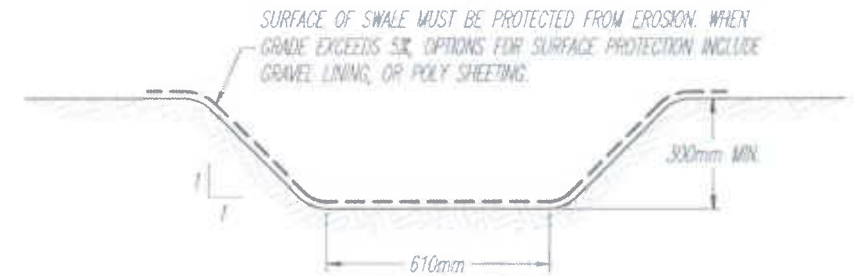
INTERCEPTOR SWALE DETAIL - BMP C200

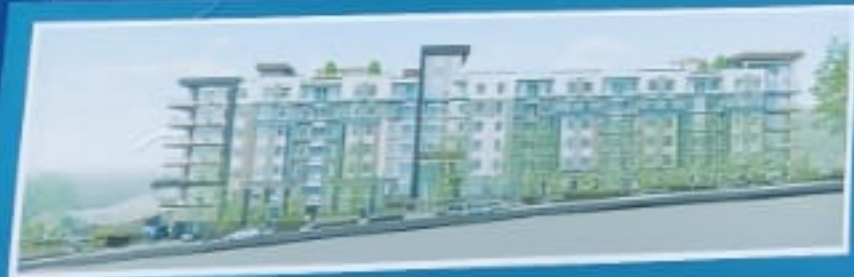
DEVELOPMENT PROPOSAL 19-011

A Zoning Amendment and Major Development permit application have been submitted that would require the consolidation of four properties to enable the development of a 6-storey rental building with 136 residential units. A Development Permit is also required.

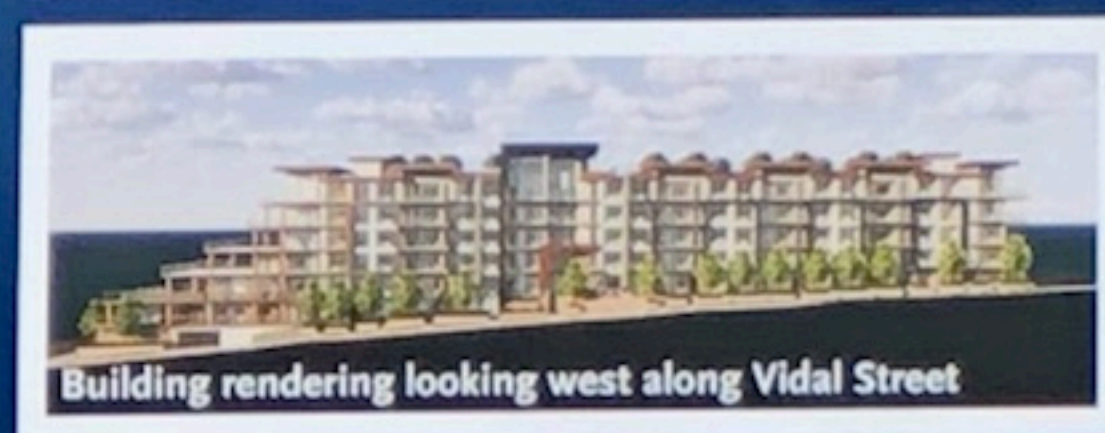
DEVELOPMENT PROPOSAL 19-011

A Zoning Amendment and Major Development permit application have been submitted that would require the consolidation of four properties to enable the development of a 6-storey apartment building with 129 residential units. A Development Permit is also required.
