WHITE ROCK

Facilities Master Plan Update

August 29, 2023

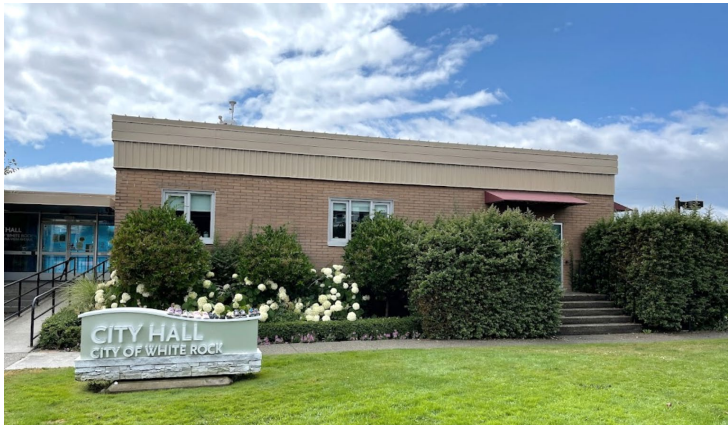
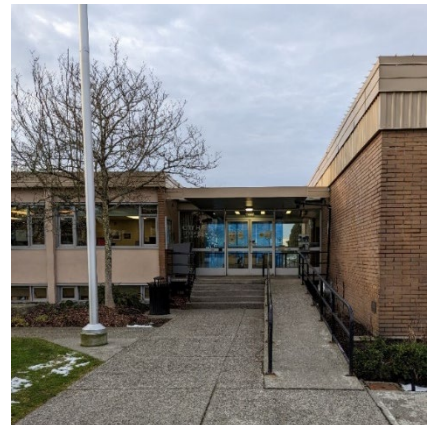
Further, it has been assessed that the existing building is non-compliant with regards to seismic and accessibility standards per City Hall – Seismic Report – 2020 (report dated January 13, 2020).

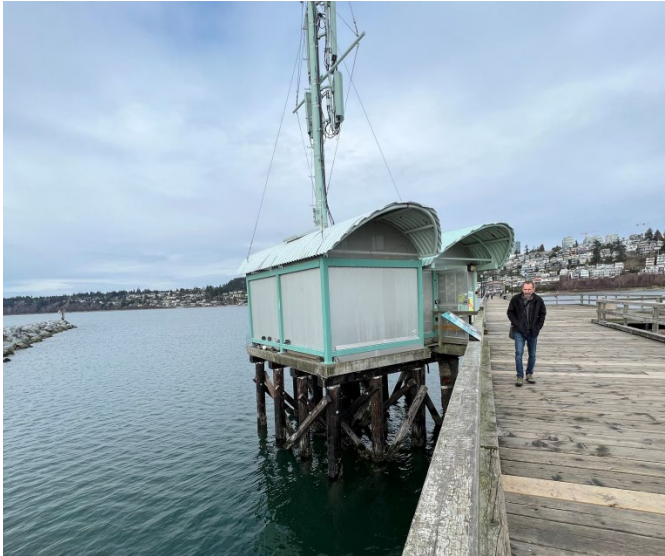
This review addresses the two structures at the end of the White Rock Pier that consist of a storage enclosure and an enclosure for communications tower equipment. The wood structure of the pier itself is outside the scope of this review. The storage enclosure contains scrap wood, surplus wood planks, and maintenance materials for the Pier.

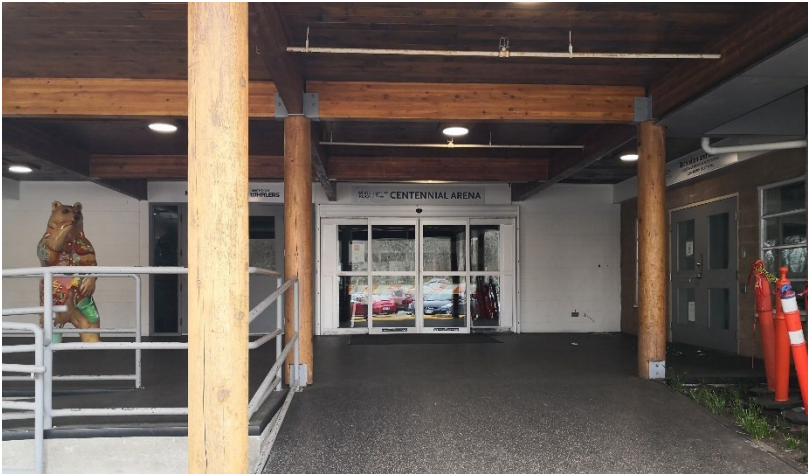
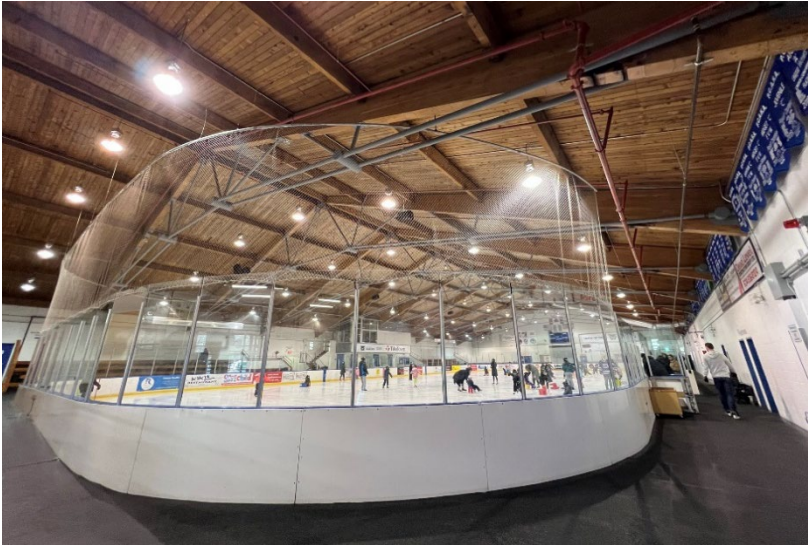
A building addition for a multipurpose hall and administration meeting room was added to the southeast corner of the building in 1998, and the main trusses above the ice rink were upgraded sometime in the 2000s. The roofing has recently been replaced through a capital project.

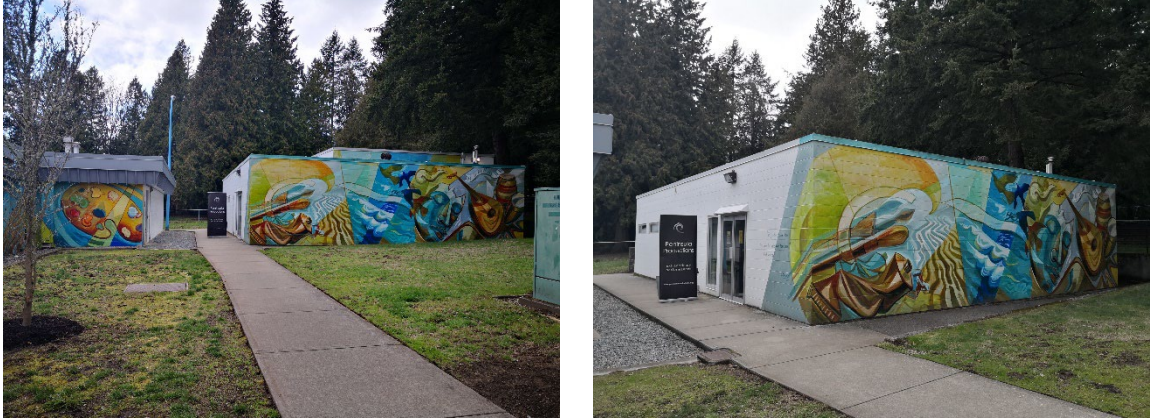
The peninsula production building, built in the early 1970s, is currently leased to a theatre group called Peninsula Productions. It was originally a youth centre for the City of White Rock. It contains a theatre space, meeting room, kitchen, and storage.

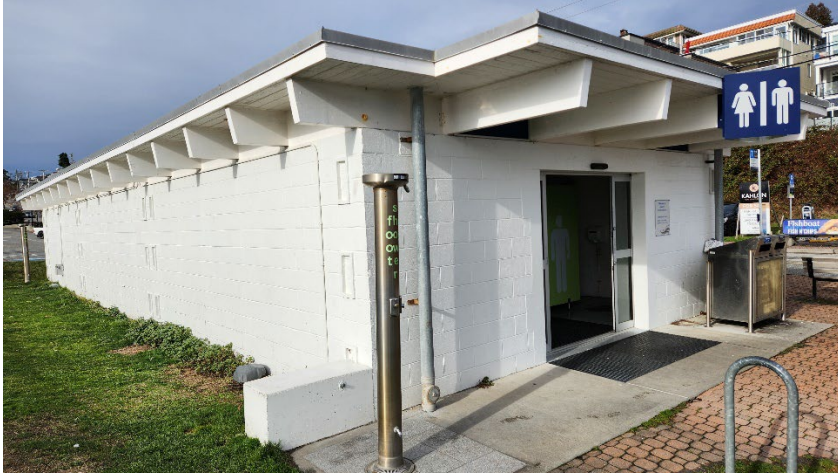
The Balsam Comfort Station is a public washroom facility located along the waterfront near the Balsam Street intersection. It contains male and female washrooms, a dedicated universal washroom and a service corridor. The building was upgraded roughly around 2011 to serve the growing public washroom needs along the eastern portion of the White Rock promenade.

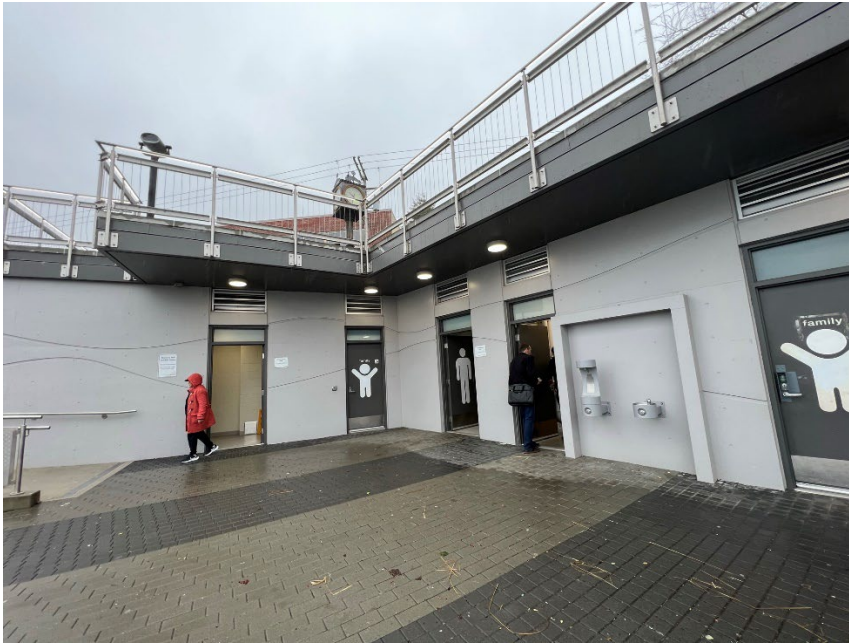
The Memorial Park Comfort Station is located at the plaza entry of the White Rock Pier. It contains male and female washrooms, three individual universal washrooms, and an office and utility room. The building was upgraded in 2019 to serve the growing public washroom needs at Memorial Park, White Rock Pier, and surrounding waterfront area particularly during peak periods in the summer months.

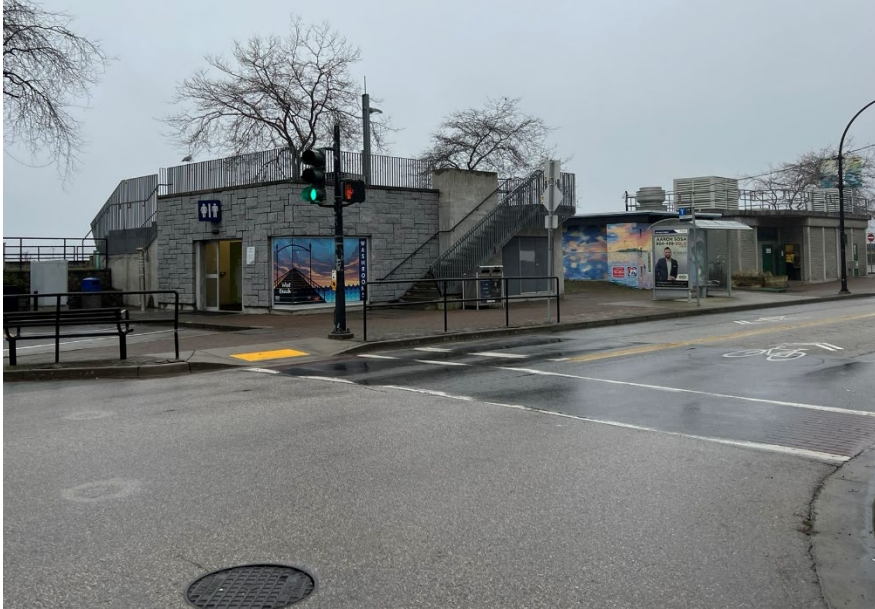
The Oxford Comfort Station is a public washroom facility located along the White Rock Beach near the Oxford Street intersection. It contains male and female washrooms, a dedicated universal washroom, a service corridor, and a separate storage building which was part of the original building. The building was upgraded roughly around 2011 to serve the growing need for public washrooms along the White Rock Promenade recreation area particularly during the peak periods in the summer months.

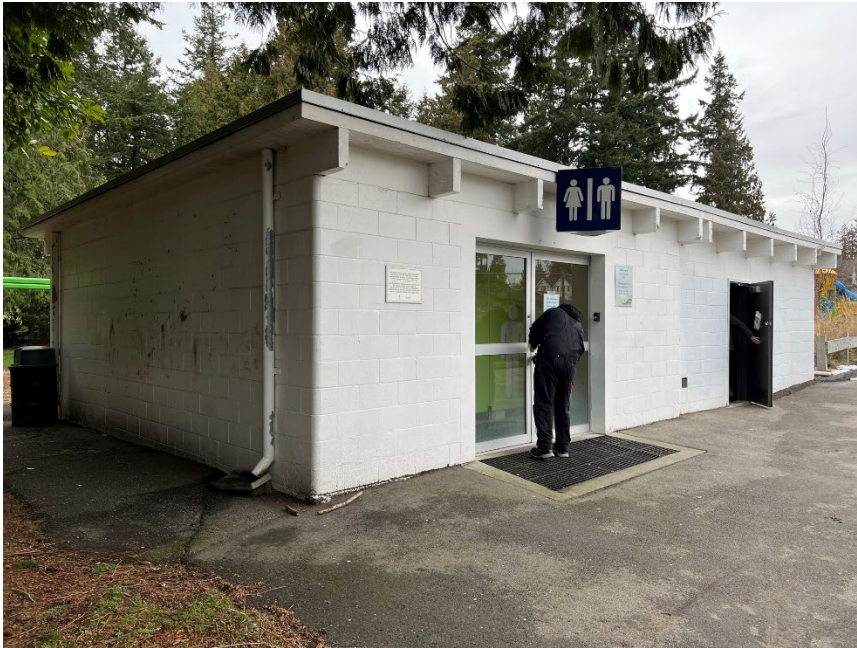
The Ruth Johnson Park Comfort Station is a public washroom facility located in Centennial Park. It contains male and female washrooms; a dedicated universal washroom; a service corridor; and a storage space. The building was upgraded roughly around 2011 to serve the growing need for public washrooms for the surrounding Ruth Johnson Trails, White Rock Generations Playground, and Centennial Park Soccer and Running Oval.

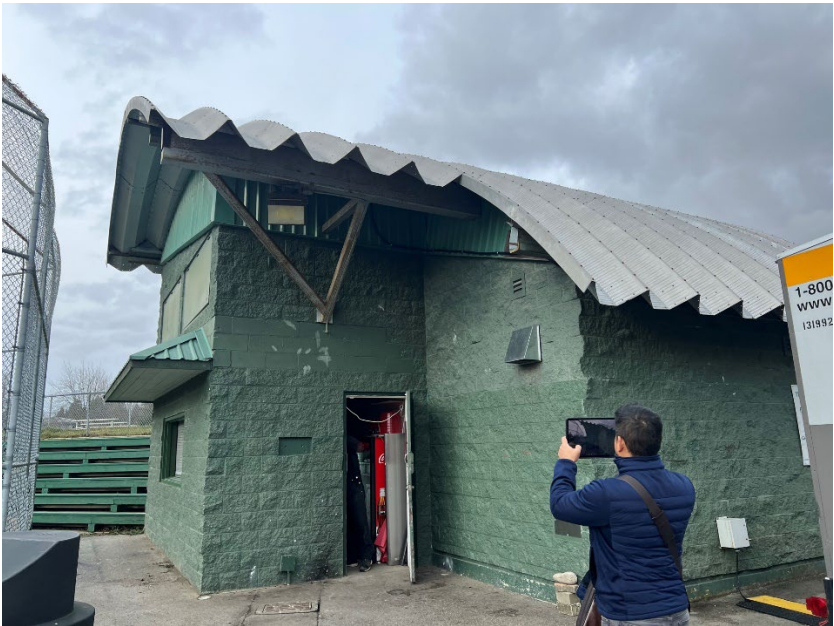
The Centennial Baseball Diamond Comfort Station is a public washroom facility and concession space located in Centennial Park. It contains male and female washrooms, a dedicated universal washroom, second level storage, and a concession space that is part of the initial building. The building was upgraded roughly around 1999 to serve the growing demand of the Centennial Baseball Diamond.

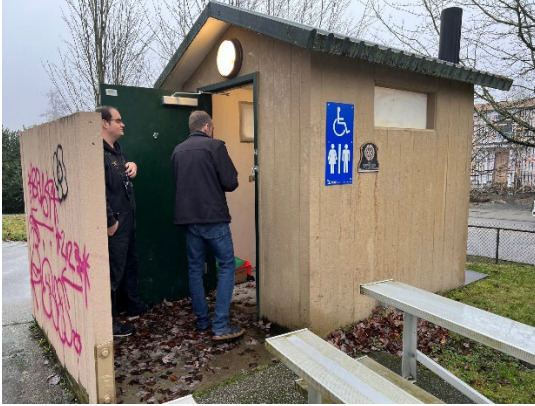
The Peace Arch Elementary Comfort Station is a public washroom facility located at the Peace Arch Elementary field. It is a single washroom building. It was built in 2011 to serve as a public washroom for recreational activities on the field.

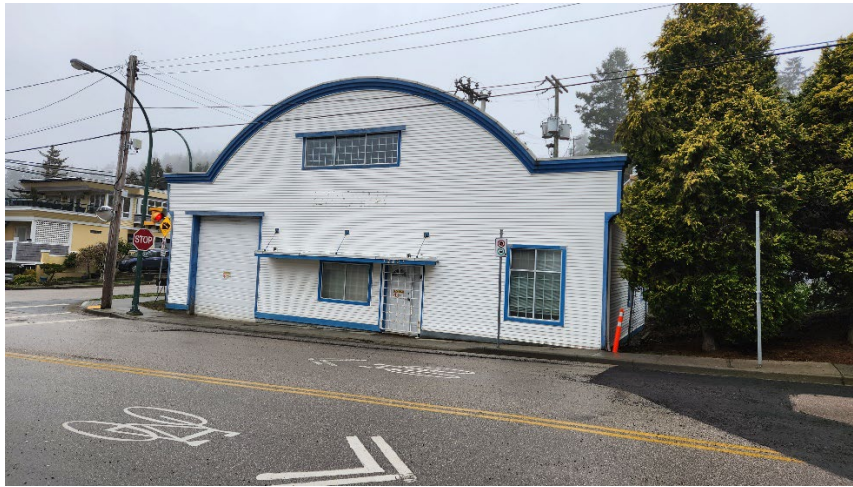
The Waterworks Yard and Shop Building, originally built in the late 1940s, is located on northeast corner of Oxford Street and Buena Vista Yard. It contains a workshop, staff lounge, offices, and a storage attic. Outside, there is a covered garage and storage shed. A few personnel of the Public Works Department work from here.

The building is showing signs of foundation settlement on the south side creating cracking in the finishes and sloping floors. If the City plans to continue to occupy the building these issues will need to be repaired. A geotechnical assessment will be the first step to determine the cause, followed by structural repairs and upgrade.

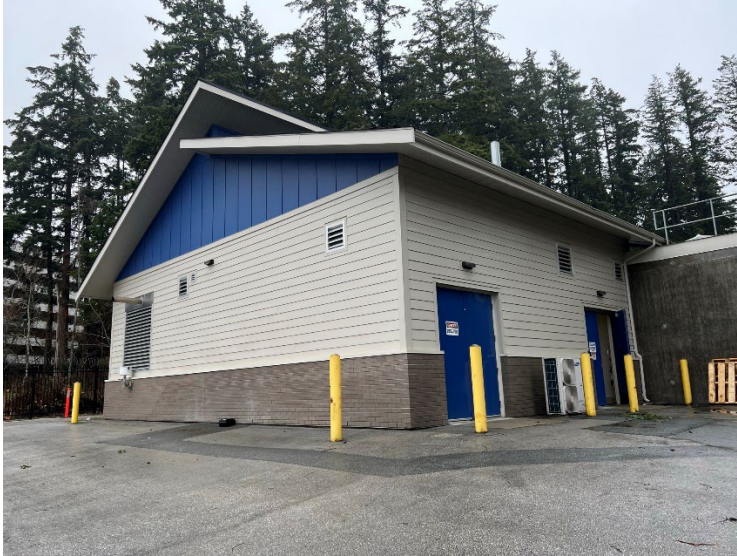
The Oxford Pump House and a separate small building housing a generator, built in 2015, is located beside the Water Treatment Plant which was later added in 2018. It also houses a few staff from the Public Works Department.

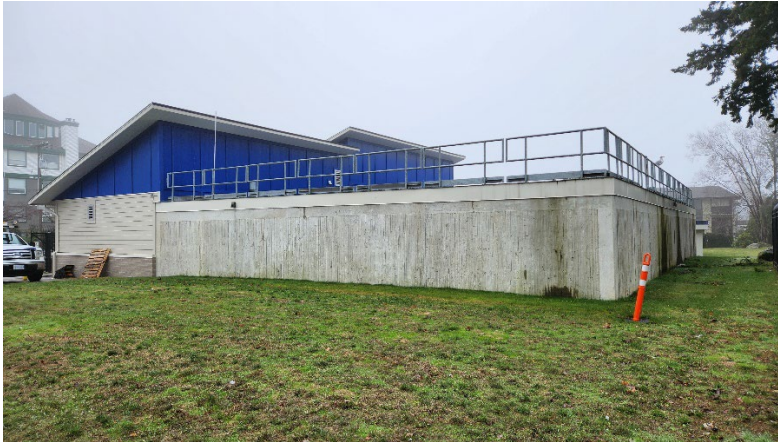
The Merklin Pump House, built in 2018, is located at North Bluff Road and Merklin Street serving as pumping station facility for the City of White Rock. It contains a pump station room, generator room, and reservoir. A few personnel from the Public Works Department work from here.

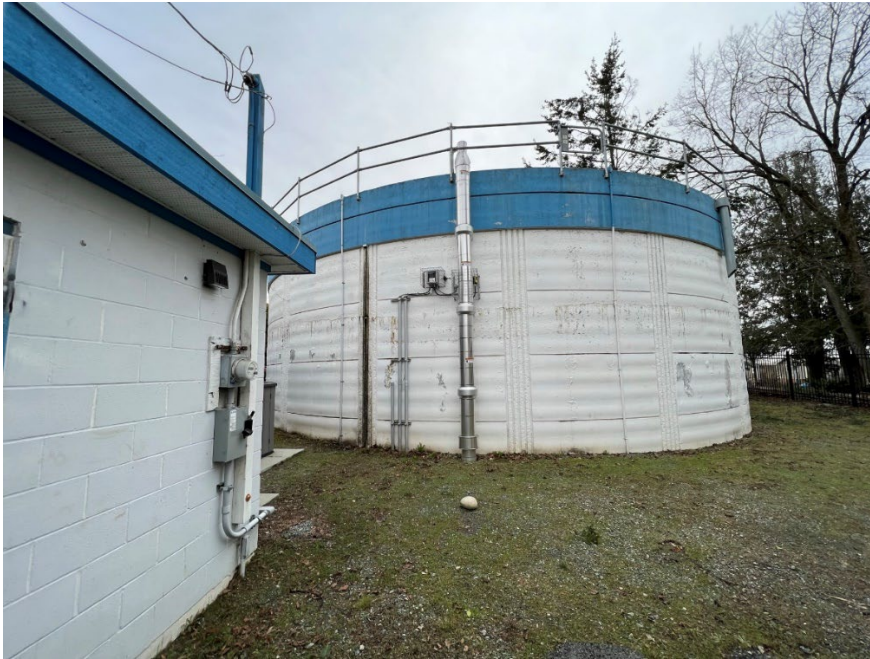
The Roper Pump House and Reservoir, built roughly around 1970, is located at Johnston Lane and Roper Avenue serving as pumping station facility and reservoir for the City of White Rock. The site contains a small single pump station building and reservoir tank. There are a few staff from the Public Works Department who service the facility weekly. It has a portable back-up generator with external transfer switch for quick connect to the building.

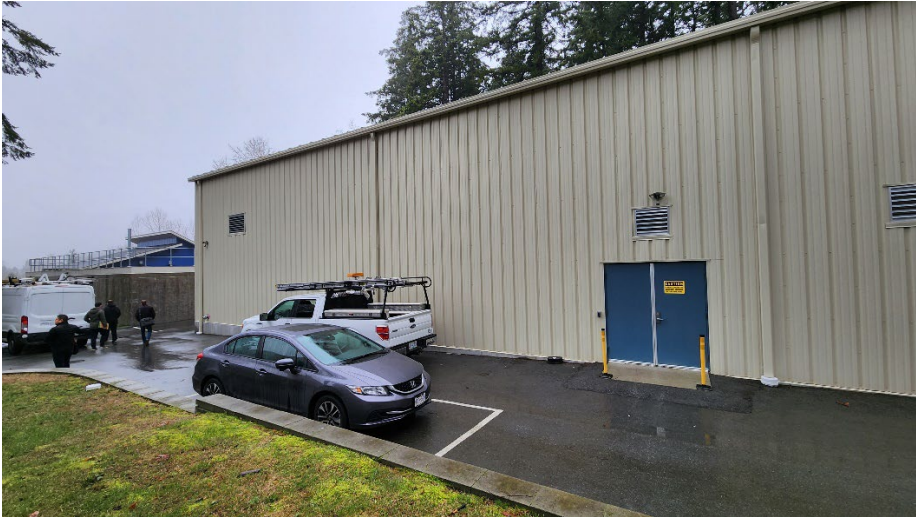
The Water Treatment Plant, built in 2019, is located at Goggs Avenue and Everall Street serving as water treatment facility for the City of White Rock. It is adjacent to the previously built Oxford Pump station and reservoir. A few personnel of the Public Works Department work from here.

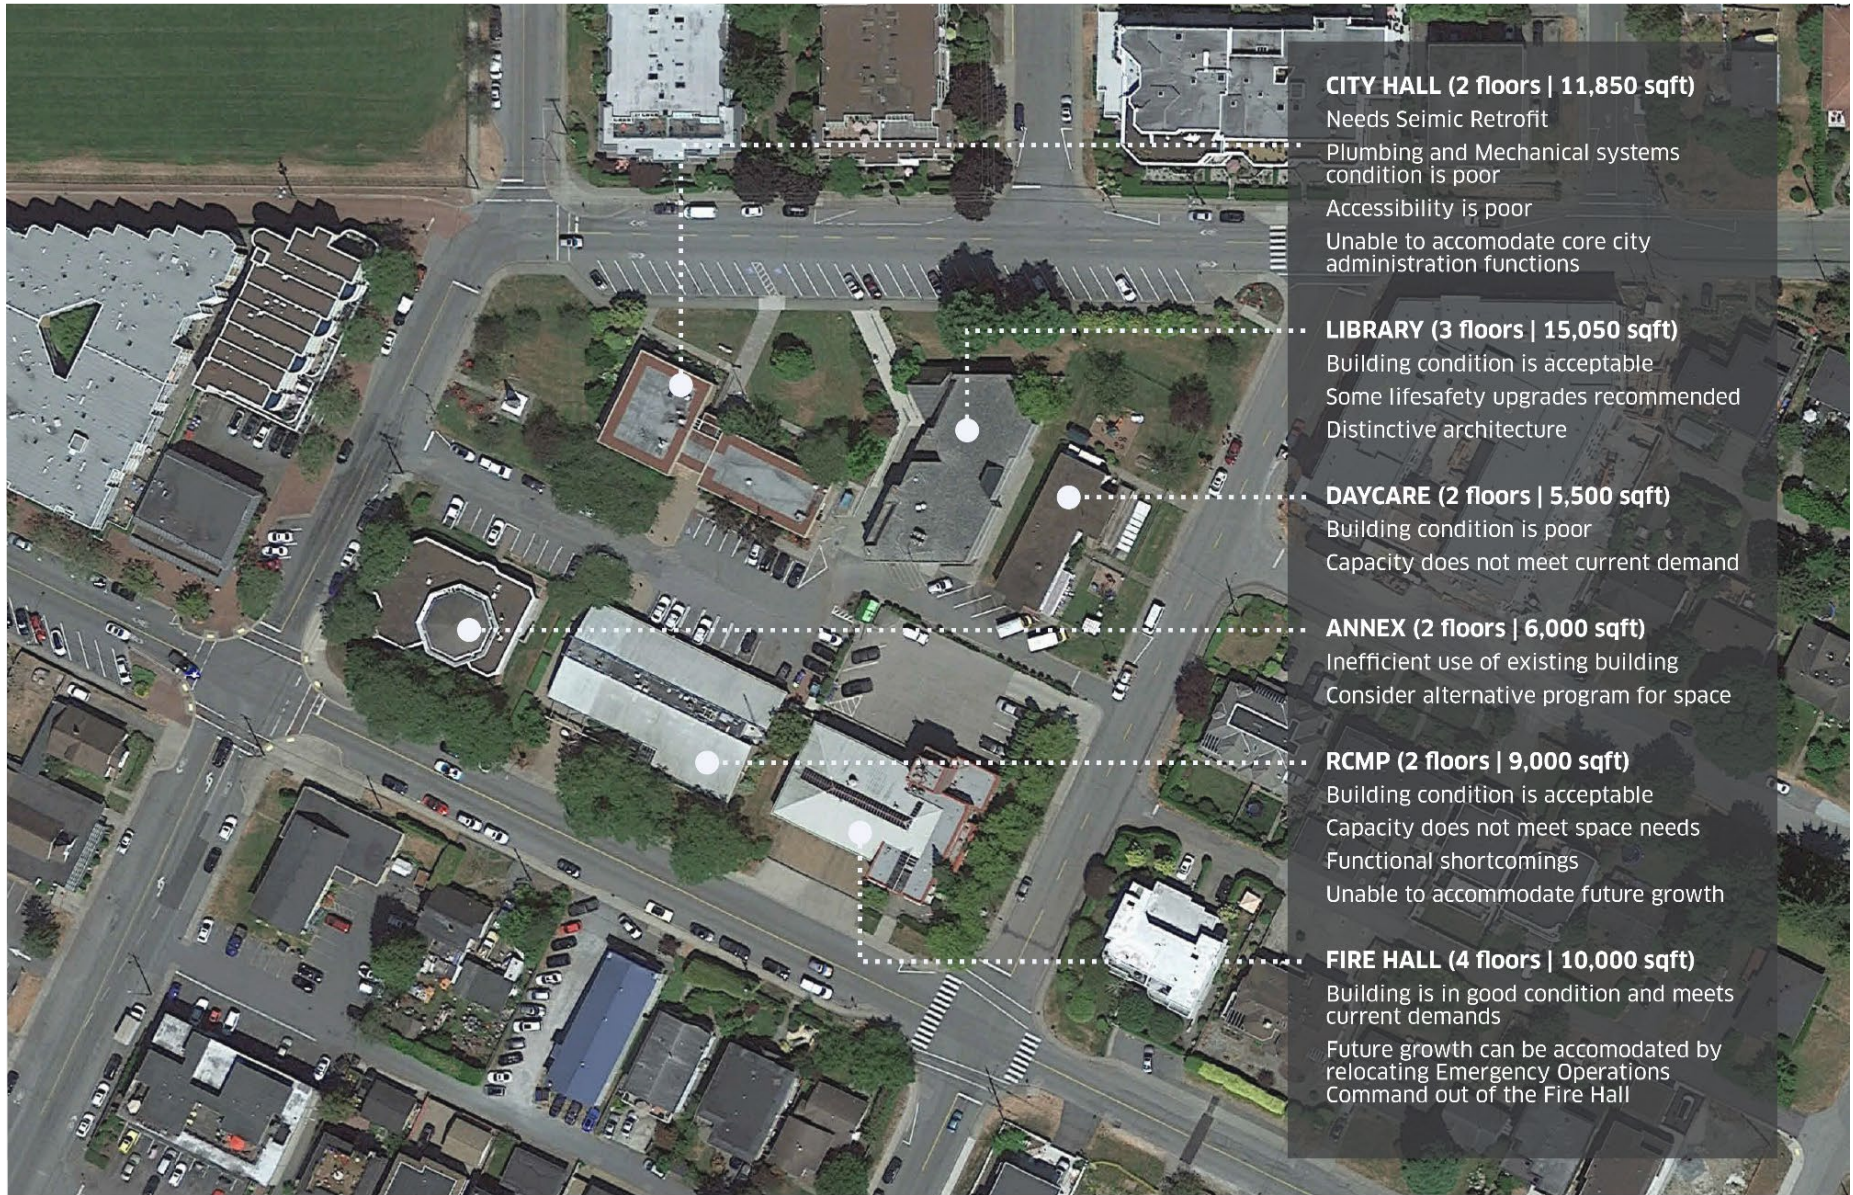
4.4.1 City Hall Block – Visual Summary of Existing Conditions

Six facilities owned, operated or managed by the City are located at the current City Hall block situated between Fir St. and Centre St., and between Buena Vista Ave. and Pacific Ave. Considered together as an urban node, they represent a unique opportunity for densification and for enhancing the public realm. The central nature of this location adds to this potential.

The map on the following page outlining salient points from facility assessments of the six buildings attempts to begin looking at these individual buildings as components of a larger whole. It is the first step to begin understanding relationships and synergies, and forms the premise for exploring approaches for potential redevelopment of this entire city block.

4.4.1 - City Hall Block – Visual Summary of Existing Conditions recaps salient points from building assessments of the six buildings in an attempt to begin looking at these individual buildings as components of a larger whole and begin understanding relationships, synergies, and challenges.

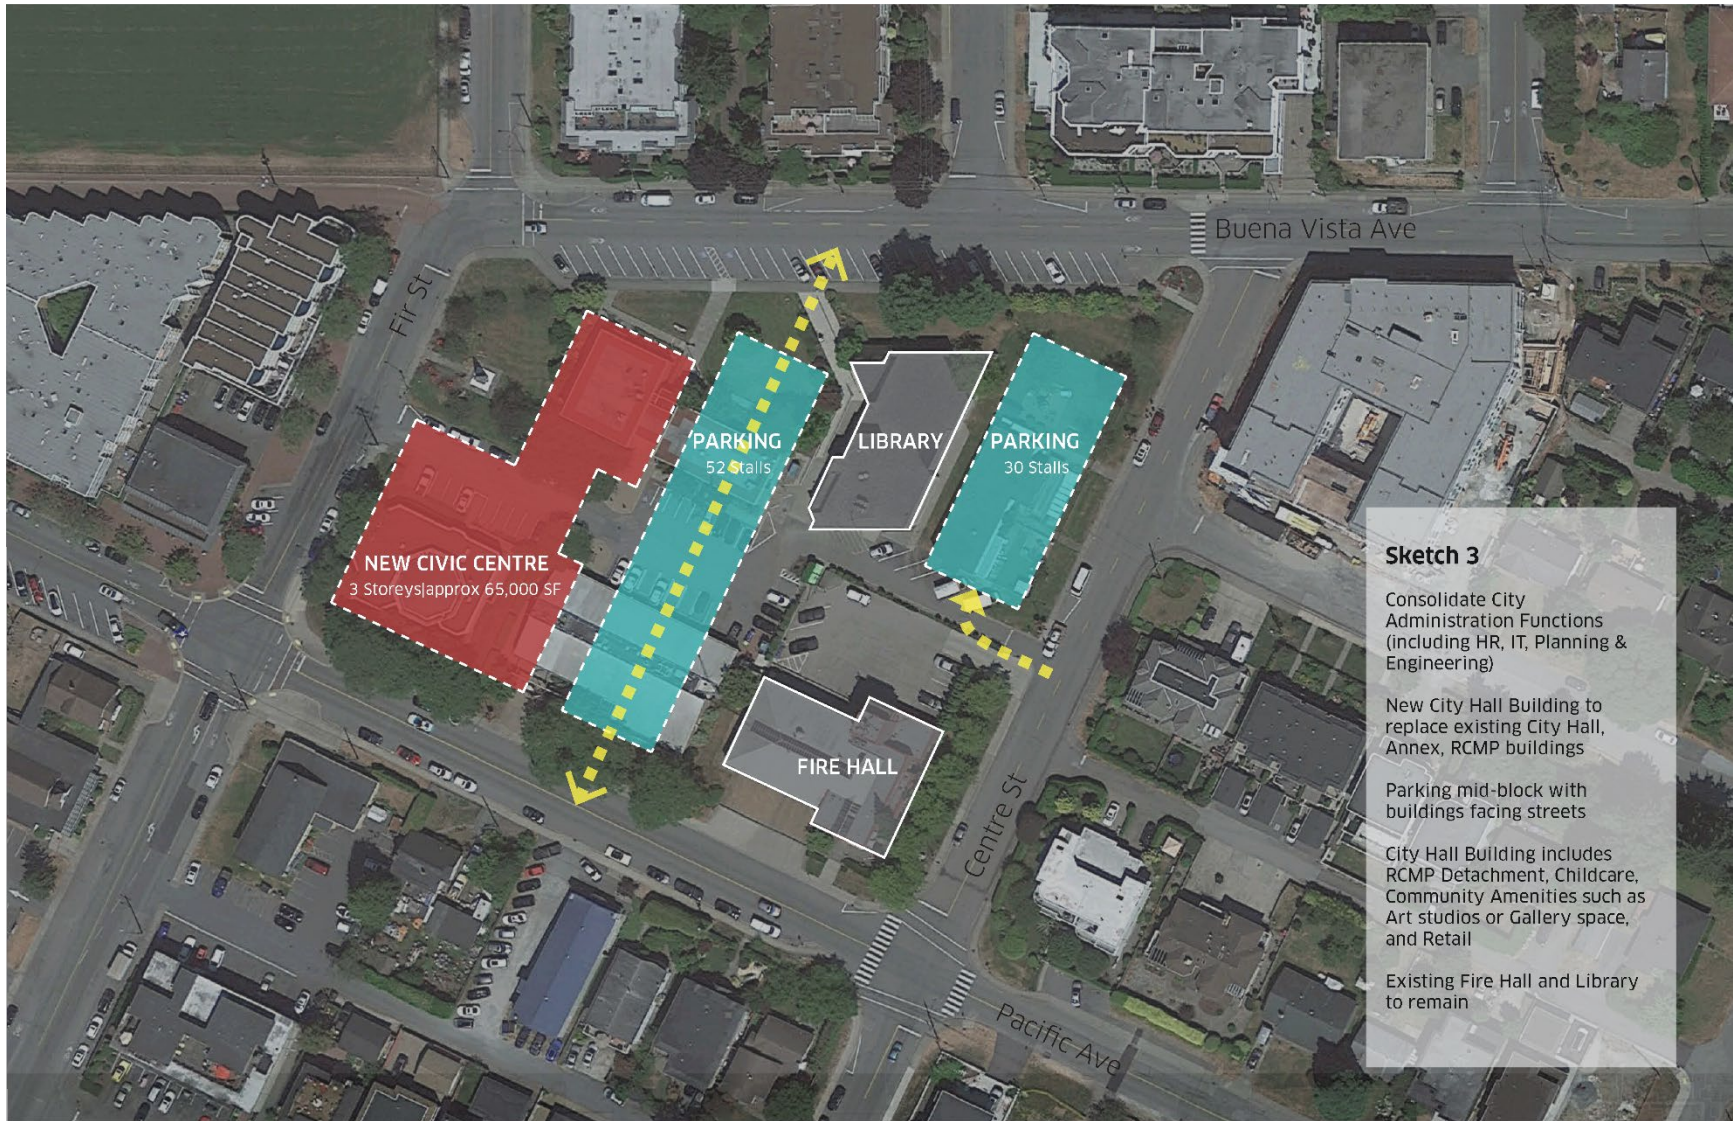
Sketch 3

Consolidate City Administration Functions (including HR, IT, Planning & Engineering)

New City Hall Building to replace existing City Hall, Annex, RCMP buildings

Existing Fire Hall and Library to remain

Based on the facility assessments and priorities that emerged through Staff interviews and workshops, further exploration of redevelopment opportunities at this city block was commenced. Sketches 1 through 6, in the following pages explore various approaches, opportunities and possibilities arising from different levels of intervention across this block.
