City of White Rock Drainage Master Plan Update

Final Report

August 2019

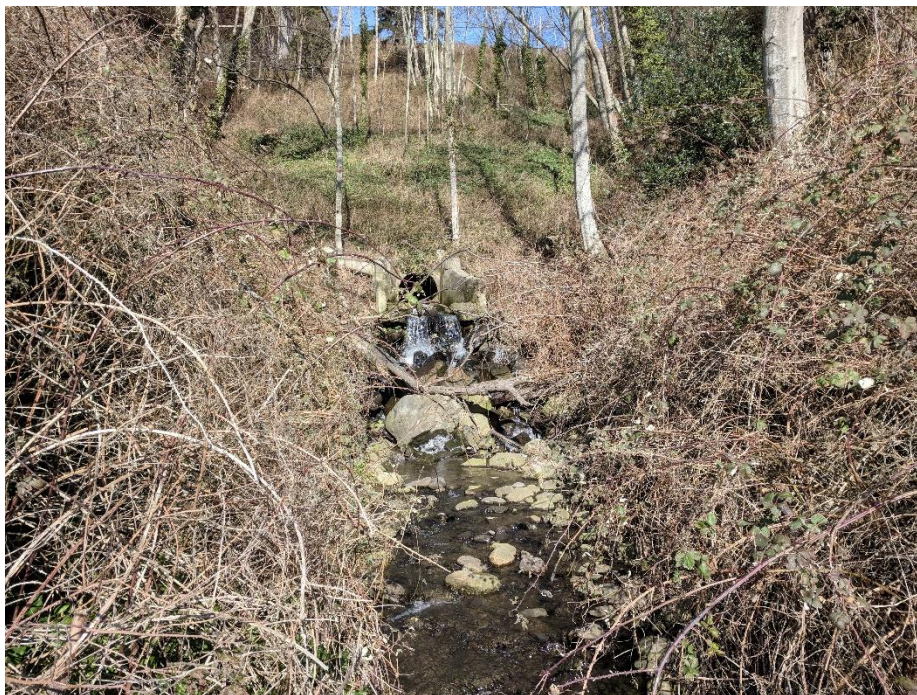
Photo 5 Collingwood Ravine – Outlet Slopes Covered with Blackberries
